Rehabilitation of the Roof Timber Trusses of a Multiuse Pavilion

Abstract

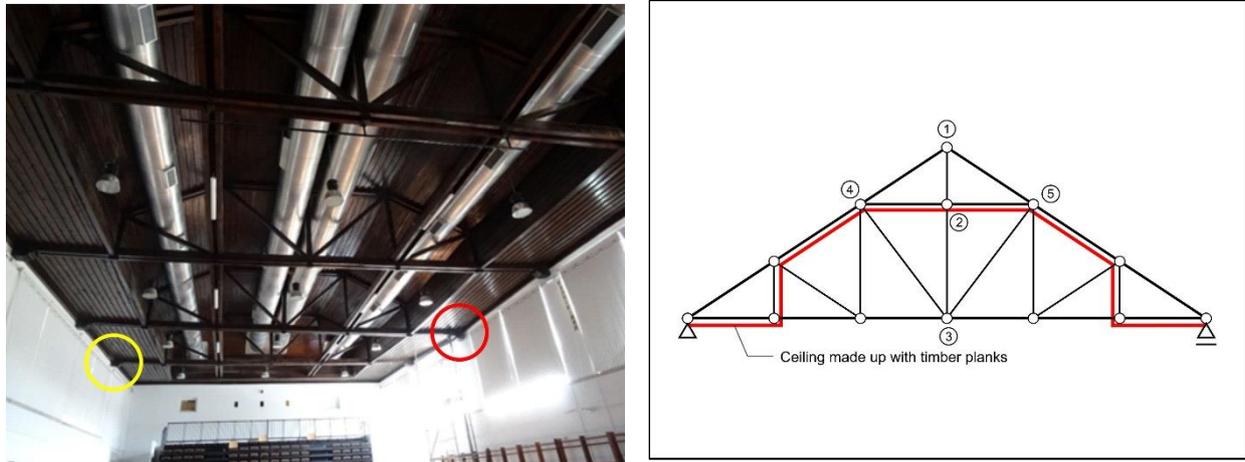
Figure 2. Inner view of the room and damaged supports (left); Scheme of the ceiling (right)

In early September 2017, coincident with the beginning of the scholar year, the collapse of one support (red circle in Figure 2-a) of one of the main trusses was detected, as well as the pre-failure condition of one support (yellow circle) of another truss. Spurious load-redistribution provided by secondary elements, even if not specifically accounted for in design, and the prompt shore of the affected trusses, in order to alleviate those elements and stop the progression of the failure process, prevented the generalized failure of the affected trusses. ITeCons [14], a research and consultancy institute hosted within the University of Coimbra, was contracted for the inspection and assessment work and, later on, for the production of the rehabilitation design. The later detailed inspection of the support area revealed that the cause of the collapse was tension failure perpendicular to the grain in a joining wooden member. Figure 4-left details the joint (some drawing simplification was introduced in the rafter and tie beam ends, for clearness), while Figure 4-right is a scheme of the observed failure mechanism.

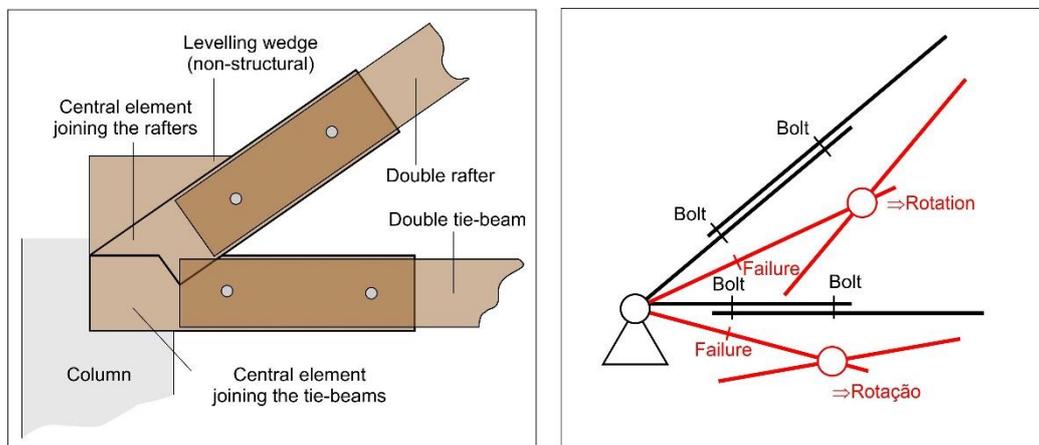
Various possible explanations for the adoption of this joint arrangement can be drawn, namely: *i*) the insufficient length of the rafters and the tie beams to allow the force equilibrium in the theoretical support point (situation schematically represented in Figure 4-left; *ii*) the insufficient length of the tie-beam toe to withstand the horizontal shear force component; *iii*) the eccentric concurrent point of the rafters and the tie-beams with respect to the theoretical support point, originating a binary that must be equilibrated by bending of these bars; *iv*) the centering of the reaction in the middle of the support in the longitudinal (wall) direction; *v*) a combination of these.

Figure 4. Joint arrangement at the support (left); Potential (observed) failure mechanism (right)

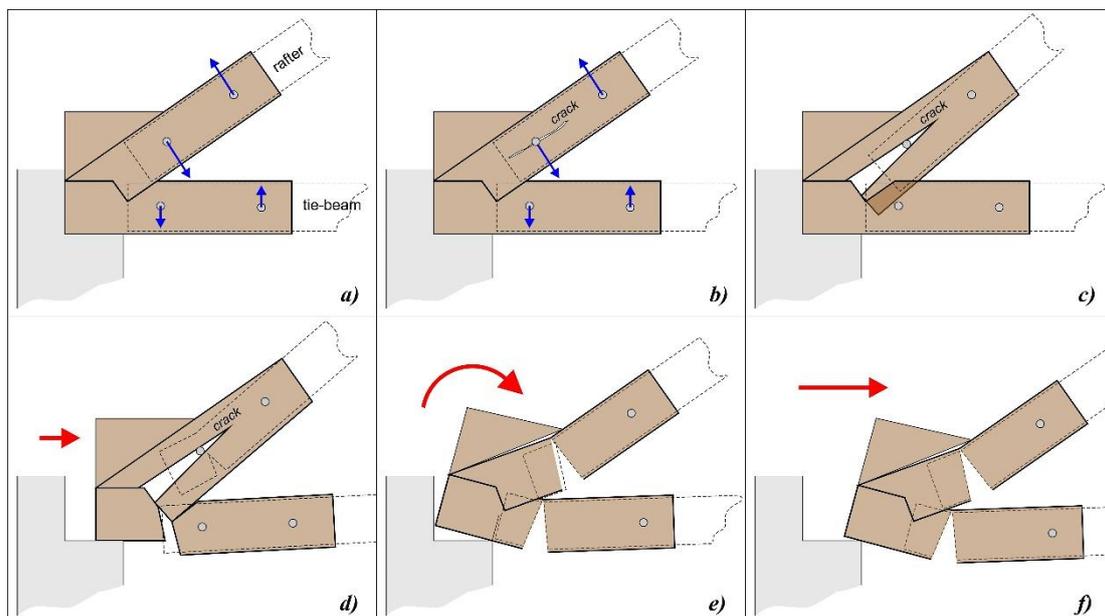
For better understanding, the sequence of events that caused the failure schematically illustrated in Figure 4-right is represented in the following figures, which agree in an exemplar manner with the photographic record of the accident collected on site.

Figure 5. Sequence of events that led to the support collapse

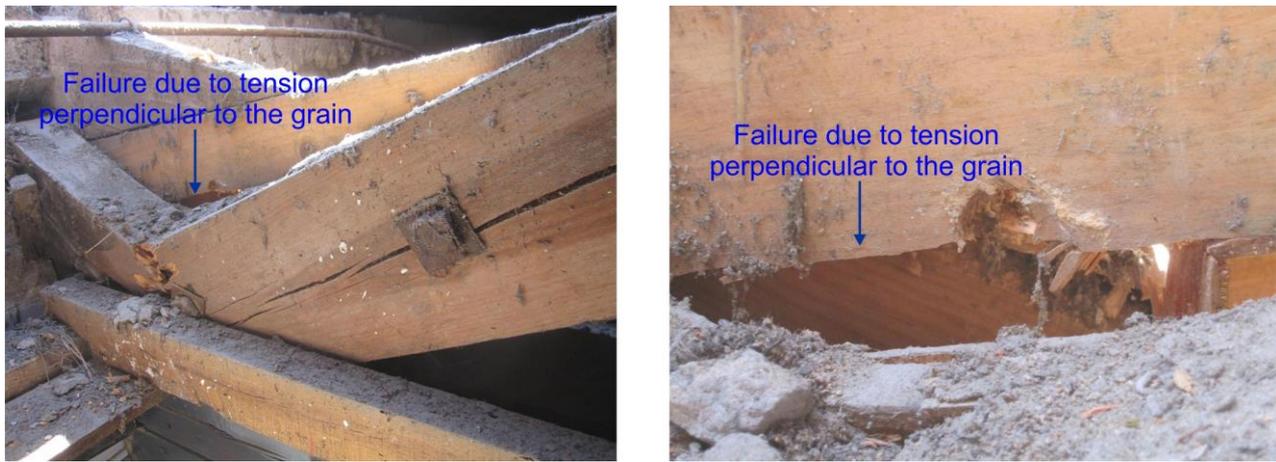
Figure 6. Failure of the central timber piece (left); Connection failure (right)

Figure 6 depicts actual representations of this mechanism. In Figure 6-right and in first plane, the central timber piece and the fracture originated at the bolt hole may be seen. The developed failure mechanism is seen in Figure 6-left. The rafters’ connections failed first and the resulting rotation caused the failure of the tie-beams below.

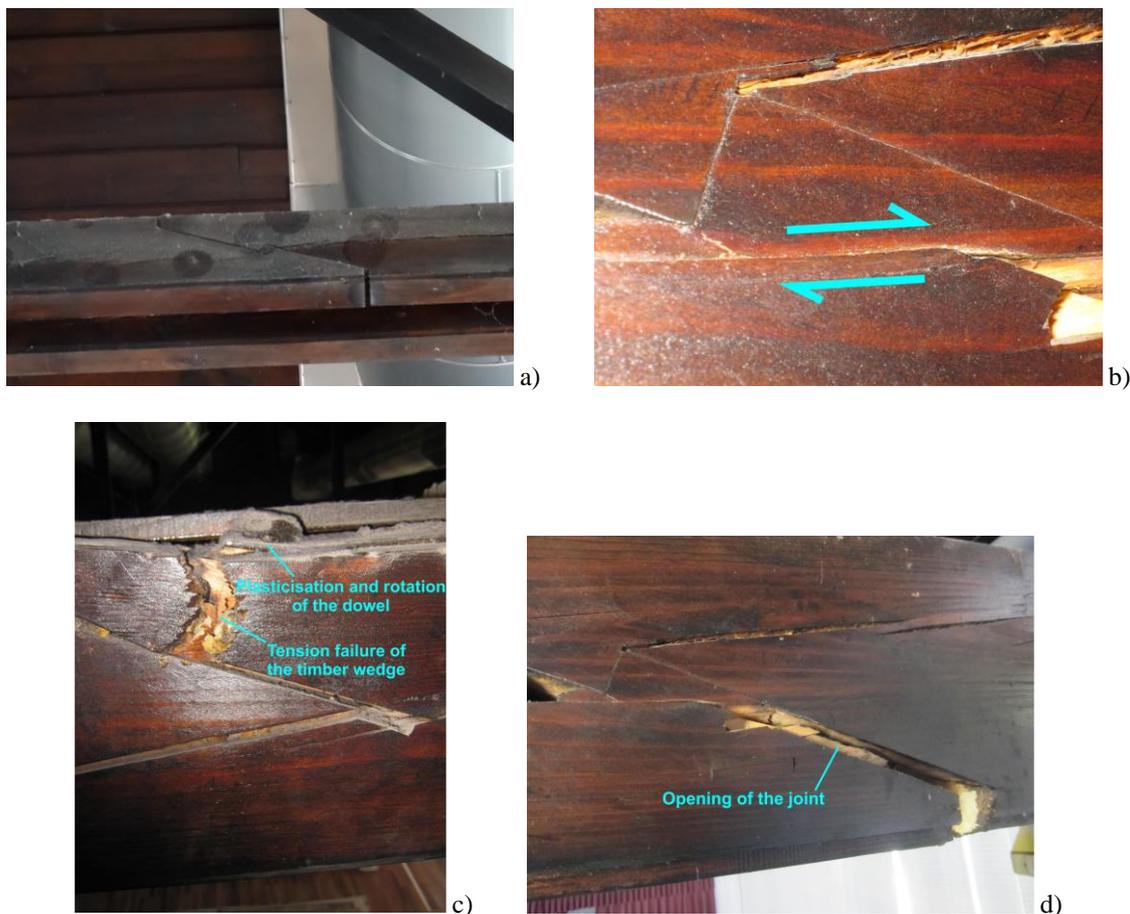
Besides supports’ failures, critical occurrences that caused the need for the structural assessment and rehabilitation works, the inspection revealed other weaknesses, of variable damage consequences but, in every case, requiring corrective reinforcement provisions. The most concerning were the incipient failures of some “Jupiter ray” carpentry connections (Figure 7-a), existing in variable locations in all the tie-beams. These were caused by shear failure of the imbricating notches, as shown in Figure 7-b.

Figure 7. a) Joint overview; b) Shear failure; c) Dowel plasticization; d) Joint opening

Although the geometry is generically correct, the notch depth – and, consequently, the length of the shear surface – is too short. According to the good practice, this depth should be 1/3 of that of the elements being joined, much more than what can be seen in the figure. Such failure is likely to cause the whole truss collapse, which did not happen due to the redundancy provided by the cross-through steel dowel used to prevent the separation of the parts, see Figure 7-c. However, the transfer of the heel force to the dowel caused its plasticization and rotation, with the consequent opening of the joint (Figure 7-d) and the tension failure of the wood wedge undergoing the embedding force of the dowel, also visible in Figure 7-c.

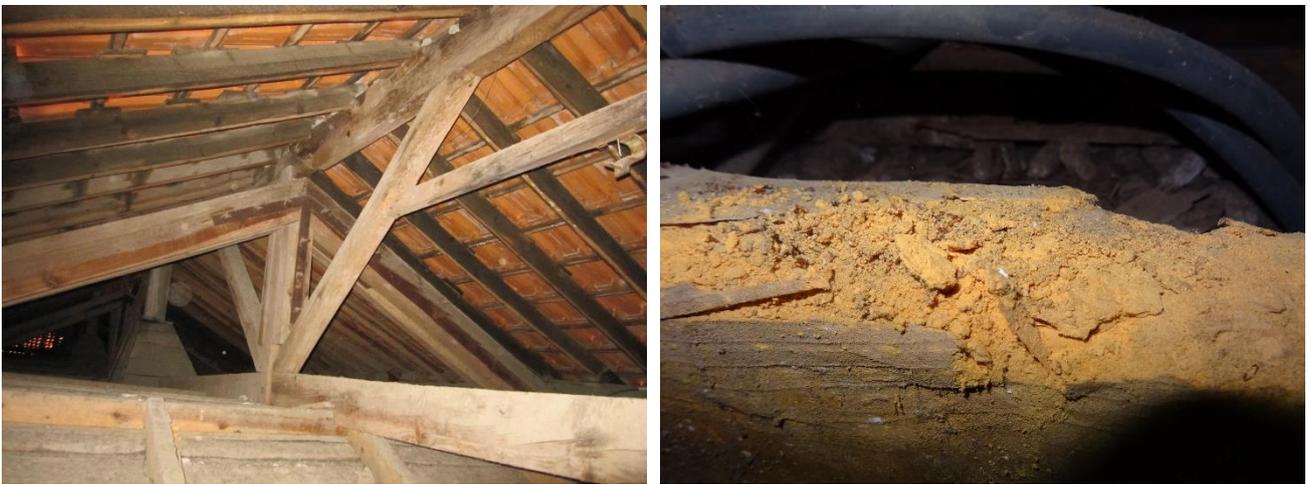
The inspection of the structure concealed by and above the wooden ceiling showed that the main structural elements (trusses, beams and bracing elements, Figure 8-left) were in generally good condition, with local and moderate beetle attack and no evidence of decay. However, several secondary elements, such as ceiling supporting clapboards and ceiling planks were severely attacked by beetles (Figure 8-right), with no other repair solution but its replacement. The most likely causes for this difference are the inferior timber grade of the latter and its larger vulnerability to egg deposition and attack, given their smaller size and larger specific surface.

Figure 8. Main elements in good condition (left); Severe attack of secondary elements (right)

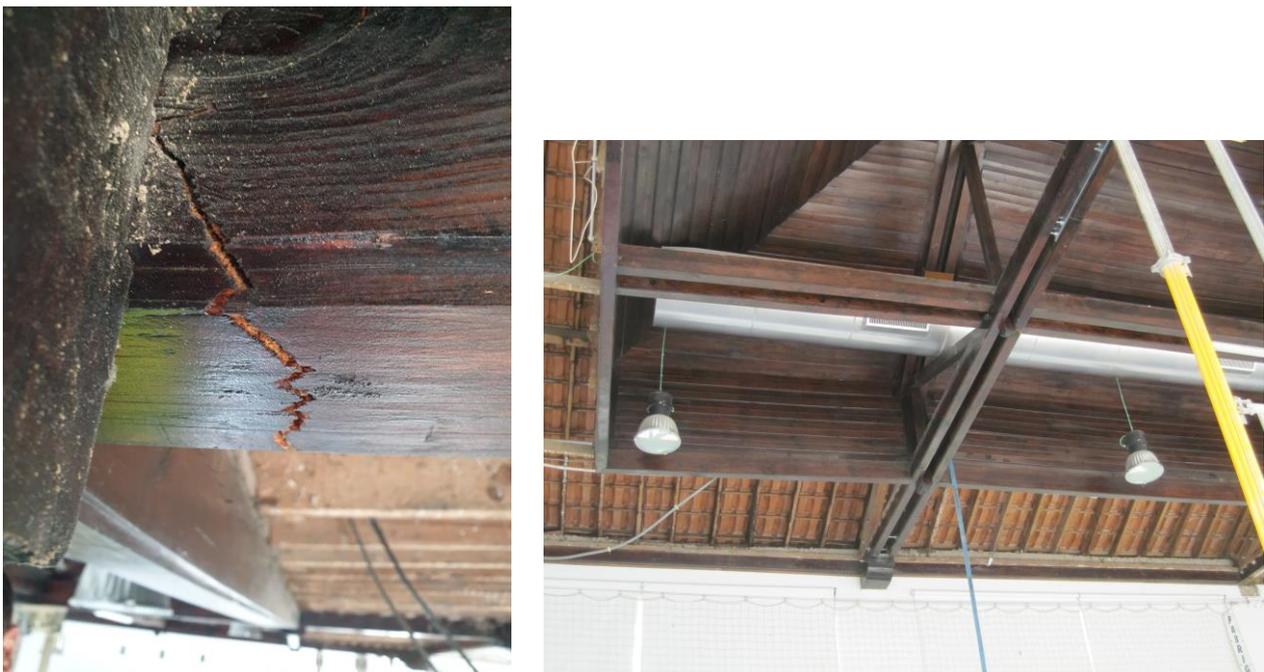
During the rehabilitation works, two further anomalies not detected during the inspection stage were found, one critical and the other secondary regarding safety issues. The former was a broken tie-beam, caused by the near presence of a large-size knot reducing the net cross-section (Figure 9-left). The latter was the excessive slope of a cantilever part of the wooden ceiling, due to the deformation of the supporting structure (Figure 9-right).

Figure 9. Broken tie-beam (left); Excessive ceiling slope (right)

national companies certified to carry out that kind of intervention finally pushed the design to the conventional solution of external steel bolted plates (Figure 11). This solution was also used to repair the fracture shown in Figure 9-left.
