## Effectiveness of Prolonged Air-Recurring on Strength of Fire Damaged RC Columns

### Abstract

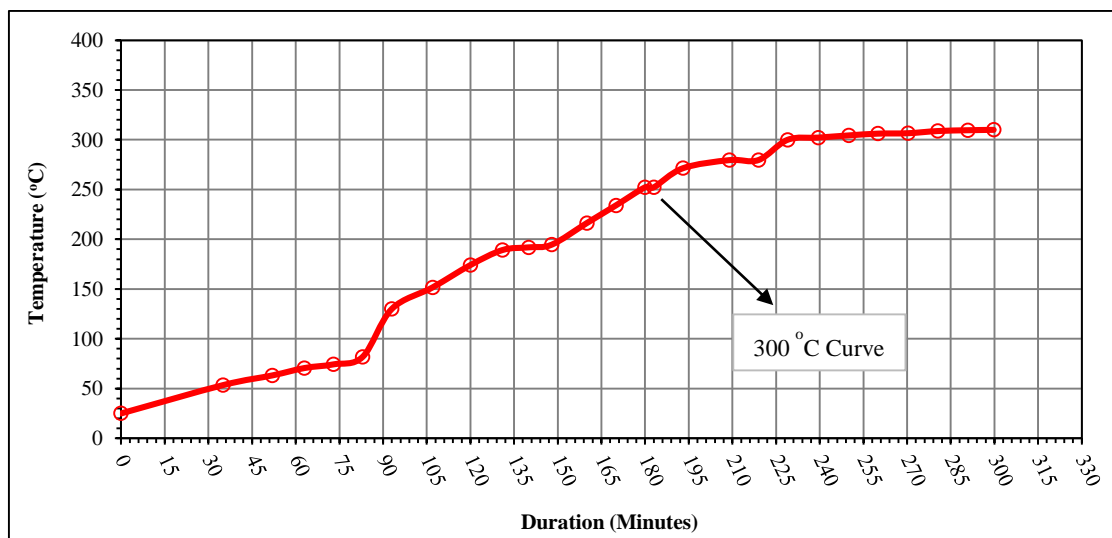
Figure 3. Time ~ Temperature Curve for 300 °C

All the specimens were heated upto the chosen/required furnace target temperature separately not in one go i.e. the specimens required to heat upto 300 °C were loaded first, un-loaded when furnace target temperature of 300 °C was achieved and then switched off. Similar process was repeated to heat other specimens at temperature levels of 500 °C and 900. The rate of heating was set at 1.6 °C/minute. It should be noted that the heating rate of 1.6 °C/minute refers to the rate of temperature rise within the furnace, not the temperature rise inside the concrete columns.

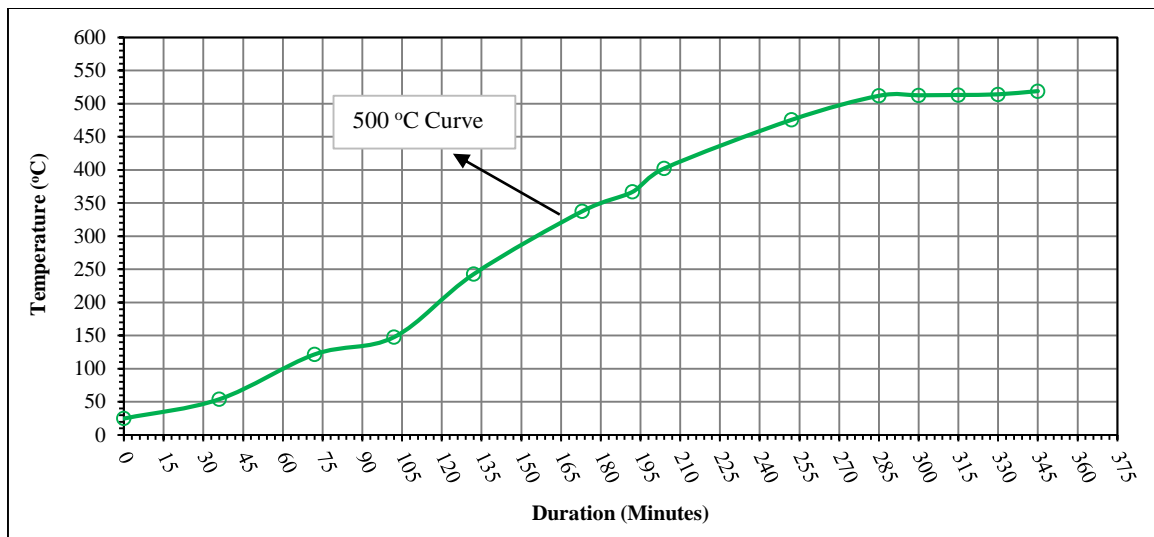
Figure 4. Time ~ Temperature Curve for 500 °C

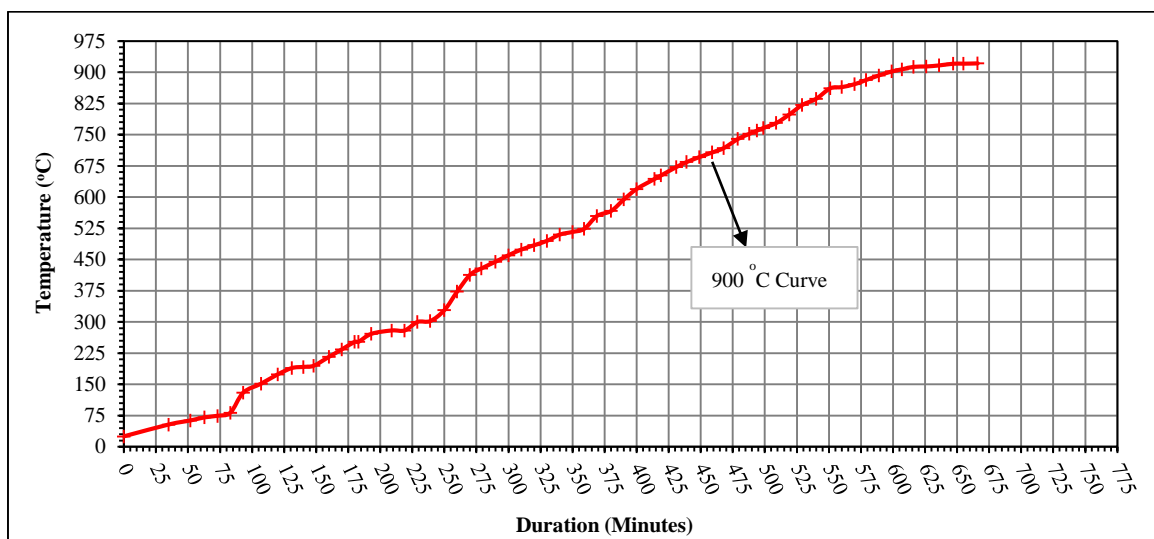
Figure 5. Time ~ Temperature Curve for 900 °C

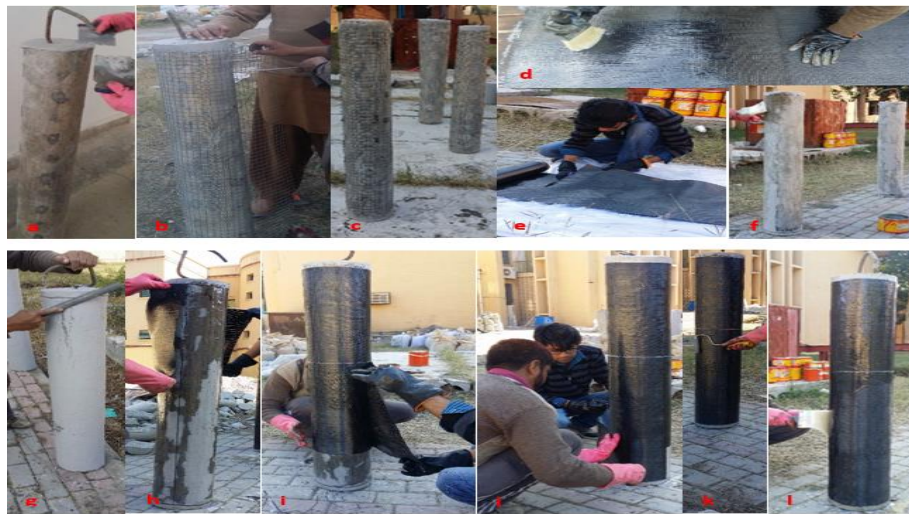
Figure 6. Repairing of Specimens

The substrate of the post-heated reinforced concrete circular columns was prepared by removing loose and friable particles with a steel wire brush. Sikadur 31 CF Slow epoxy resin mortar was used to fill the cavities, micro cracks, voids and dikes of post heated specimens to get smooth surface. Sikadur 31 CF Slow adhesive and repair mortar components A and B were mixed in the ratio of 2:1 by weight for at least 3 minutes with a mixing spindle attached to a slow speed electric drill (maximum 300 rpm) until the paste became uniform in consistency and greyish colour was achieved. While mixing aeration was avoided. The whole mix was poured into a clean container and stirred again for approximately 1 minute at low speed to minimize air entrapment. It was observed that there was no loss of section for columns except those exposed to 900 °C temperatures. Therefore, a thin layer of not more than 2 mm epoxy resin mortar was applied on the surface of columns using spatula and trowel in order to fill cavities, micro cracks.

The surface of specimens was made smooth with grinder having steel disc attached to it and further substrate of post-heated reinforced concrete columns was prepared by removing loose and friable particles using steel wire brush. In this technique, the same size of holes 10 mm in diameter and 76.3 mm in depth were made normal to the longitudinal axis of the post-heated columns using drilling machine. The same numbers of holes i.e. 24 were made on the surface area of the post-heated circular columns in a staggered manner, such that six holes in one layer along longitudinal axis. The surface of the post-heated columns was cleaned using steel wire brush and the dust due to drilling was removed from the holes using blower cleaner. Sikadur 31 CF Slow adhesive and repair mortar components A and B were prepared by mixing in the ratio of 2:1 by weight for at least 3 minutes with a mixing spindle attached to a speed electric drill

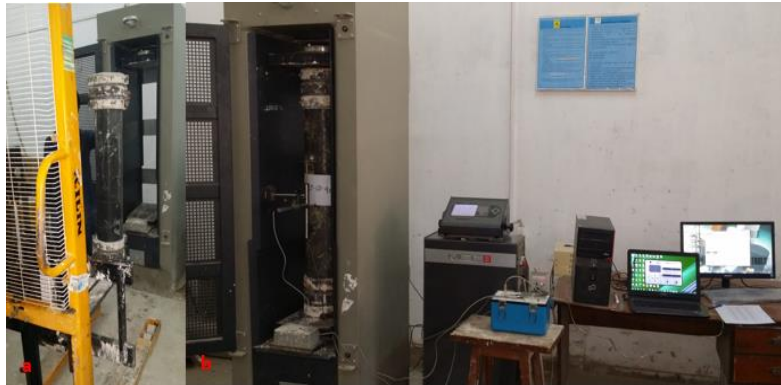
All columns were capped with plaster cement as per ASTM C 617-98 "Standard Practice for Capping Cylindrical Concrete Specimens at their ends, top and bottom to confirm parallel surfaces and distribute load uniformly before testing. Each column was instrumented with three linear displacement sensors (LDSs) and one linear variable displacement transducers (LVDTs). Two LDS were fixed at mid-height on all specimens over a total length of 355 mm in the longitudinal direction. These LDSs were fixed between two steel angles which were attached to the column surface using a screw driven into drilled hole of 5 mm depth. Further each column was instrumented with one LDS and one LVDT in hoop direction at mid-height over the CFRP wrapped surface to determine lateral. The sensors were attached at the mid height and on the opposite faces of each column. The load was applied, using load control, at a loading rate of 0.05 MPa/s. The columns were tested to failure under axial compression using 5000 kN capacity compression testing machine and the data was monitored and logged using an automatic data acquisition system (P3 box) as shown in Figure

6. Steel collars of about 5 mm thickness were used up to depth of about 200 mm (equals to diameter of specimen) at top and bottom of columns in order to avoid local failure near ends due to machine platen effect at column edges and transfer load till centre so that failure would occur nearly at centre and full capacity of column would be assessed.

Figure 7. Testing Setup

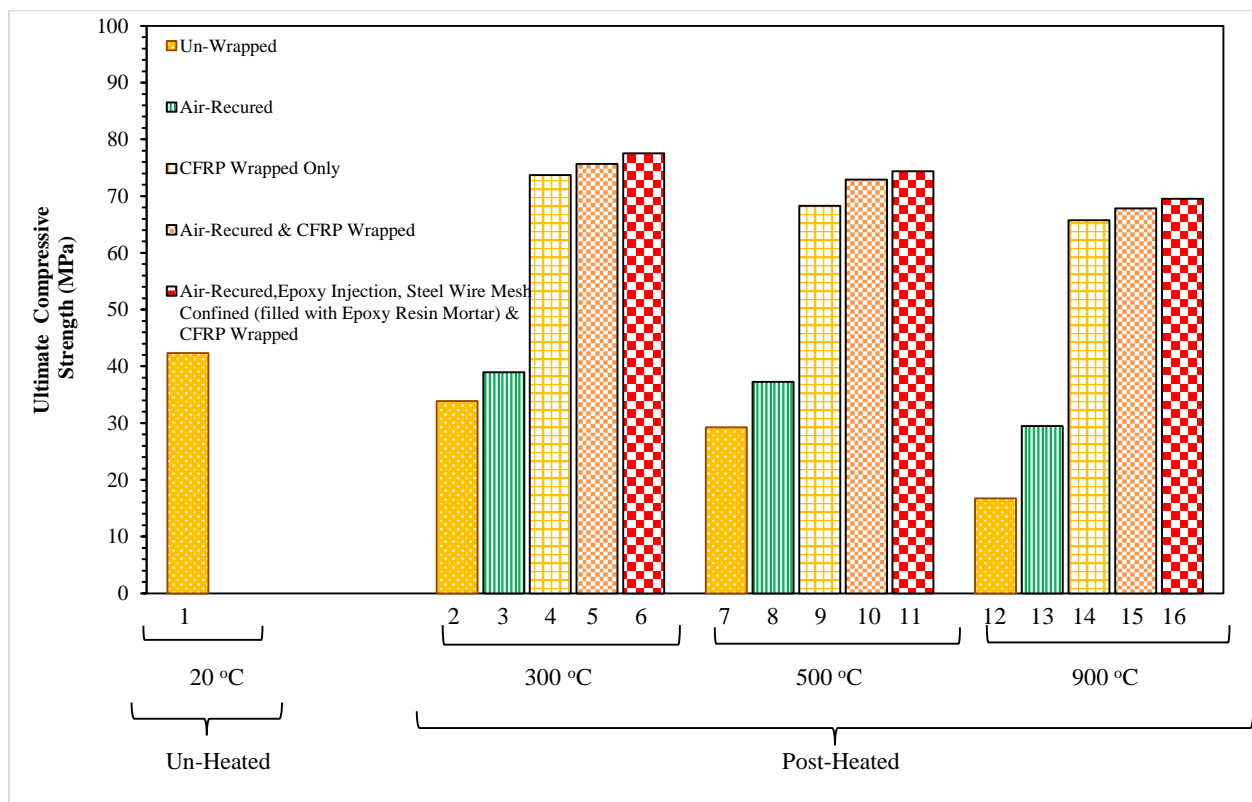
It can be seen from Figure 9 and Table 9 that the compressive strength of RC columns was degraded 8%, 12% and 30.42% when exposed to temperatures 300 °C, 500 °C and 900 °C respectively. The strength of the post-heated RC circular columns exposed to the temperature 300 °C was increased up to 78.70%, 83.09% with respect to un-heated control specimens and 94.26%, 99.02% with respect to air-recured post-heated control specimens using singlehandedly CFRP, and epoxy injected steel wire mesh filled with epoxy resin mortar along with CFRP jacketing techniques respectively. However, the strength of the post-heated reinforced concrete (exposed to temperature 500 °C) was increased by 72.17%, 75.64% with respect to the un-heated RC control specimens and 95.69%, 99.63% with respect to the air-recured post-heated RC control specimens using singlehandedly CFRP, and epoxy injected steel wire mesh filled with epoxy resin mortar CFRP composite jacketing techniques (refer to Table 9) respectively. It is evident from Figure 9 that even severely degraded compressive strength of the post-heated concrete (exposed to temperature 900 °C) was found to be increased by 60.19%, 64.21%, with respect to the un-heated concrete control specimens and 130.23%, 136.01% with respect to the air-recured post-heated concrete control specimens using the singlehandedly CFRP wrapping, and epoxy injected steel wire mesh filled with epoxy resin mortar along with CFRP composite jacketing techniques (see Table 9) respectively. It is worth to highlight that all the CFRP confinement techniques showed higher strength compared to the unconfined un-heated and un-confined air-recured post-heated RC specimens. This attributes to the fact that the CFRP wrapping system provides a circumferentially uniform confining pressure to the radial expansion of the un-heated or air-recured post-heated RC columns tested under axial compression when the single layer of unidirectional carbon fibre was wrapped transverse to the longitudinal direction of the tested cylinders. It is also interesting to note that the effect of CFRP confinement techniques on the axial compressive strength of the air-recured post-heated concrete was increasing with increasing the heat damaging level ranging from 300 °C to 900 °C in the way when compared to respective heat damaging level as shown in Table 9. This could be due to the fact that reduction in compressive strength and under axial compression, the radial expansion of the post-heated concrete was increasing with increasing the level of temperature exposure and thus allowing more tensile stress to be produced in the CFRP composite wrapping system.

Figure 9. Ultimate Compressive Strengths at various Temperatures

The un-heated un-confined and air-recured post heated unconfined RC circular columns were tested under axial compressive loading to make comparison with those of air-recured post heated specimens exposed to different temperature levels varying from 300 °C–900 °C and repaired with various confinement techniques. It is well established fact in literature that there is significant reduction in compressive strength of concrete, varying between 15-40% at around 300 °C and 41-80% at and above 500 °C (AL-Nimry et al. [16]). This certified and authorized comparison of these reported values to those of pro-longed air-recuring of post heated columns exposed to levels ranging between 300 °C -900 °C. The compressive strength of structural elements/members depends on the maximum axial stress that can withstand/resist by these members. The compressive strength of RC circular columns was calculated by dividing the maximum observed load while testing to the cross-sectional area of the specimen upon which load was transferred/applied. The numbers 1-16 presented on X-axis in Figure 8 represent: Six un-heated unconfined concrete control specimens (Tests 1-6)Two air-recured post-heated (exposed to 300 °C) unconfined RC control specimens (Tests 7, 8)Two air-recured post-heated (exposed to 300 °C) singlehandedly/only CFRP confined RC circular columns (Tests 9, 10) Two air-recured post-heated (exposed to 300 °C) epoxy injection steel wire mesh epoxy resin mortar along with CFRP confined RC circular columns (Tests 11 ,12)Two air-recured post-heated (exposed to 500 °C) unconfined RC control specimens(Tests 13, 14)Two air-recured post-heated (exposed to 500 °C) singlehandedly/only CFRP confined RC circular columns (Tests 15, 16)Two air-recured post-heated (exposed to 500 °C) epoxy injection steel wire mesh epoxy resin mortar along with CFRP confined RC circular columns (Tests 17 ,18) Two air-recured post-heated (exposed to 900°C) unconfined RC control specimens (Tests 19,20)Two air-recured post-heated (exposed to 900 °C) singlehandedly/only CFRP confined RC circular columns (Tests 21, 22)Two air-recured post-heated (exposed to 500 °C) epoxy injection steel wire mesh epoxy resin mortar along with CFRP confined RC circular columns (Tests 23, 24). Figure 8 shows the degradation of compressive strength exposing to the temperatures ranging from 300 °C to 900 °C and its restorability using the various repairing confinement techniques. It is evident from Figure 8 that the compressive

strength of the RC specimens was degraded after heating and the rate of strength degradation increases with the increasing level of temperature ranging from 300 °C to 900 °C.
