## Evaluation of Cable Force Changes Effects on Cable Stayed Bridge

The proposed bridge, which is cable stayed bridge crosses the Hlaing River that flows through Western Yangon. It was completed in 2000 and is currently used to connect Insein Township with Hlaing Tharyar Township. It has the 20 years' service life. It requires the inspection and the evaluation of the real condition of the structure. As cable element plays an important role in cable structures, evaluation of the real state of the stay cable is one of the main focuses of the cable stayed bridge. Firstly, in the research work all cables are inspected to evaluate the current condition of the cables with included visual inspection and vibration-based cable force measurement method. With the help of static and moving load analysis, the effect of force change cables in which the successive force changes are considered, and the possible cable loss effect on the structural behavior of the bridge are also investigated. The finite element model of the cable stayed bridge is developed based on the geometric shape and material properties from MOC and is modelled with finite element software MIDAS Civil. The tension forces obta

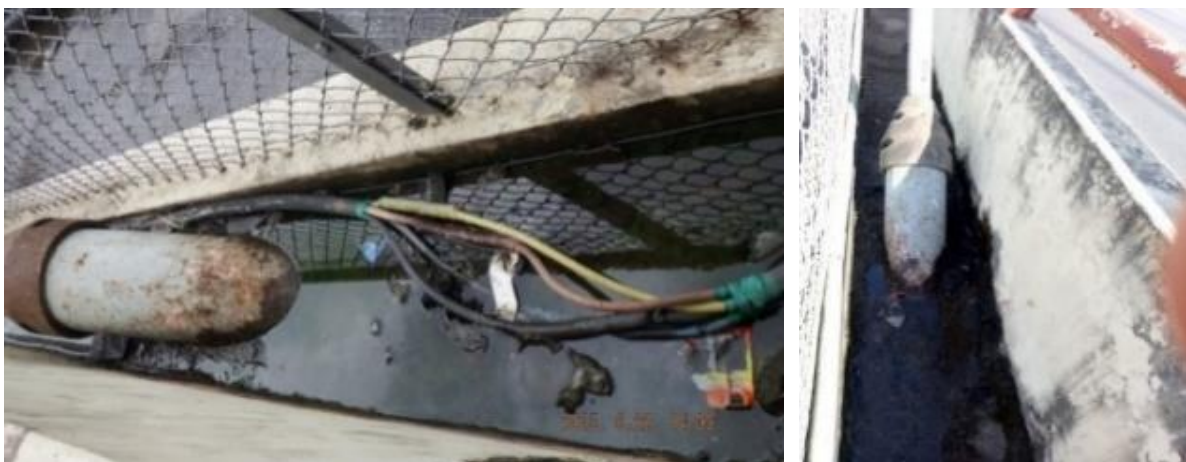
A lot of literature shows that the damage of cable stayed system mainly appears in anchorage systems, guide pipes and cable sheathing (NCHRP Synthesis 353). Therefore, anchorages, guide pipes and cable sheathing are mainly inspected. Figure 6 show the condition of cable anchorage portion observed by inspection team of MOC in June, 2015. Drain blockage conditions are occurred on the top chords and cable anchorage zone due to garbage. If an effective water drainage system is not provided, crevice corrosion and pitting can occur at the anchorage because of water runoff and debris accumulation [16].

Figure 6. Drainage blockage in cable anchorage zones (MOC, 2015)

The visual inspections of the cables in June 2015 and December 2018 found damp conditions in the cable anchorages (cable 12 to cable 33) on the main span because of the poor drainage condition and lighting pole footings. The inspections of the cable's free length observe degradation of the protective sheathing of cable 3, cable 30 and cable 33 at downstream side.

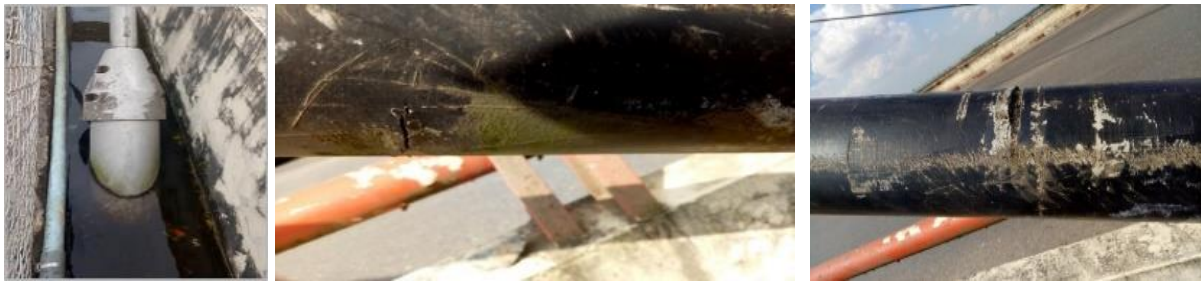
**Figure 7. Poorly drain condition and cable anchor zone in damp condition and cracks and damage in sheathing of cable3 D/S in December 2018**

Visual inspections on the cables sheathing and cable anchorage portions were done in December 2018 and August 2019 and the accurate pictures of the cable condition were captured. In December of 2018, cables in damp anchorages and poor drainage condition due to insufficient slope and lighting pole footing on main span were found, and small damage and only one crack in the cable sheathing were also detected in cable3D/S as shown in figure7. In August 2019, the inspection showed new small scale cracks in the cable sheathing at the cable3D/S as shown in figure 8. Radial cracks were observed in cable sheathing of cable30D/S as shown in figure 9, that may allow the moisture and initiate corrosive attack of the cable strands. Due to the large quantity of entrained water in the cables, water stains were found on the lower portion of the cable33D/S as shown in Figure 10.

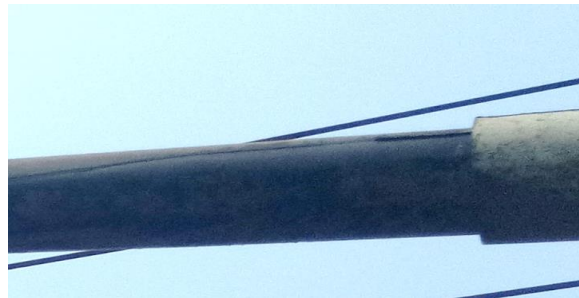
**Figure 9. Cracks in sheathing of cable30 D/S in August 2019**

The analysis and result found that if the tension force in the cable30D/S continues to decline as expected, the cable (cable30D/S) is critical than any other cables and no longer used, and a timely action is necessary. The cable is needed more attention during cable tension's inspection. As the result of loss of the cable30D/S, increases the adjacent cables by 20% of cable stress at ULS because the stress in the loss cable redistribute to the other remaining cables. It is also observed that the initiation of failure condition can start in the cable3D/S as the cable reaches to the stress limit of SLS. Under the effect of the cable force changes (current condition), successive decreasing cable force (after 10 years later) and one cable loss, deflection condition and shape for both deck are also analyzed and investigated. In the current condition, the significant deck deflection change is not encountered. In the case after 10 years later, the deck deflection changes are only occurred around the cable30 at downstream site. In the cable30D/S failure event, the deck responses are found to be still within the allowable limit although the deck deflection changes are significant at the anchorage point of failure cable. In this study, the abnormal cable force variations in 8% of all cables does not suffer the significant effect on the response of the bridge. In the one cable loss case, the cable3D/S is more critical than the other force variation cables. In all cases of study, as the deck deflections are still within the allowable limit, the adequacy of the bridge is still at sufficient level.

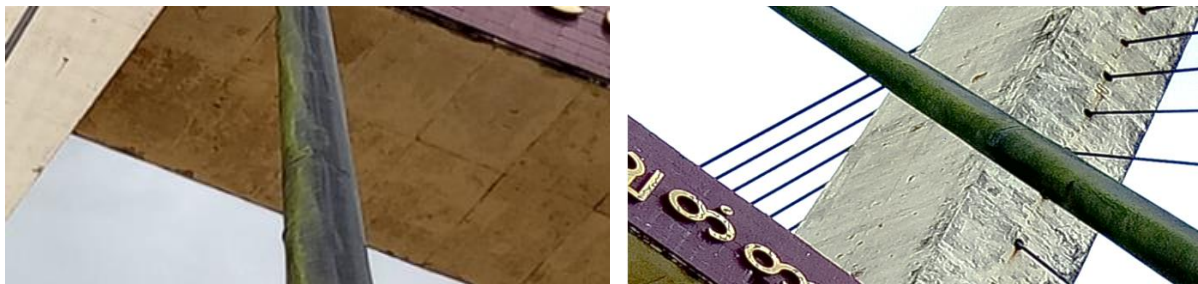
**Figure 10. Water stains on lower portion and cracks in sheathing of cable33 D/S**

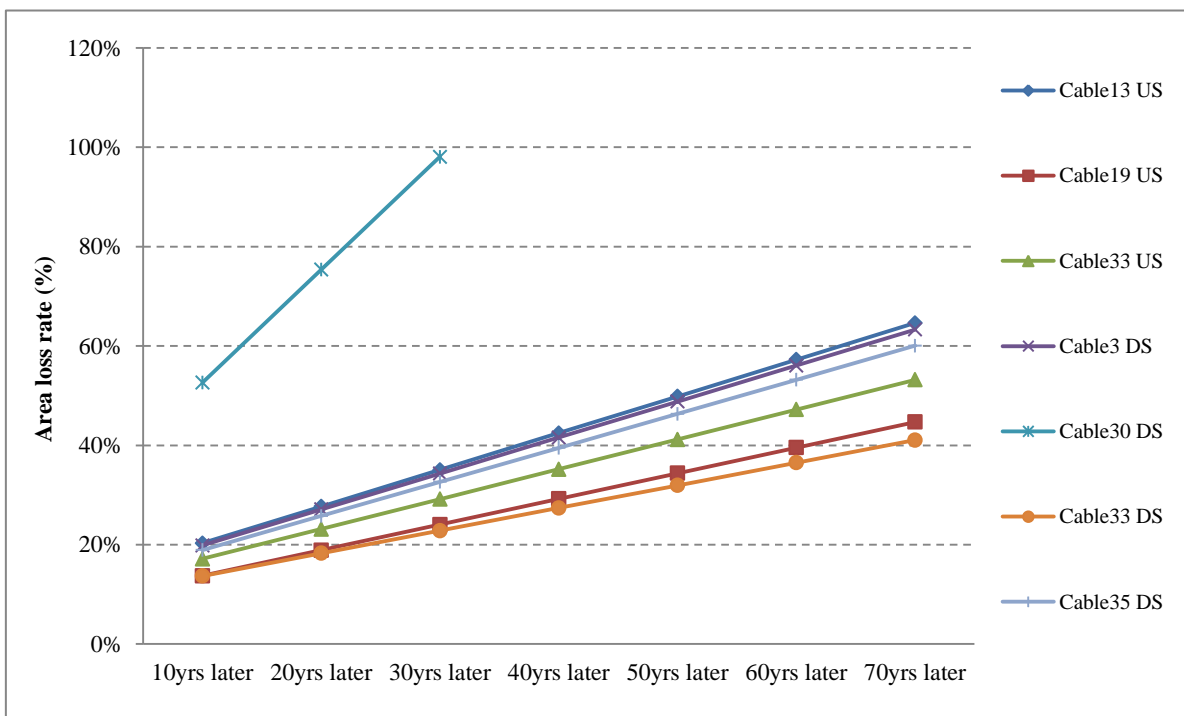
By applying the equation 1, the area loss rate of the seven cables are calculated. In the upstream side, three cables (cable 13, 19 and 33) are suffered up to area loss rate 13.2%, 12.55% and 10.5% respectively. In the downstream side, it is observed that the maximum cable force change (39.2%) occurs in cable 30 and other three cables (cable 3, 33 and 35) are 15.3%, 10% and 11.5% respectively. By the area loss rate equation, the area loss rate percentage is directly proportional to the values of cable force changes. According to linear regression model, the Figure 14 shows the area loss rate variation of a particular cable (Cable13, 19 and 33U/S and Cable3, 30, 33 and 35D/S) with increase in time.

Figure 15. Area loss rate variation of cables

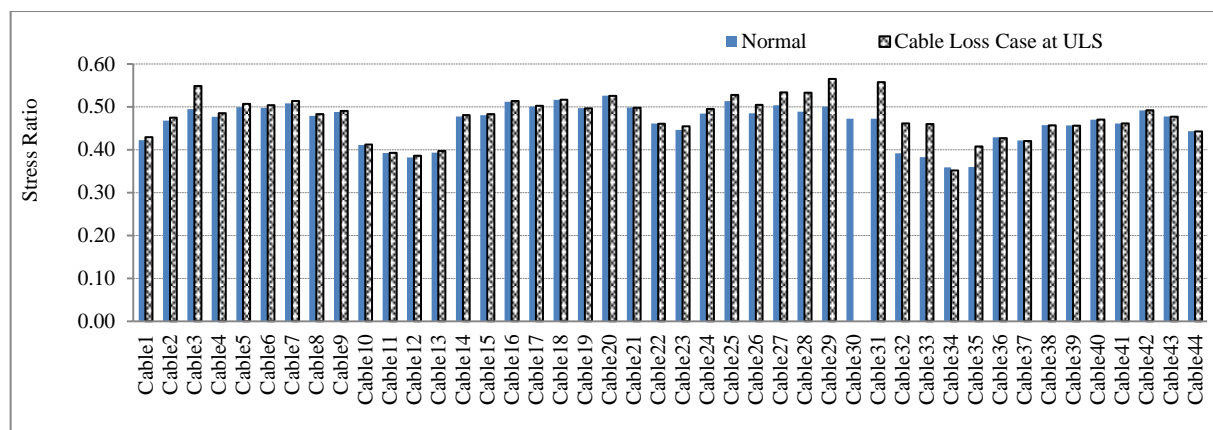
Figure 23. Comparison of cable stress ratio change on upstream side

Figure 24. Comparison of cable stress ratio change on downstream side

Figure 25. Comparison of cable stress ratio change on upstream side

Figure 26. Comparison of cable stress ratio change on downstream side

The cable loss leads to the redistribution of load to adjacent cable. From the above mention figures 23 to 26, at SLS, all cables have the stresses below limit stress with the exception of the cable3D/S which reach to the stress limit. It is found that the increases in stresses are more obvious in the cables near the cables loss location.

At ULS, no cable exceeds the stress limit. Although cable3D/S reach the stress limit of SLS, the cable well remains below the stress limit of ULS. For one cable loss case, the cable3D/S is critical than the other cables. Moreover, the current visual inspection on the cable3D/S observes the slowing increasing rate of radial crack of the sheathing.

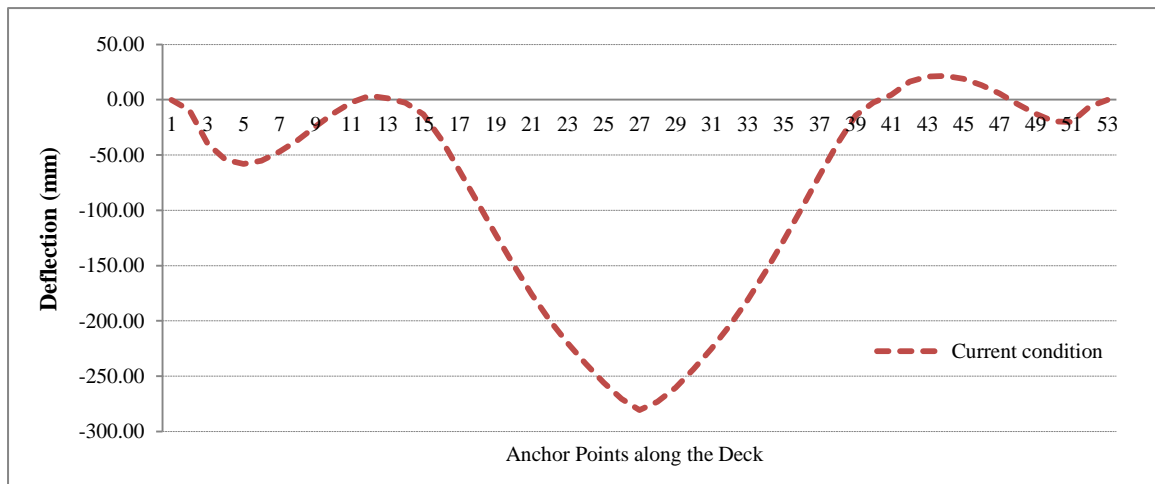
Figure 27. Deflection on upstream side along the deck

Figure 28. Deflection on downstream side along the deck

In the current condition, the deck deformed symmetrically in upstream side and downstream side, and the maximum deflection happened in the middle of the deck. In both U/S and D/S, there are no significant deflection changes on the anchorage points along the deck.

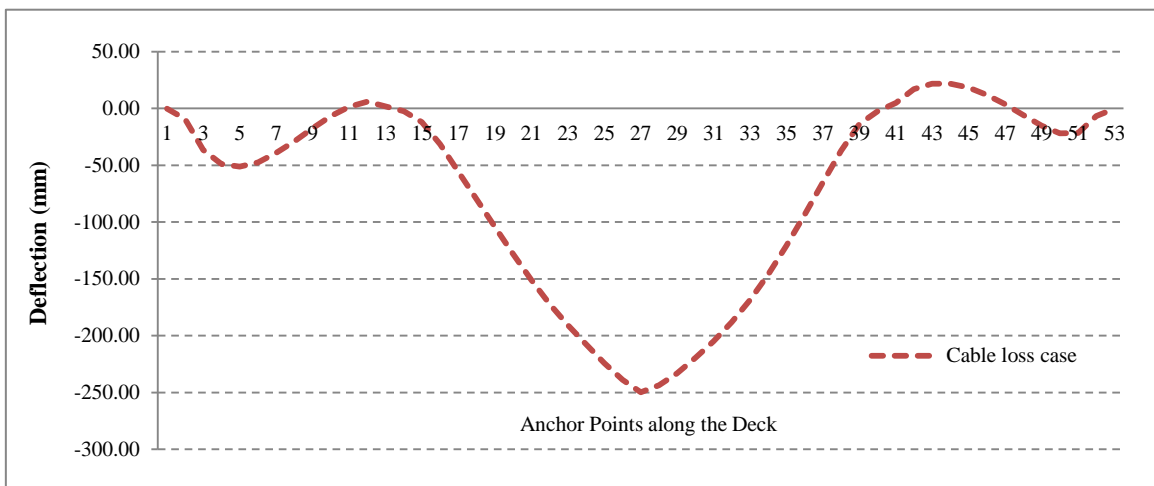
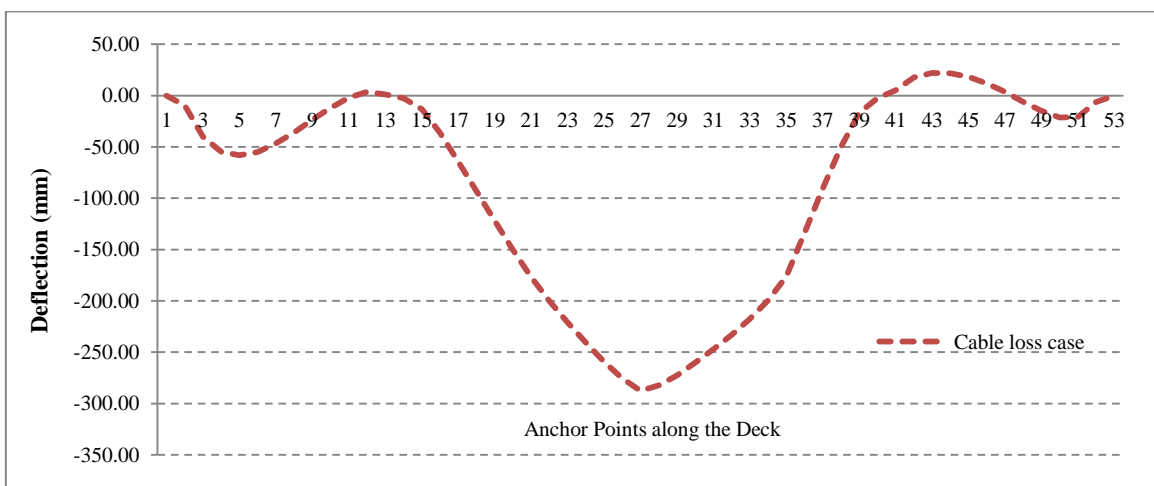
Figure 29. Deflection on upstream side along the deck

Figure 30. Deflection on downstream side along the deck

Figure 31. Deflection on upstream side along the deck

Figure 32. Deflection on downstream side along the deck

From the above figures, as for the cable loss case, in which one cable loss is located on the main span of downstream side, the deflection configuration on downstream side is slightly changed. The deformation of the deck in upstream side does not significantly change and is similar to the deflection shape under current condition. In the current condition, the significant deck deflection change is not encountered. In the case of 10 years later, the deck deflection changes are only occurred around the cable30 at downstream site. In the cable30D/S failure event, the deck responses are found to be still within the allowable limit although the deck deflection changes are significant at the anchorage point of failure cable.
