## Structural Vulnerability Assessment of Historical Buildings in Turkey

*Keywords:* Historical Masonry Buildings; Konak Mosque; Time History Analysis; Probabilistic Seismic Risk Assessment.

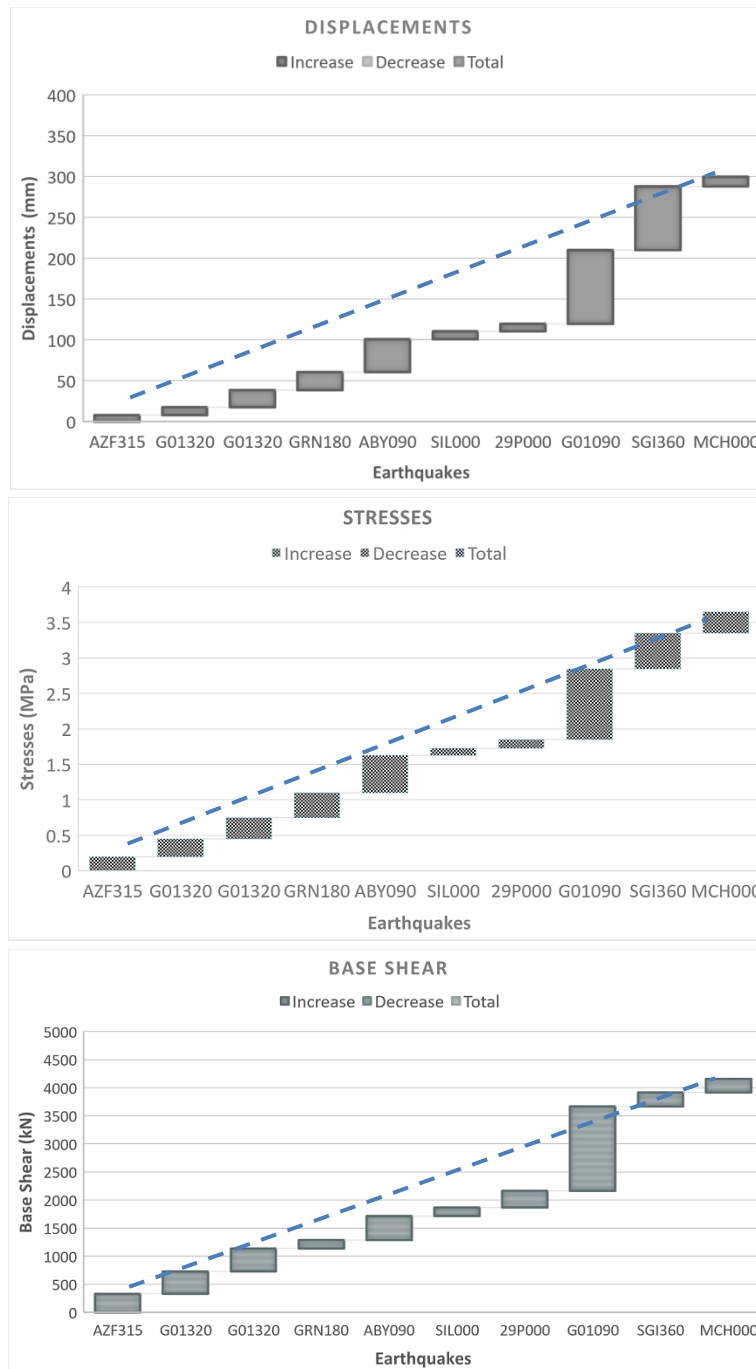
Figure 7. Displacement, Stress and Base Shear values of Konak Mosque

SAP 2000 software was used for time history analyses to determine the structural behavior of the historical building. 12 mode values were considered in the dynamic time history analyses. Displacements, stresses and base shear values were interpreted and the results were displayed graphically and discussed. The values of the displacement stress and base shear obtained from Konak Mosque is given in Figure 7. In Figure 7, displacements, stress and base

In the study, time history analysis and fragility analysis were carried out. As a result, the highest displacement, stress and base shear values occurred at Loma Prieta [G01090] earthquake, and the lowest displacement, stress and base shear values were occurred at Anza [AZF315] earthquake. Fragility analysis was carried out as a part of probabilistic risk assessment. Displacement exceedance probability values were determined by using time history analysis results, and accordingly fragility curves were sketched in two dimension and surface graph. Graphics were drawn by using exceedance probability corresponding to each displacement values. Fragility curve and surface were depicted. Saddle point was also determined as the optimum point.

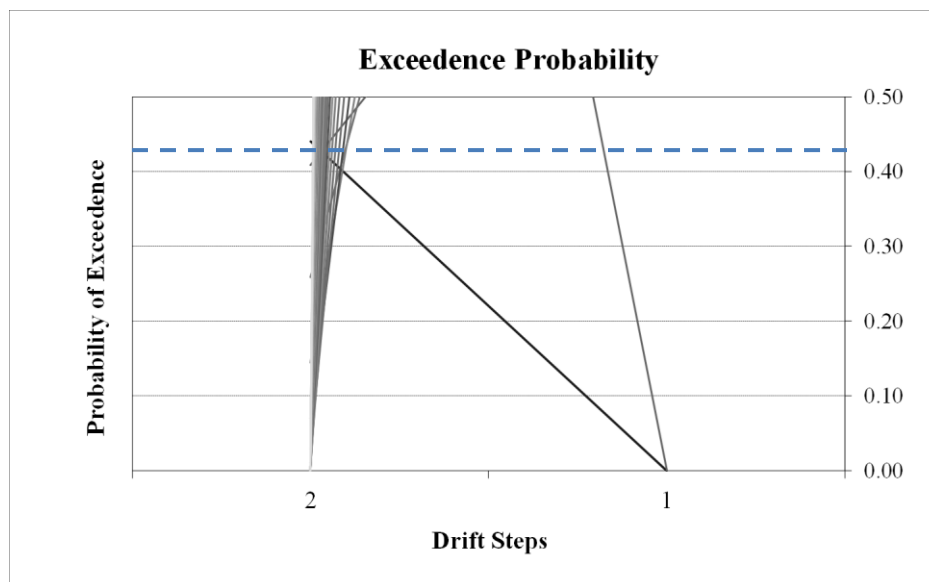
Figure 8. Fragility curve of Konak Mosque

shear values obtained for selected earthquake data. The increase and decrease are given in numbers in the Figure 8. to describe the demand. Demand line is giving us linear proportion in the graphs.

In this study, time history analysis results were used to carry out fragility analysis. Fragility curves were sketched by using values which were obtained as exceedance probability corresponding to each displacement value. Exceedance probability values of Konak Mosque were obtained for selected earthquake ground motion values. The fragility curve is shown Figure 8. In Figure 8, the demand was determined at around 42% line. In Figure 9, fragility is given in a surface distribution and with this surface graph, probability of exceedance can be defined for various drift values. In Figure 9, saddle point is determined for the obtained values.

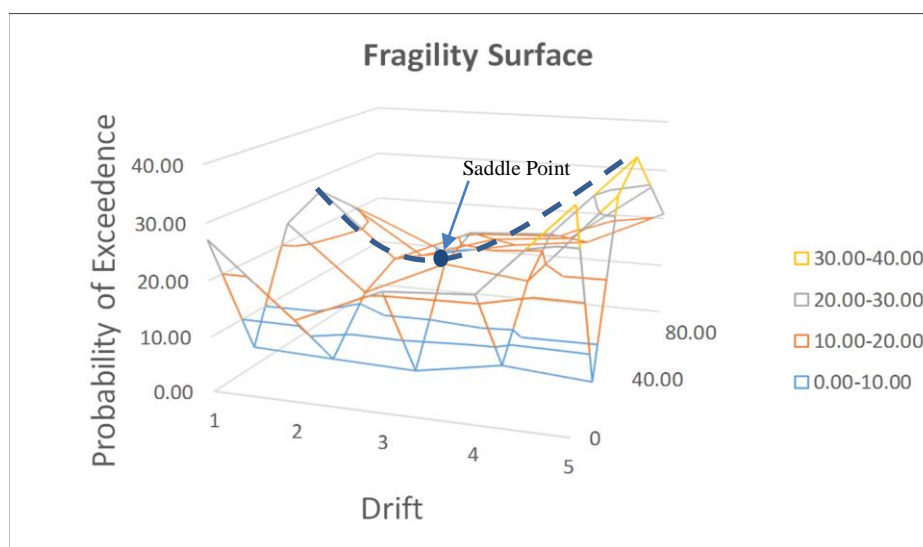
Figure 9. Fragility surface for Konak Mosque
