Corrosion Resistance of Reinforcing Steel in Concrete Using Natural Fibers Treated with Used Engine Oil

Alejandro Flores Nicolás^{1*}, Elsa. C. Menchaca Campos¹, Mario Flores Nicolás², Omar A. Gonzalez Noriega¹, Cesar A. García Pérez¹, Jorge Uruchurtu Chavarín¹

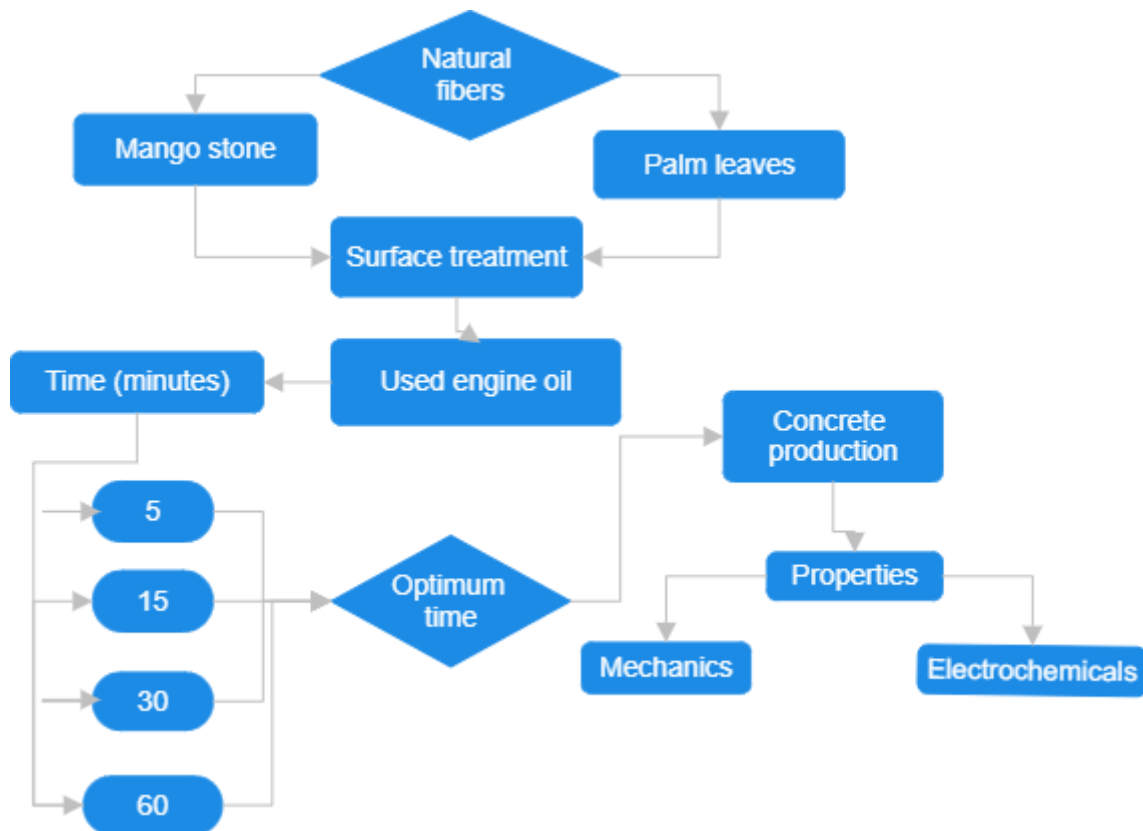
Figure 1. Flowchart of the experimental methodology

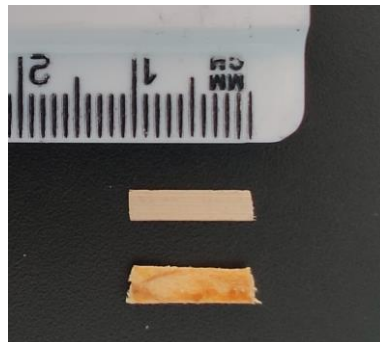
Short fibers were cut manually with dimensions of 10 mm in length and 3-4 mm in width, and 0.1 mm in thickness and presented in Figure 2.

Figure 2. Measurements of natural fibers

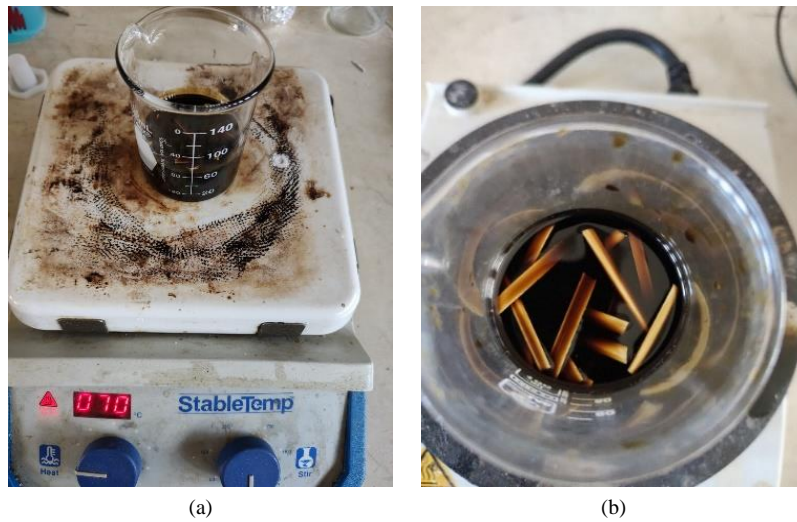
Natural fibers surface treatment (TNF) using capillary impregnation using 30 CMF fiber or 50 CPF fiber strips. Afterwards, they were immersed in UEO at 70 °C temperature for 5, 15, 30, and 60 minutes as shown in Figure 3. These times are considered to obtain the best conditions to penetrate fibers completely and less natural fibers water absorption.

Figure 3. a) Surface impregnation of the fibers b) Fiber saturation

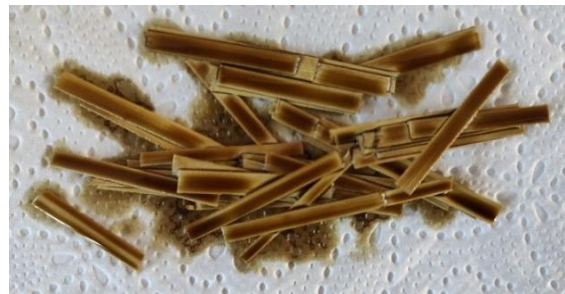
Afterward, humidity absorption was determined, by saturating fibers in distilled water for 24 hours, removing them, and cleansed with an absorbent cloth to retire UEO excess until obtaining dry superficial fibers, as seen in Figure 4. Then fibers were weighed on a 0.0001 g precision Denver Instrument electronic scale. The samples were dried again at 70 °C for one hour and weighed again.

Figure 4. Surface drying of treated fibers

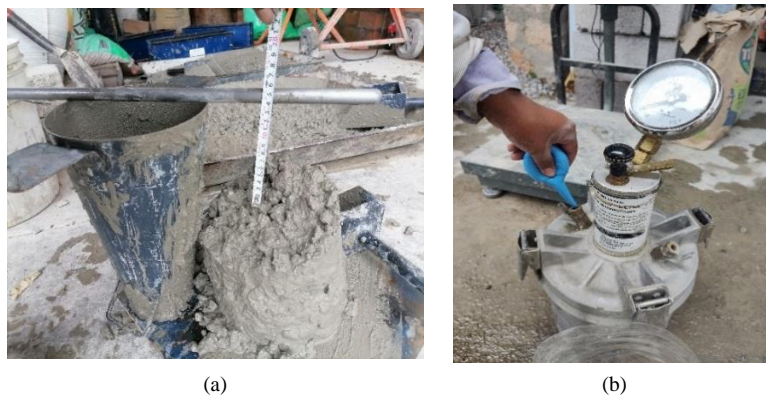
The mixture was prepared as follows: first gravel, after a small quantity of water was poured. Then sand was added, then the cement, and finally the rest of the water incorporating the TNF. Physical tests such as air contained in the mixture, according to the standards [39, 40], as seen in Figure 5. Cylindrical specimens were prepared with standard dimensions of 15 cm diameter and 30 cm height [41] for 7 and 28 days of compression testing.

Figure 5. a) Slump test b) Air content

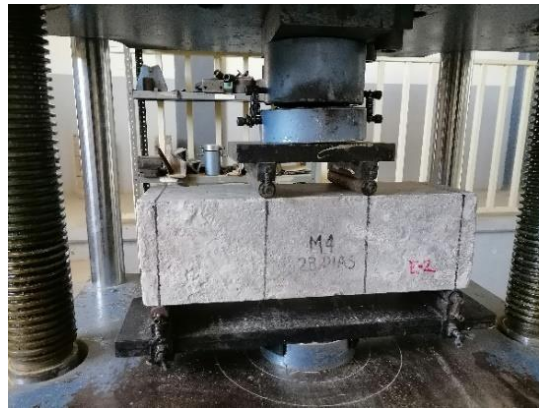
where $f'f$ is the flexural resistance, P is the applied load, L is the distance between supporting points, b is the width, and d is the average slope of the sample as shown in Figure 6.

Figure 6. Concrete flexural strength test

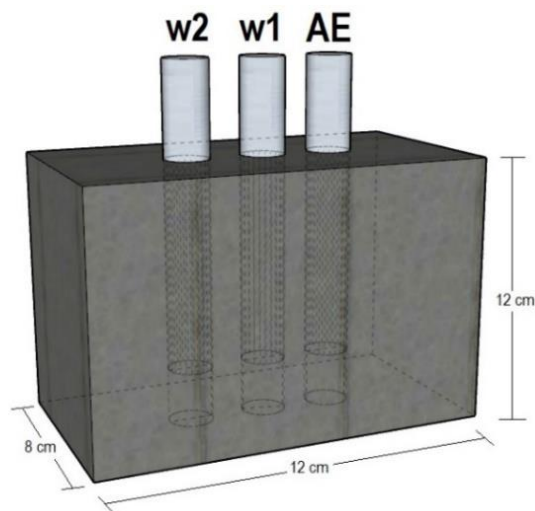
Cubic samples were made for the electrochemical tests, with dimensions of 12 cm length, 8 cm width, and 12 cm height as shown in Figure 7, and three low carbon steel rods were embedded. The steel rods were named working electrodes W_1 and W_2 , and a third rod was used as an auxiliary electrode according to the electrochemical cell proposed for the different measurement techniques. The coating of the paste with the steel bar was 3.5 cm, simulating a structural element, and Teflon tape was placed at the steel/paste interface in order to avoid contamination or any alteration in the measurements. The contact area of the rebar embedded in the concrete is 22.30 cm². The specimens were transported to a place with adequate humidity conditions, curing for 28 days.

Figure 7. Sample dimension for electrochemical tests

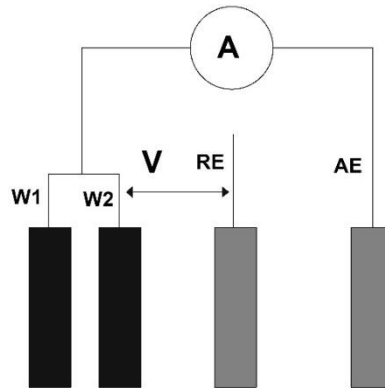
The method involves the measurement of small fluctuations in the current signals created between two nominally identical electrodes, and the voltage signals that are generated between the reference electrode and the working electrodes [47]. The electrochemical cell connection for the other electrochemical techniques is described in Figure 8, two working electrodes W_1 and W_2 were used as corrosive working elements, a reference electrode (RE) Ag/AgCl was used, and closing the circuit a third rod was used as auxiliary electrode (AE). A Gill AC-ACM Instruments device was used, and measurements of 1024 readings were taken at a standard rate of 1 reading/second.

Figure 8. Electrochemical cell configuration

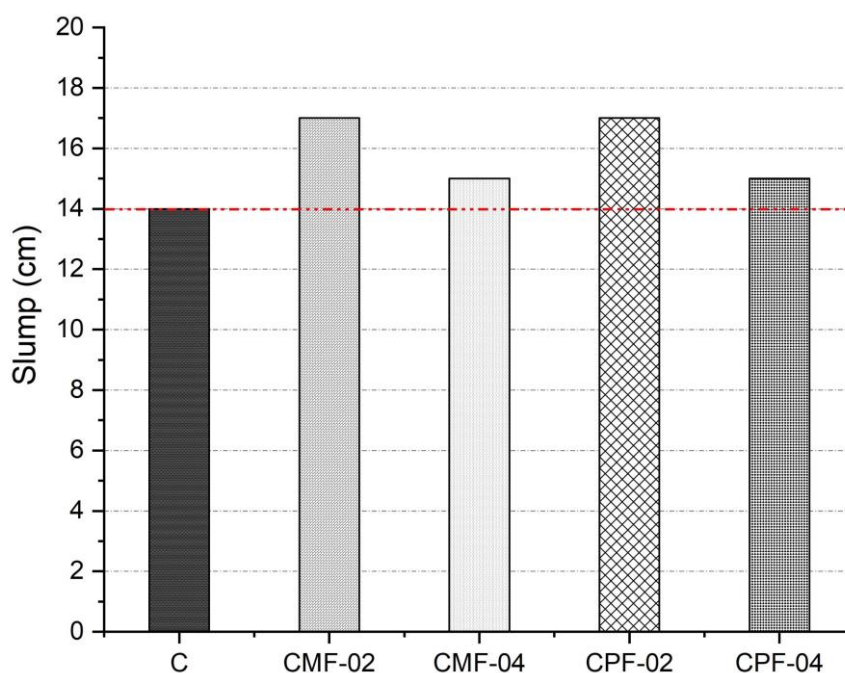
The slump test is used to evaluate the consistency or workability of the concrete mix. The workability is an indicator of quality control of materials such as fine and coarse aggregates with the cementitious matrix [4]. Workability concrete results are shown in Figure 9 where the concrete control presents a 14 cm slump effect, and when adding treated natural fibers (TNF) an annealing increase due to the reduction in water quantity was obtained, and a consequence of UEO acting as a water reducer during the curing process, and the increase in a slump from high contents of SO_3 in UEO [35, 57]. It was shown that the UEO particles act as a super-plasticizer in the concrete mix and these results are in agreement with other authors [58, 59]. The results for air content are shown in Figure 10, where it can be observed that the specimens with treated fibers increased the amount of voids in the cementitious matrix, which could indicate that the use of WEU caused a bad interaction between the paste and the fiber, i.e., the adhesion decreased drastically for samples CPF-02 and CPF-04 with air content values of 133% and 123% with respect to the control sample, showing that the increase of UEO absorption increases the air content.

Figure 9. Slump variation in concrete with TNF

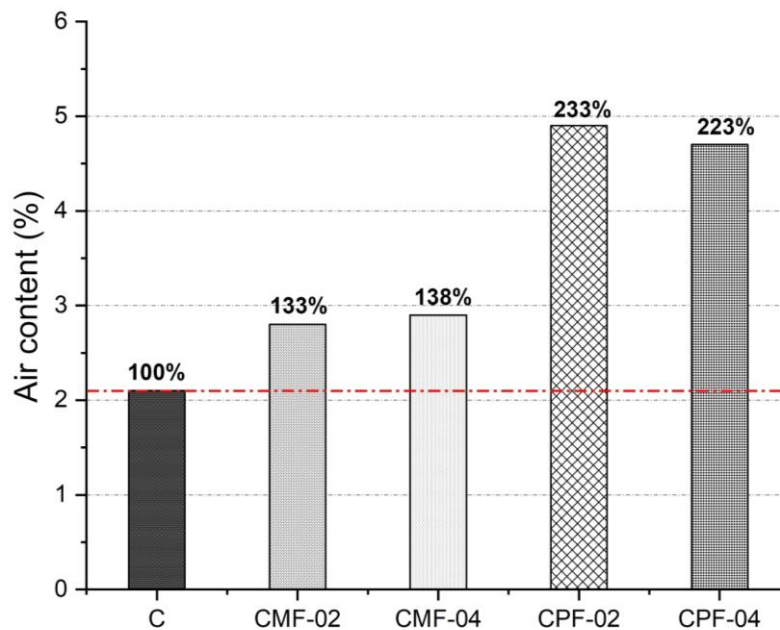
Figure 10. Air content in concrete with UEO-treated fibers

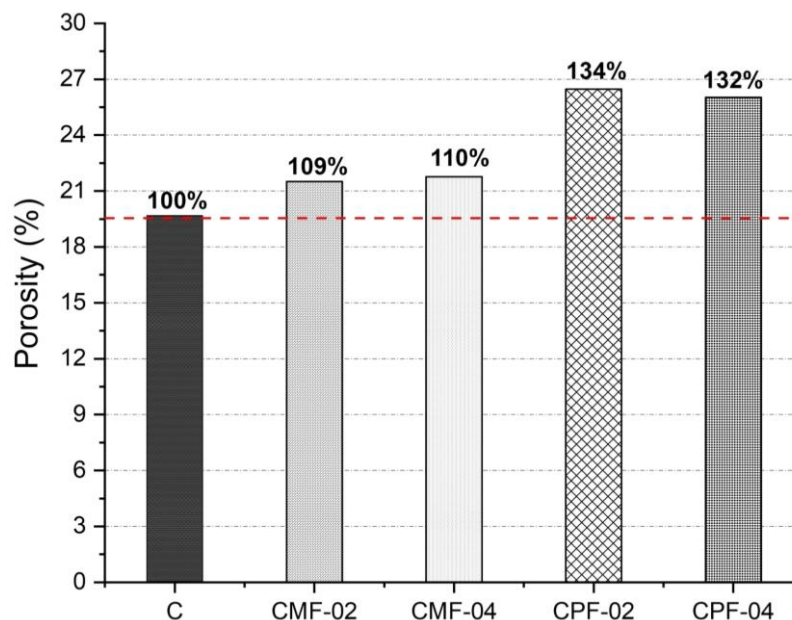
In the complex concrete microstructure, pores may be present in nanometers up to the macro scale [60], and porosity was obtained from air content results [61]. Figure 11 presents the concrete porosity results, where sample C shows 19% porosity, with an a/c relation of 0.54, being this result similar as reported by other authors [46, 62, 63]. All samples with TNF present more void content when compared to the control sample provoking an increase in permeability, directly affecting its compression resistance [64]. It can be appreciated that CPF-02 and CPF-04 samples present a higher percent porosity of 34% and 32%, possibly due to UEO directly affecting the interfacial zone between the aggregates and fibers matrices.

Figure 11. Percentage porosity of concrete with TNF

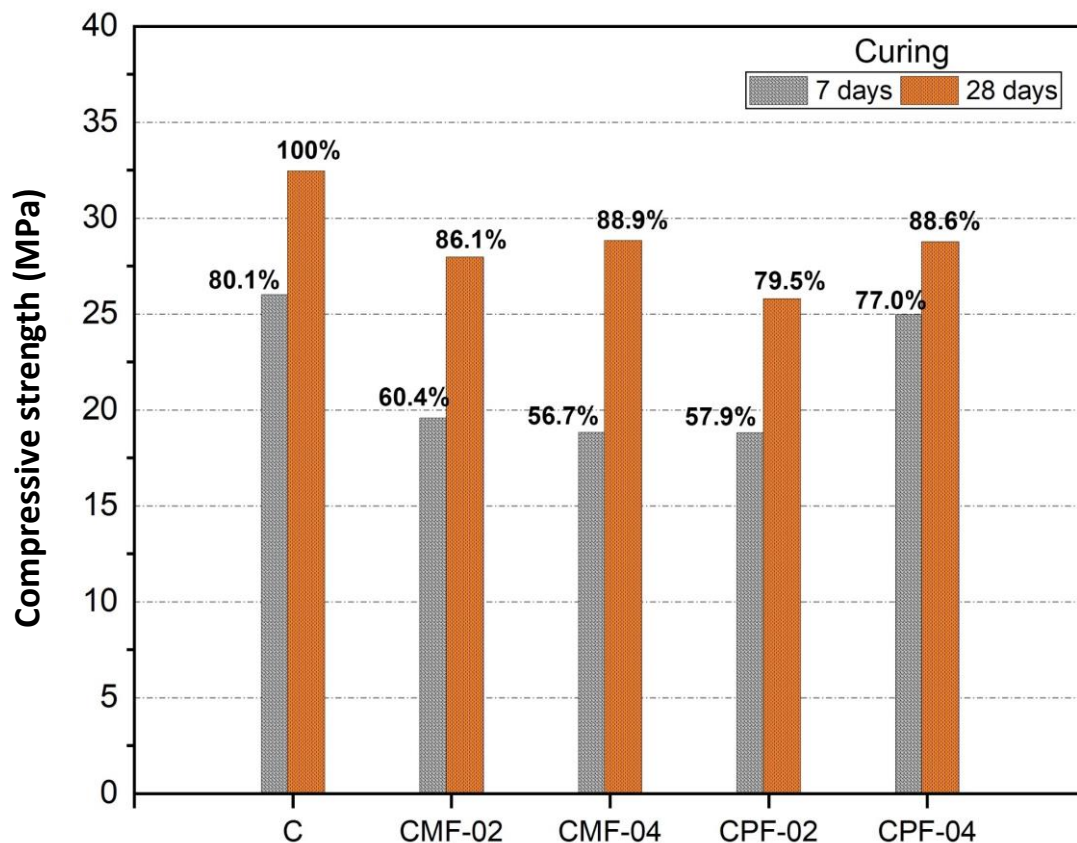
This decrease in the $F'c$ is similar to the ones reported by different authors adding up a small percentage of UEO in the concrete paste [66-70]. The percentage decrease of $F'c$ with oil impregnation in the natural fibers ranges from 11.1% to 20% with respect to sample C, as can be seen in Figure 12. At the early curing time of 7 days, it can be observed that samples CMF-04 and CPF-02 have a lower development in their mechanical properties as a consequence of the hydrophobic characteristic of the UEO. This causes a delayed reaction of $Ca(OH)_2$, which has not yet been completely consumed for the production of calcium silicate hydrate (CSH); therefore, the bonding between the fiber and the matrix is poor [71].

**Figure 12. Variations of compressive strength during the curing process**

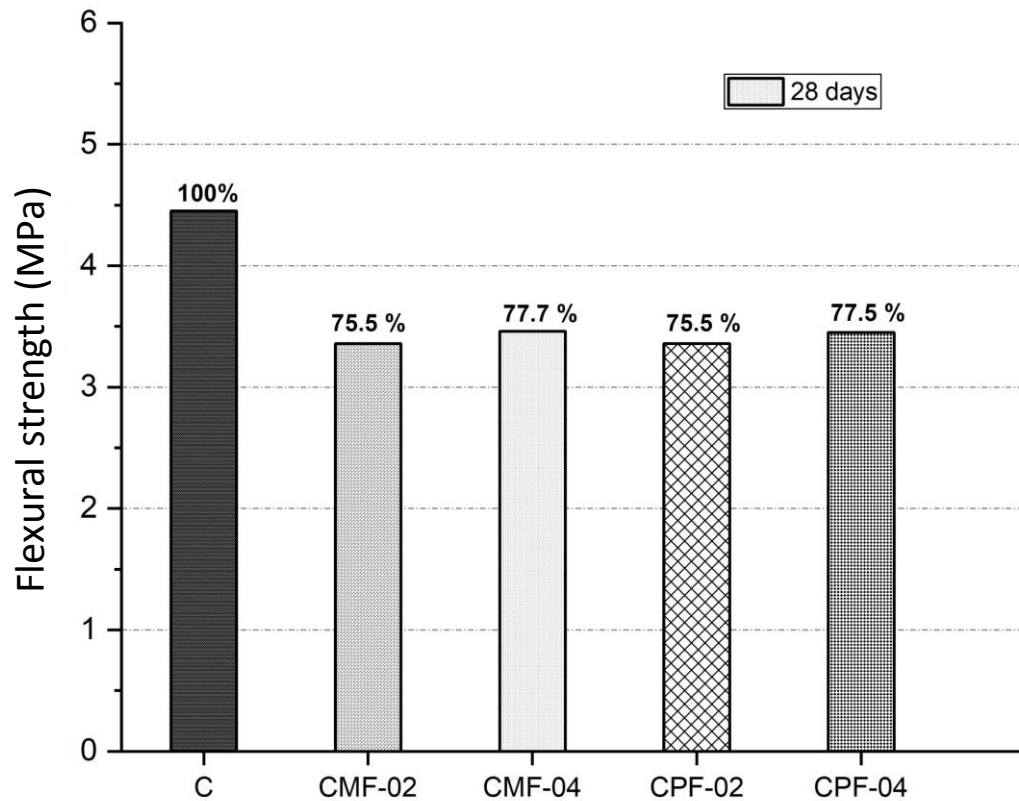
Average concrete flexural resistance ($F'f$) at 28 curing days is shown in Figure 13. The effects of the UEO on the flexural strength are negative, decreasing by 25% with respect to the control sample, and the incorporation of the fiber in the concrete paste does not prevent the propagation of cracks when the material is subjected to stresses. The Flexural strength of concrete decreases due to the weakened bond interface, the failure mode of the fibers is predominantly because of heavy metals present in the used oil engine, namely ZnO and P_2O_5 [20, 58]. With the use of UEO and fibers, a decrease in the mechanical properties of concrete has been reported elsewhere [72-74].

Figure 13. Variation of flexural strength of concrete with TNF, cured at 28 days

- The $f'f$ of all samples treated showed a decrease between 22% and 25% compared to the sample without added fibers. The UEO modified the fiber surface, losing the rough texture and promoting concrete specimens to present a fragile cracking failure.

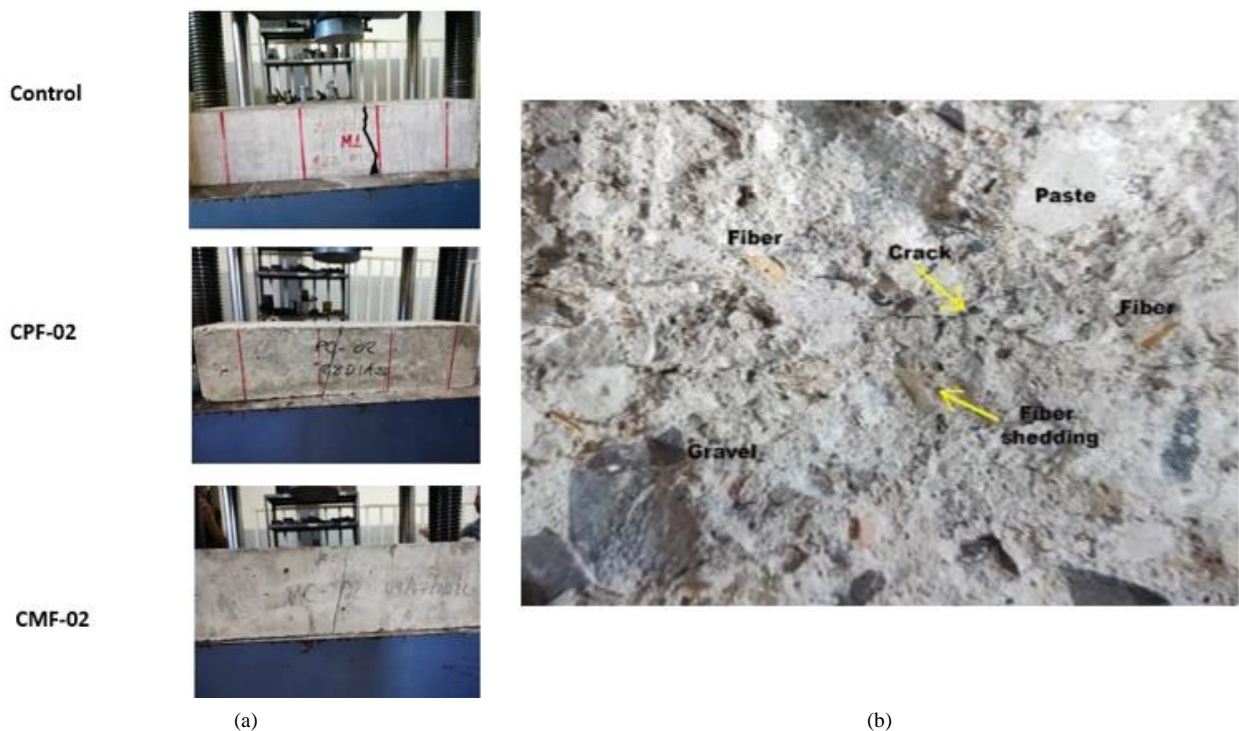
The results of the cracks in the flexural test are shown in Figure 14-a), as it can be generally noted that all specimens show a single crack passing through the center in the third of the beam. Specimen control shows a vertical crack characteristic of reinforced concrete; likewise, the specimens with natural fibers CPF-02 and CMF-02, show a brittle shear failure of diagonal type, as previously described the tensile strengths are low, the main cause is the null adhesion of the UEO treated fiber with the cement matrix as can be observed in Figure 14-b).

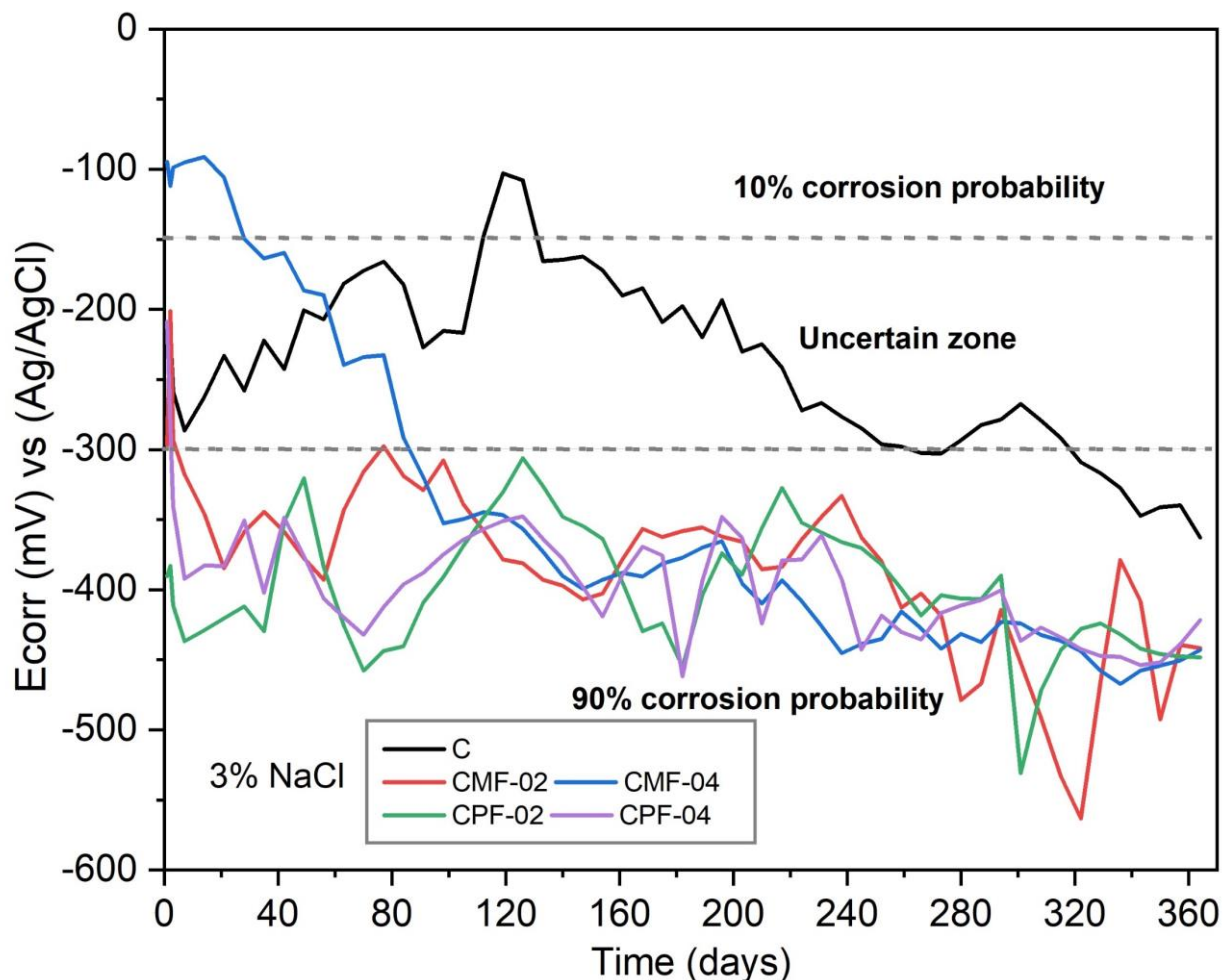
The corrosion potentials for the concrete samples with oil-treated fibers are shown in Figure 15. At the beginning of the monitoring, it is observed that the sample CMF-04, presents more positive E_{corr} values of -100 mV compared to the other samples, placing it in a zone of 10% probability of corrosion. This phenomenon indicates a good distribution of the fibers that delay the transport of fluids and chloride ions [34].

Figure 15. Corrosion potential values for structural steel

After 80 days the sample has a drop in E_{corr} potentials entering a zone of uncertainty, as time progresses and on day 365 of exposure this sample acquires more negative values from -400 mV to -550 mV entering a zone of 90% probability of corrosion, this fact could mean the increase of chloride ion content solution on the surface of the steel/concrete interface [76]. Samples CMF-02, CPF-02 and CPF-04 are in an active zone with 90% probability of corrosion from the beginning to the end of the measurement days, due to the high porosity of the samples, which causes higher voids in the cement paste and higher concentrations of oxygen, water and chloride ions [77, 78]. Chloride and oxygen ions compete to reach the surface of the reinforcing steel through a diffusion phenomenon [79]

- All samples presented a 90% probability of corrosion, with more negative values of corrosion potential ranging from -400 mV to -550 mV.
- The sample CMF-02 presented a better positive performance in the corrosion rate on the steel with high values of R_n and R_p of $1 \times 10^8 \Omega \cdot cm^2$, indicating the formation of a protective film of UEO on the steel surface, decreasing the diffusion of Cl^- , H_2O , and oxygen, and appreciating negligible corrosion damage on the road.

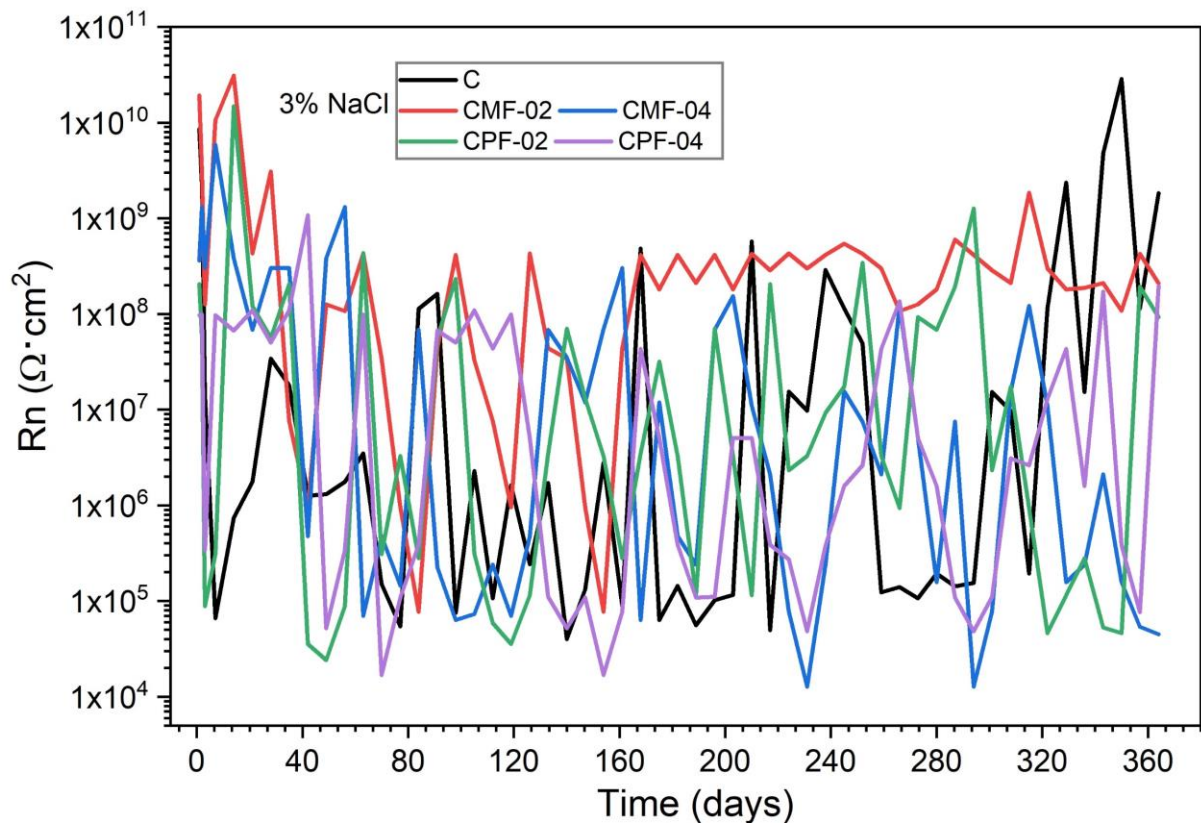
Figure 16. Rn values in the reinforced concrete

On day 40 of monitoring, high and low transients of Rn with values between $1 \times 10^{10} \Omega \cdot \text{cm}^2$ and $1 \times 10^5 \Omega \cdot \text{cm}^2$ are observed for all samples, low values of Rn could indicate that the concentration of chloride ion increases on the surface of the steel bar, consequently, the corrosion rate is severe [82], i.e., the corrosion rate is inversely proportional to the values of Rn.

The values of UEO-treated samples are higher than the control sample, as the exposure time progresses the R_n values for natural fibers maintain the increase, high values of noise resistance, corrosion rate decreases, the entry of Cl^- in the concrete increases the rate by the reduction of the alkaline hydrated products of the cement that passivates the embedded steel [83], i.e., the steel bars are passivated and depassivated by the interaction of the aggressive agents that were transported through the pore network of the concrete.

At the end of exposure, all samples show high and low R_n values, these fluctuations possibly due to passivation depassivation events transient behavior. It is not clear if the trend would continue as low or if it would follow the same trend as the control. However, sample CMF-02 shows high and constant R_n values of $1 \times 10^9 \Omega \cdot \text{cm}^2$ from day 160 to 365 days of exposure to the saline medium, this phenomenon may indicate that the treated fiber and the oil behave as a physical barrier, which may cause a slower diffusion of aggressive agents, also high R_n values indicate passivation in the metal and a negligible corrosion rate [46].

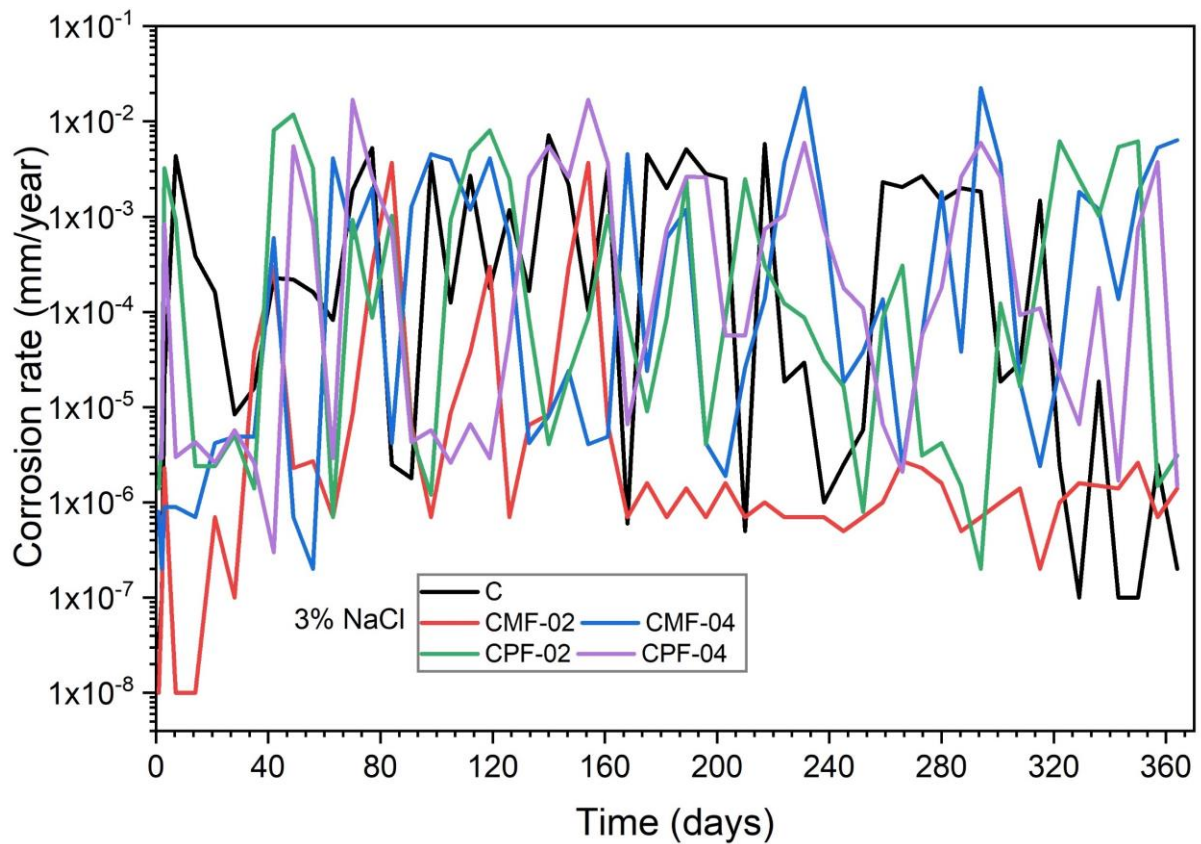
Figure 17. Corrosion rate for steel rod

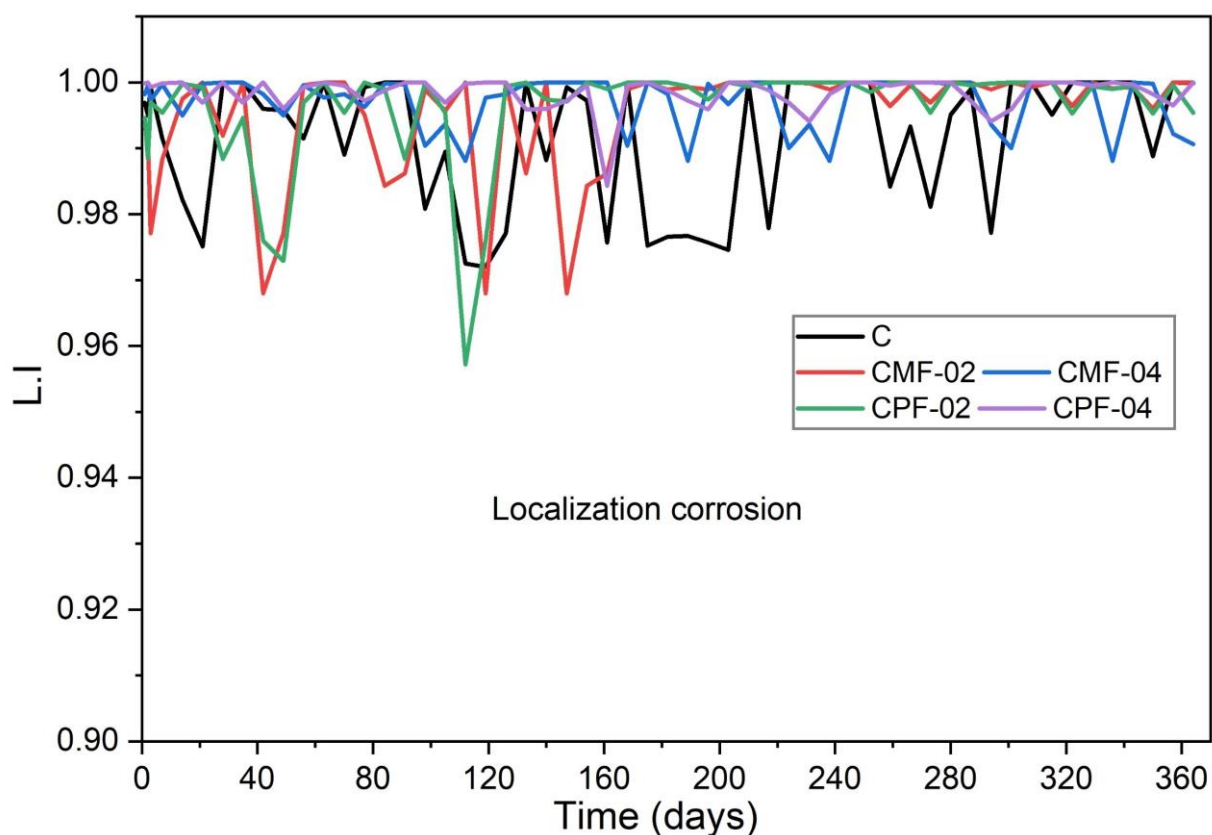
An electrochemical parameter that can be obtained with the EN test is the type of corrosion that is present in the steel bars through the localization index results as shown in Figure 18. It has been argued in the literature that L.I., can be used to determine the nature of the type of corrosion with values approaching 1 being characteristic of localized corrosion [85].

Figure 18. Type of corrosion in the steel/concrete system

It can be observed in a general way that all the samples with treated fibers have localized corrosion, that is, there are small areas of the rod surface, producing an important local reduction of the reinforcement section [64]. This type of corrosion is more likely to occur in reinforced concrete structures exposed to saline environments [86].

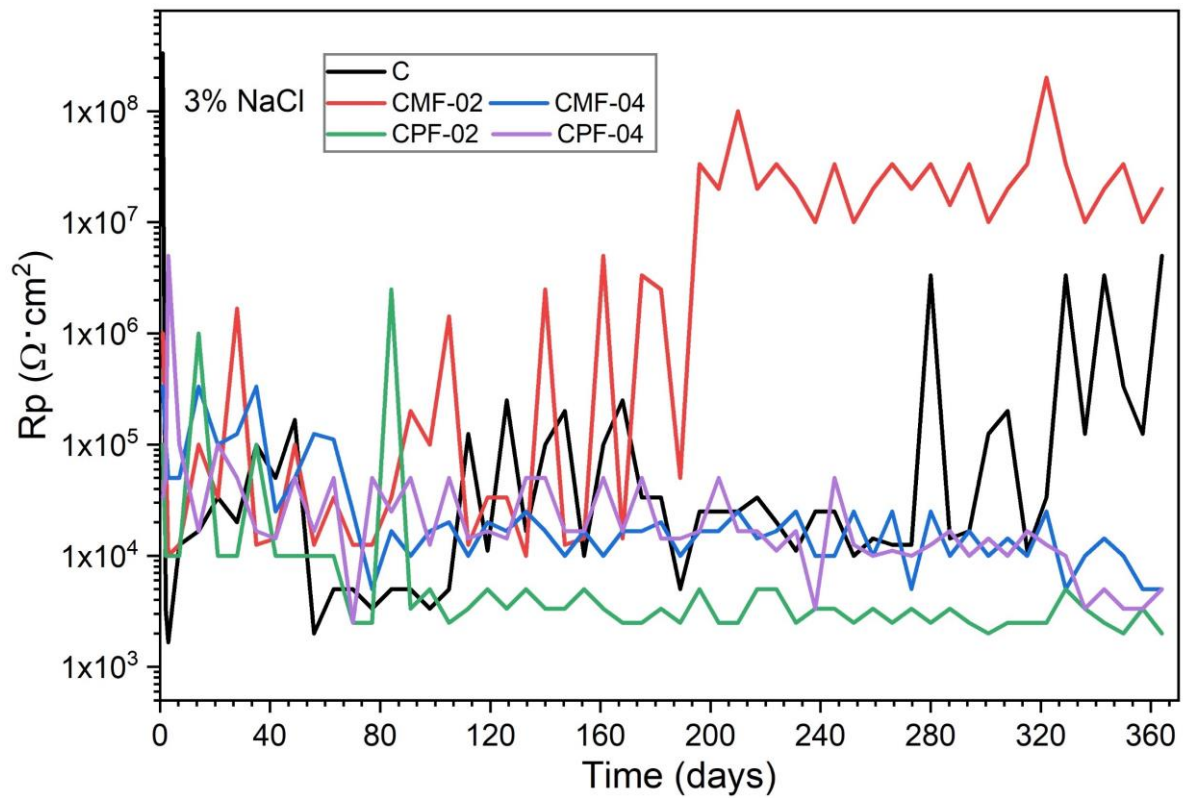
The values of the treated fiber concrete samples can be observed in Figure 19. At the beginning, all samples acquired R_p values of around $1 \times 10^5 \Omega \cdot \text{cm}^2$, indicating that the steel is under low corrosion attack. As the immersion time progresses on days 210 and 365 of monitoring, sample CMF-02 presents a rise in R_p behaviors as observed with high values of between $1 \times 10^5 \Omega \cdot \text{cm}^2$ and $1 \times 10^7 \Omega \cdot \text{cm}^2$, indicating a passivation in the metal surface and obtaining negligible corrosion damage as seen in Figure 20. Generally, steel corrosion is considered to be in the passive state if the current density is less than 0.1 mA/cm^2 and in the active state for values greater than 1 mA/cm^2 [44, 49]. The UEO has a positive effect on the corrosion rate by acting as a film or barrier around the metal; these results are comparable to those of other authors [87].

Figure 19. Average values of R_p

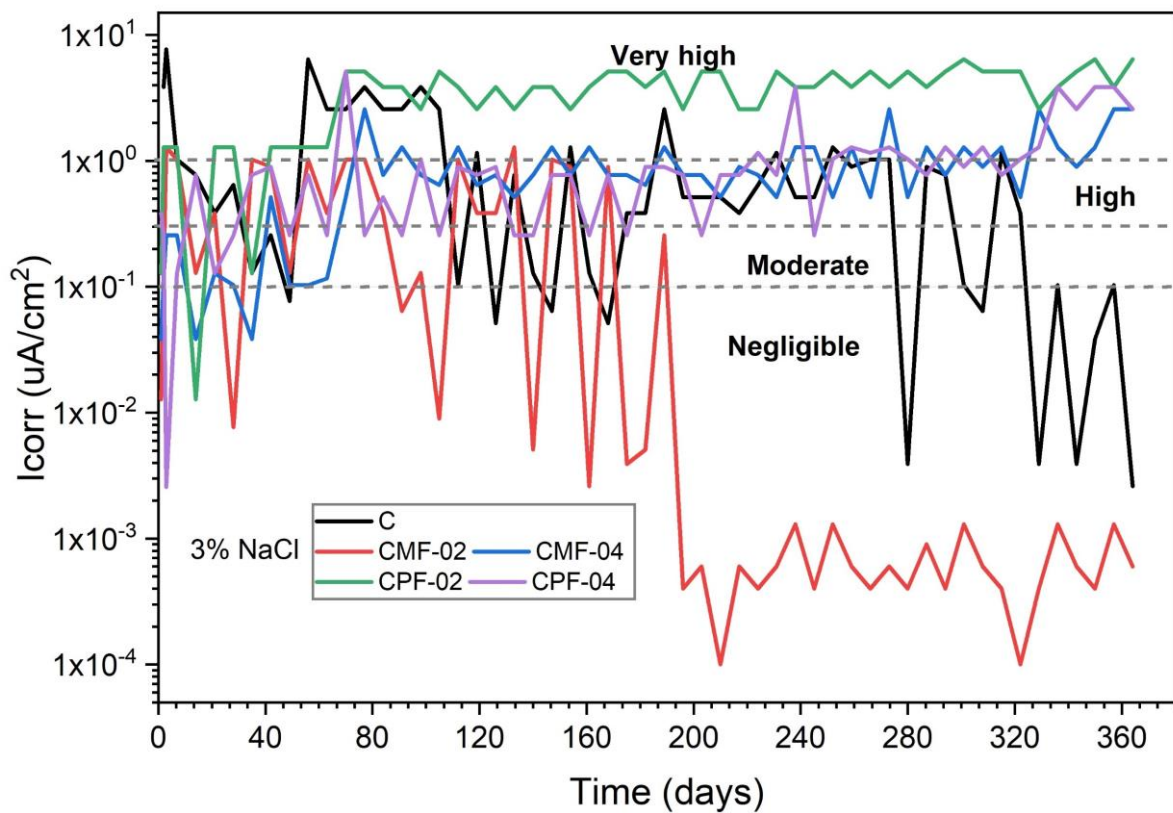
Figure 20. Current density values on the risk of steel corrosion

In the CPF-02 sample, low R_p values can be observed as the days of exposure progress, with values between $1 \times 10^3 \Omega \cdot \text{cm}^2$ and $1 \times 10^4 \Omega \cdot \text{cm}^2$ indicating high corrosion rate in the metal, due to poor adhesion of the fibers with the paste; likewise, the high porosity of the concrete paste by consequence has greater presence of oxygen diffusion and chloride

ions at the steel/paste interface, [88]. The values for the treated fibers have diverse from negligible to very high service life values compared to sample C. The samples CMF-04, CPF-02, and CPF-04 present very high I_{corr} values, increases in I_{corr} over time may not necessarily represent an increase in corrosion rate throughout the rebar, but rather the depassivation and initiation of active corrosion of greater amounts of rebar surface area [89]. Chloride penetration occurs mainly through capillary pores as free Cl^- chlorides by adsorption, diffusion, and capillary permeation [90]. The amount of fibers has a direct influence on the degree of corrosion of reinforcing bars in concrete [77].

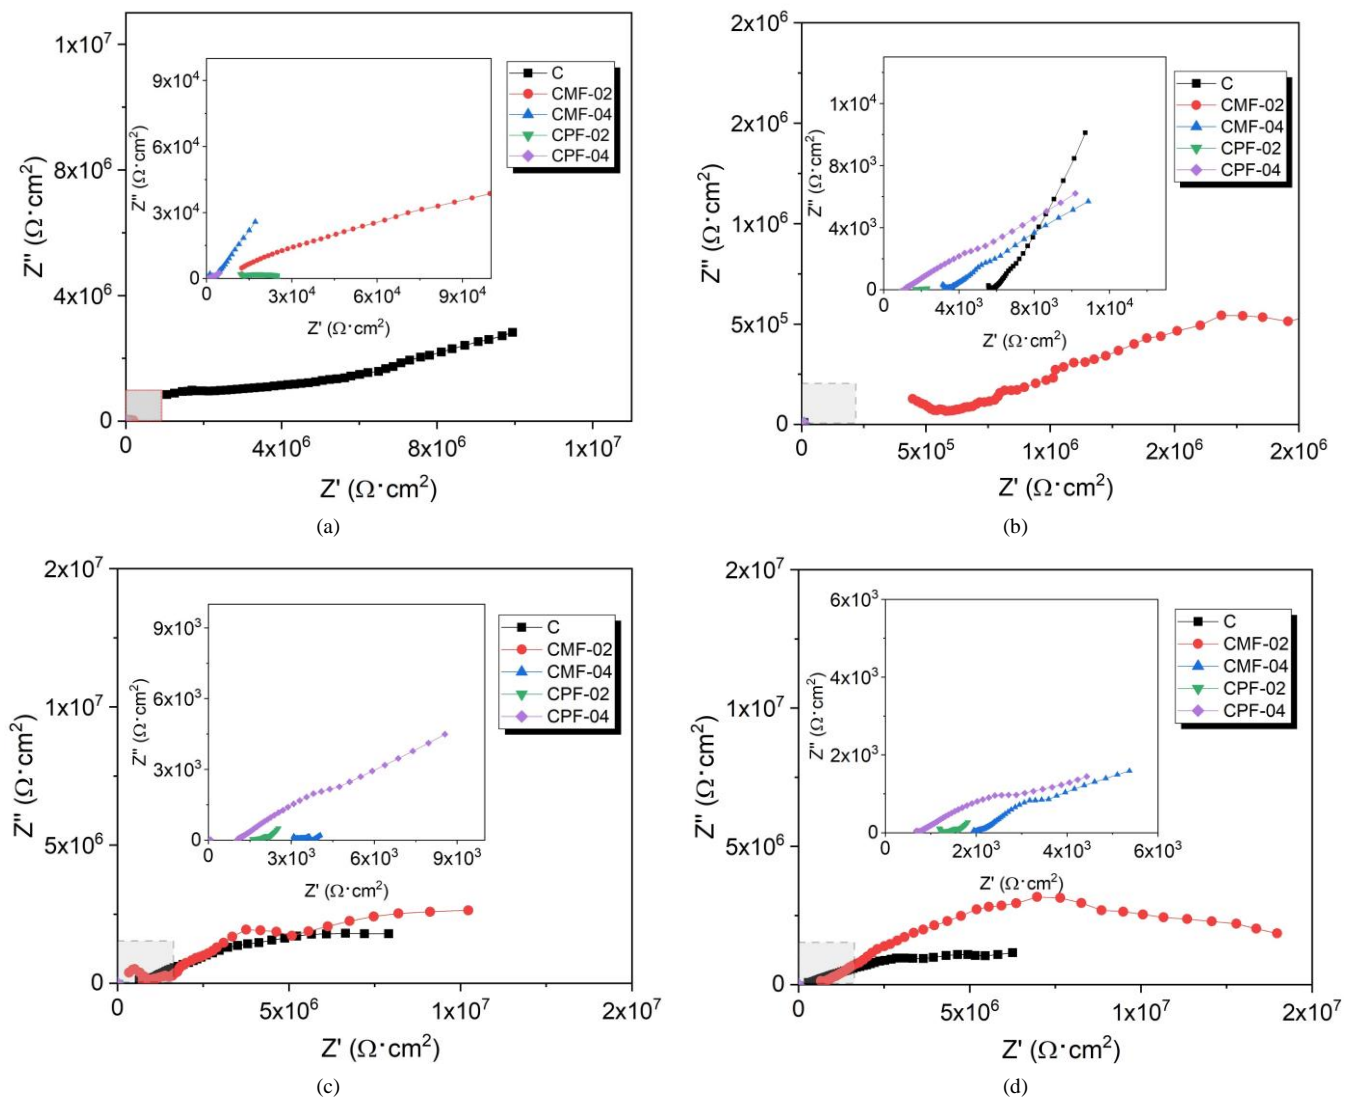
The EIS results are shown in Figure 21, at the beginning of measurement at 24 hours, it can be widely observed that the control sample presents a better solution resistance R_e and a higher impedance R_p , with values of 1×10^6 and $1 \times 10^7 \Omega \cdot cm^2$ this phenomenon can be explained by the low porosity.

Figure 21. Nyquist diagrams for the days of a) 1, b) 168, c) 280, and d) 365

Small and depressed semicircles can be noticed for samples with treated fibers, indicating low R_e and impedance values due to the presence of larger pores in the concrete, causing not only increased diffusion of chloride Cl^- ions but also diffusion of O_2 and H_2O [54].

For day 168, a remarkable improvement can be noticed for the fibers treated with used oil; the sample CMF-02 presents a better R_e as well as high impedance values of $1 \times 10^6 \Omega \cdot cm^2$ with respect to the control sample. This fact could indicate the formation of a protective film of UEO on the metal surface by the high impedance values indicate a lower corrosion rate in the steel bar [96]. In addition, it was demonstrated that the physical properties of concrete, such as air content and porosity, have a direct relationship with corrosion damage to the metal due to the transport of species at the steel-concrete interface.

During the 240-day measurement, it was observed that the control sample had high values of R_e and R_p of $1 \times 10^7 \Omega \cdot cm^2$, which could indicate passivation in the metal. At the end of the 365 days of monitoring, it is appreciated that the sample CMF-02 has had a positive response to the corrosion process of the steel for 168 days, maintaining a constant impedance until the end of the exposure. High values in this low-frequency region may be associated with the presence of the passive film [97, 98].

- In all samples, diffusion processes were observed on the steel/concrete interface, according to the EIS data.
