Structural Assessment and Rehabilitation of an Existing Hydraulic Masonry Structure Supporting Railway

Aly A. Makhlof¹

¹ Construction Research Institute (CRI), National Water Research Center (NWRC), Delta-Barrage, 13621, Egypt.

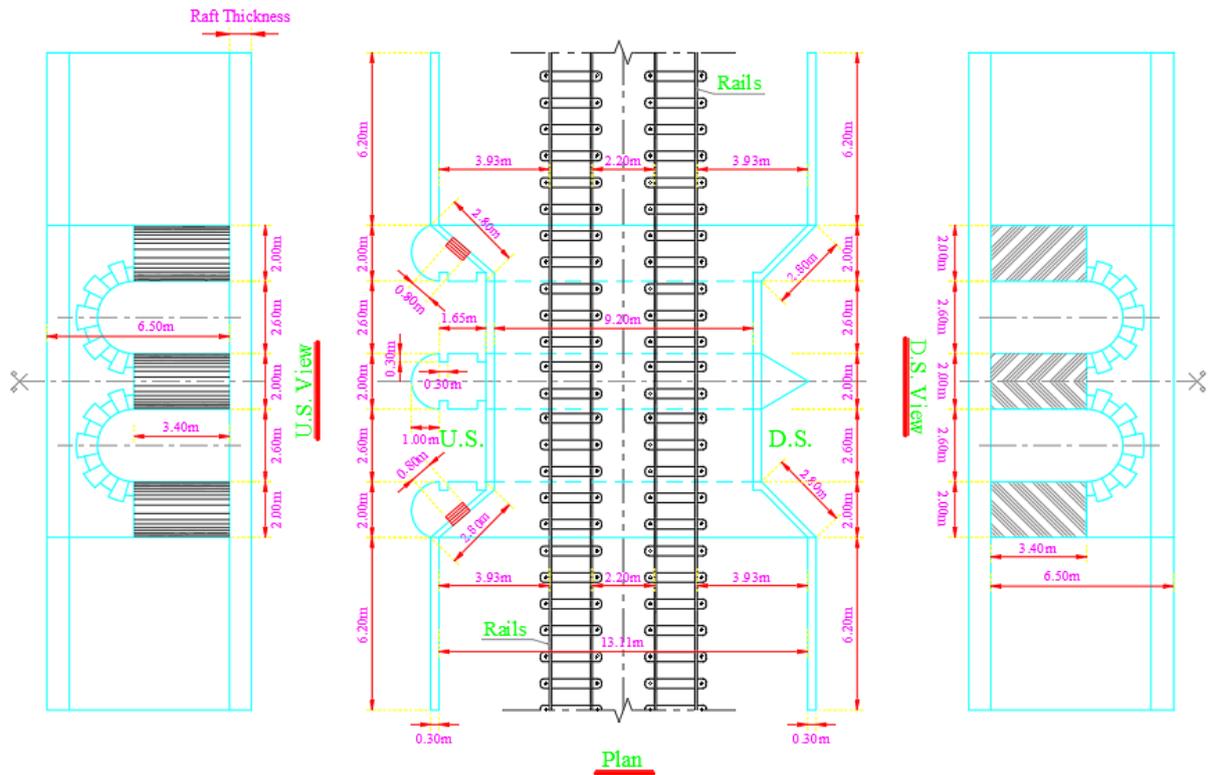
Figure 2. Current layout of the Regulator before rehabilitation works

Samalout Regulator is located at 219 + 078 km on the right side of the Ibrahimiya Canal right bank in Samalut - Minya Governorate, Egypt (Figure 1). It has proved impossible to correctly trace the construction history of this work due to inadequate information. It was built in 1834, crossing under the main Upper Egypt railway lines. The Regulator consists of two openings, each opening 2.60 m, as shown in Figure 2. There are two abutments with masonry arch rings. The piers were overlaid with a masonry arched bridge of 2.00 m thickness. The Red Clay Bricks have been used for construction with mortar. The Regulator was exposed to railway loads over two lanes. A standard gauge length of 1.435 meters was identified. Standard spacings and dimensions of the railway system are illustrated in Figure 3.

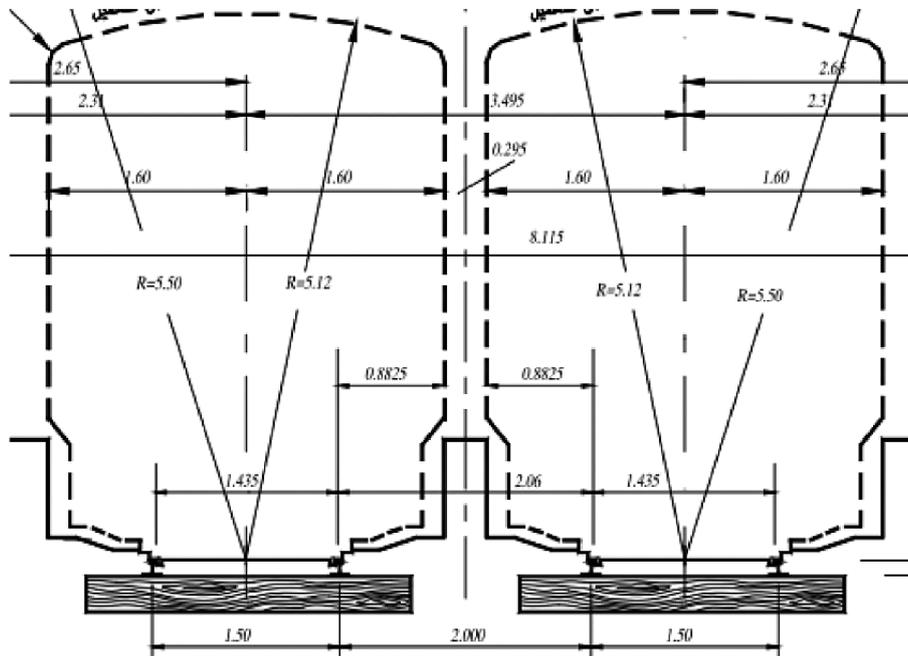
Figure 3. Standard spacing for the railway system (all dimensions are in meters) [30]

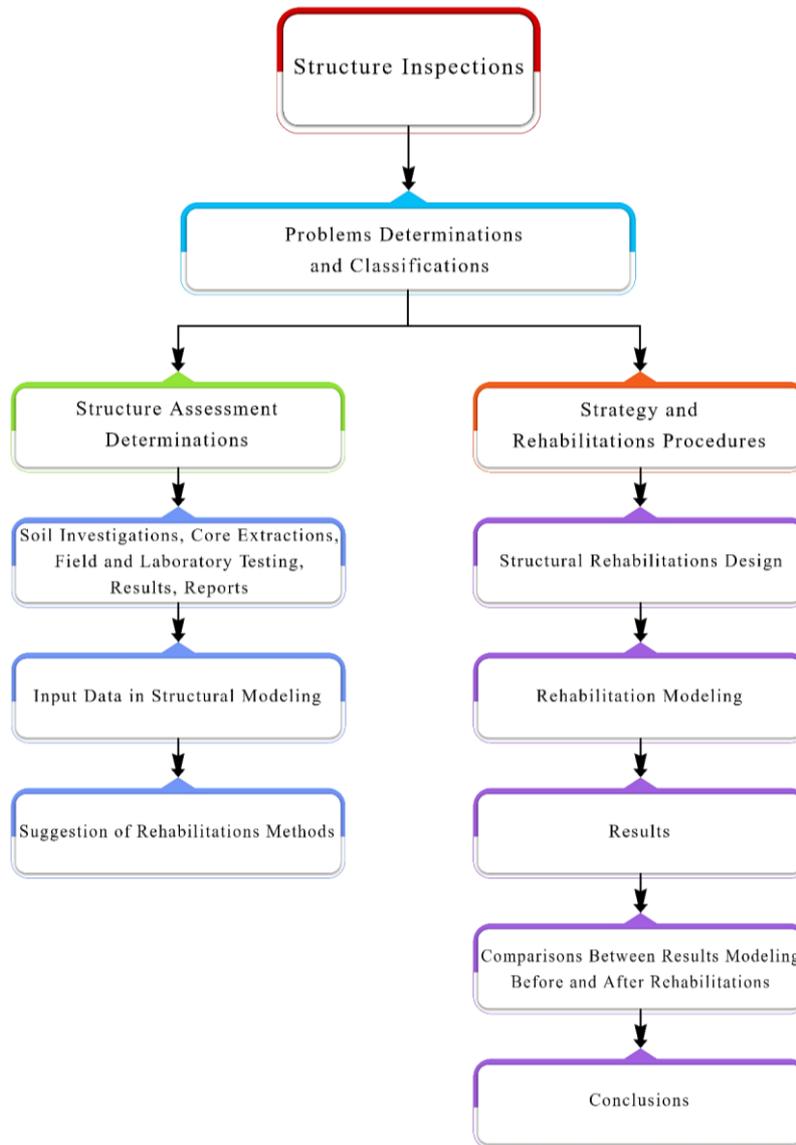
Figure 4. Frame work of the process methodology

Figure 4 shows the framework of the process methodology and its implementation after developing the geometric representation of the masonry arch regulator. A visual inspection is conducted to determine the apparent condition of the regulator (Figure 5). Material properties of the constitutional material are extracted for material assessment. Continuous coring was conducted in two periods. Two reports addressed the test results of these samplings, dated 2015 and 2021, respectively. The Construction Research Institute team took samples, and tests were conducted according to the Egyptian Code for the Design and Implementation of Concrete Structures [31]. Figure 6 shows the obtained samples as well as the test configuration.

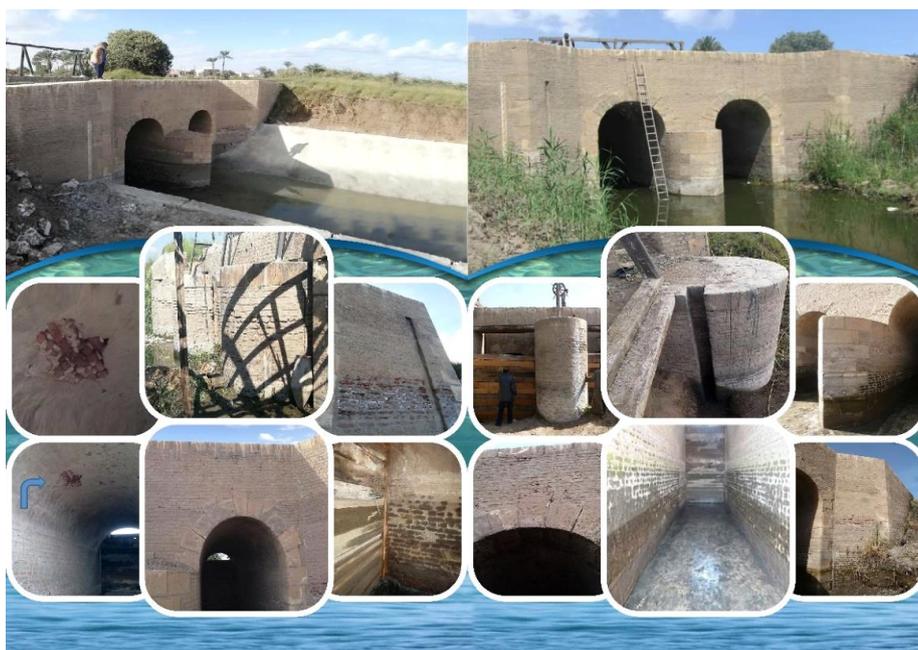
Figure 5. Visual inspection conducted to assess the apparent condition of the Regulator

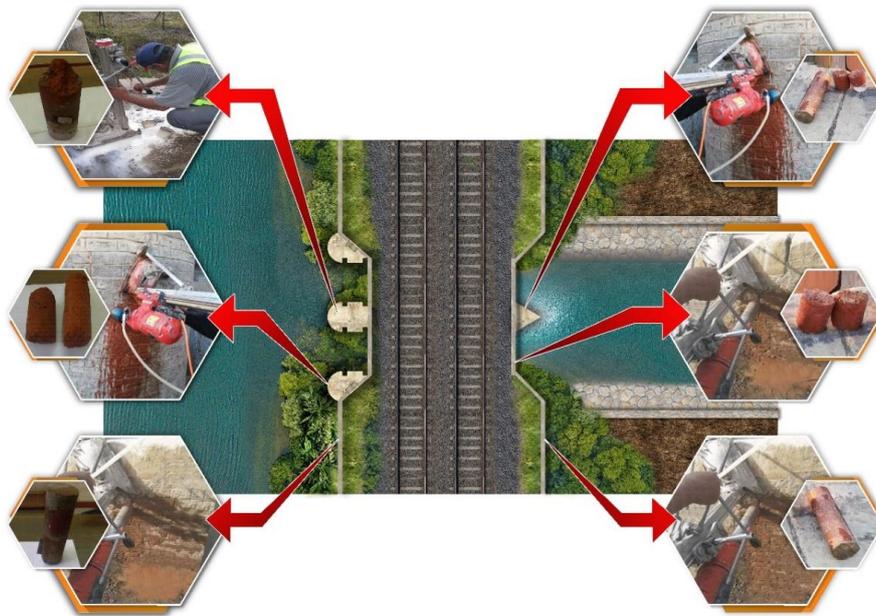
Figure 6. Concrete cores extracted from different locations through the Regulator

Several cores were extracted according to what is shown in Figure 6 so that they represent all the elements of the Regulator and are, therefore, distributed to different places in the Regulator. By observing the extracted cores, it became clear that a complete separation of the samples of some cores had occurred at the interval between the mortar and the bricks, as it was found that the thickness of the mortar appeared to be relatively large and, to a noticeable degree. The mortar used was Qasromil mortar (lime and brick-based mortar), as shown in Figure 7. The coring was done in two separate periods. Two reports addressed the findings of these samplings, dated 2015 and 2021, respectively, by the Construction Research Institute (CRI), NWRC.

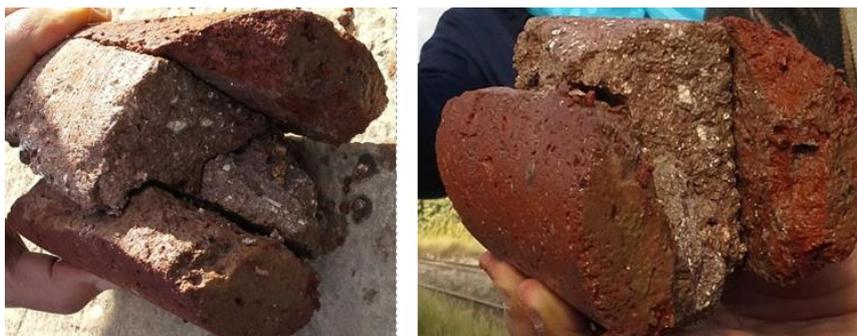
Figure 7. Complete separation observed between the mortar and bricks in

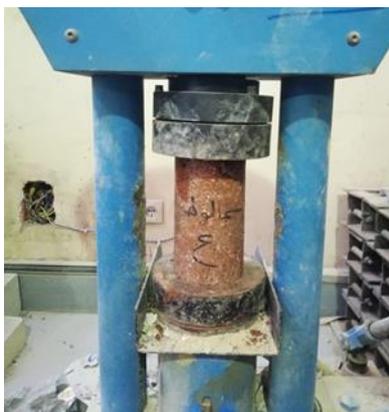
Figure 8. Compression test of core sample

Figure 8 shows the test configuration. In 2015, the compressive strength tests of the tested cores showed that the compressive strength values of the tested samples ranged between 44.60 kg/cm^2 and 48.80 kg/cm^2 , with a total average of about 46.50 kg/cm^2 . In 2021, the compressive strength tests of the examined cores indicated that the compressive strength values of the samples varied from 41.08 kg/cm^2 to 47.63 kg/cm^2 , with an overall average of around 44.27 kg/cm^2 . The masonry unit weight samples vary from 16 to 18.5 kN/m^3 with an average value of 17 kN/m^3 . The deterioration rate in the year is 0.8%. Allowable tension strength is assumed to be no more than 10 %, considered compressive strength.

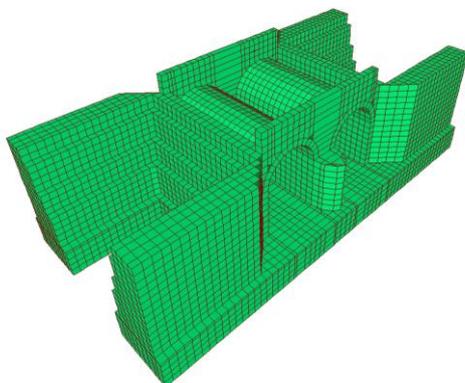
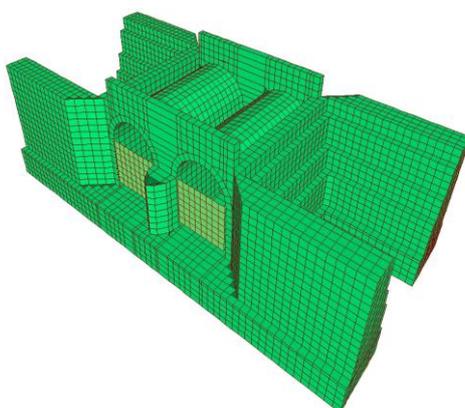
Figure 9. Finite Element Model (FEM) of the entire existing Regulator shape in the downstream direction

Figure 10. Finite Element Model (FEM) of the entire existing Regulator shape in the upstream direction

Figures 9 and 10 illustrate the final stage of modeling the regulator with its original geometry. An envelope of the critical load combinations was generated and compared for both models, i.e., before and after strengthening. Water loads were applied as hydrostatic pressure, while the dynamic effects of water were modeled as equivalent static loads in accordance with the Egyptian code. Similarly, the dynamic earth pressure was represented as factored static loading as per the Egyptian foundation code [30]. The seismic loads were evaluated using the response spectrum analysis outlined in ECP 201 [30].

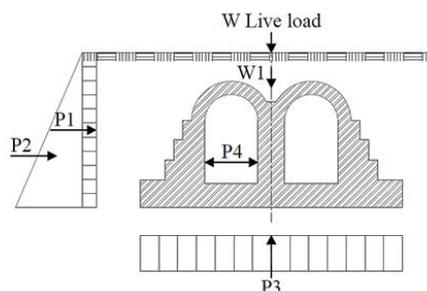
Figure 11. Case loading of the Regulator

To simulate the operating conditions and new railway loads, the Finite Element Model (FEM) was subjected to normal operating loads, railway breaking forces, and seismic loads. For massive sections where small deformations were expected, linear modeling was utilized to identify the most stressed regions of the Regulator. Earth pressure was modeled using equivalent static loading, and the effects of uplift pressure, maintenance forces, and impact forces were incorporated (Figure 11). These forces included P1: surcharge, P2: earth pressure (static and dynamic), P3: uplift pressure, P4: water pressure (static and dynamic), W1: weight of soil layer above the arch, and W live load: train live load. Uplift pressure was treated as equivalent to static pressure.

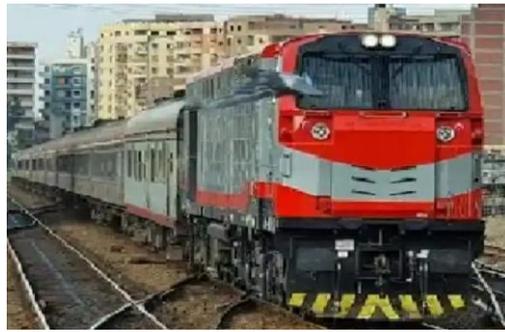
Figure 12. Train model weighing 122 ton

To simulate the railway impact, a train model was introduced (Figure 12), assuming the locomotive's mass to be 122 tons. The results provided insights into the stress distribution and performance of the Regulator under existing and new loading conditions, further validating the structural modifications and their compliance with modern design standards.

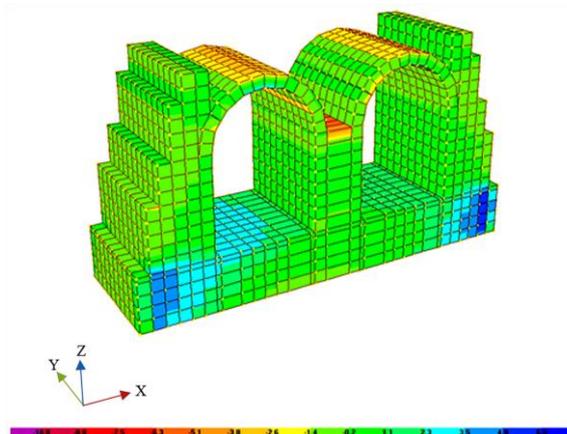
Figure 14. Maximum stresses in the original structure due to static and dynamic loading along x-direction (kg/cm²)

Figures 14 and 15 illustrate the normal stress distribution along critical cross-sections in the x- and y-directions under normal operating conditions. In the x-direction (Figure 14), elevated stress concentrations were observed around the central portions of the arches and specific sections of the abutments. The analysis of the raft indicates that its entire height remains in compression, with compressive stresses reaching 1.4 kg/cm². However, tensile stresses as high as 5.80 kg/cm² were observed at the sides of the raft beneath the abutments, exceeding the allowable masonry tensile strength. These findings are consistent with the field measurements by Anwar et al. [8], who reported maximum tensile stresses of 2.7 kg/cm² at the base of walls. Additionally, tensile stresses at the top of the raft at the centre of the regulator opening reached 2.85 kg/cm².

The abutments showed compressive stresses throughout their height, reaching 1.4 kg/cm², while the piers exhibited compressive stresses ranging from 1.4 to 5.14 kg/cm². In the arches, compressive stresses varied between 1.4 and 3.80 kg/cm² near the crown, whereas maximum tensile stresses of 4.70 kg/cm² were observed at the bottom near the arch crown, surpassing the allowable masonry tensile strength. These results align with Anwar et al. [8], who also reported critical tensile and compressive stresses in similar structures.

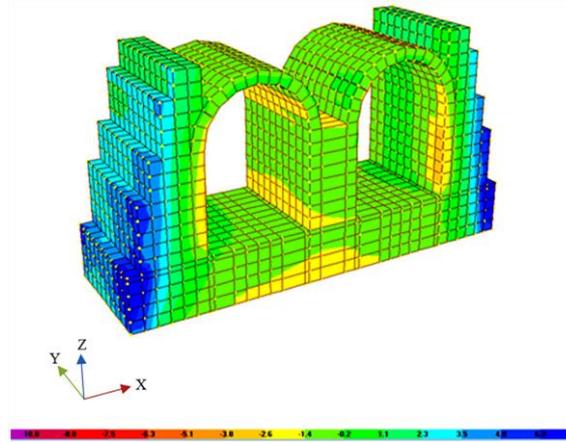
Figure 15. Maximum stresses in the original structure due to static and dynamic loading along y-direction (kg/cm²)

In the y-direction (Figure 15), significant stress concentrations were observed around the abutments and the base of the structure. Tensile stresses in the raft beneath the abutments peaked at 5.80 kg/cm², while tensile stresses at the top of the raft reached 2.30 kg/cm², far exceeding the 0.7 kg/cm² reported by Anwar et al. [8] for similar cases. The abutments also experienced tensile stresses of 5.80 kg/cm², further exceeding safe limits. No tensile stresses were observed in the piers, where compressive stresses peaked at 2.60 kg/cm². Meanwhile, compressive stresses in the raft, arches, and abutments remained below allowable limits, confirming the findings of Anwar et al. [8] regarding compression stress distribution. The analysis highlights that the tensile stresses in the raft, abutments, and arches exceed allowable masonry tensile strength, posing a risk of cracking and structural deterioration. Specifically, tensile stresses peaked at 4.54 kg/cm² in the arches and 5.80 kg/cm² in the abutments, emphasizing the need for targeted strengthening measures. In contrast, the stress levels in other structural elements, such as piers and wing walls, were found to be within acceptable limits.

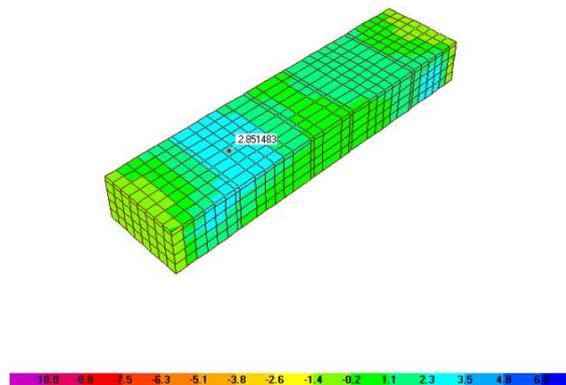
Figure 16. Maximum stresses (kg/cm²) in the original raft due to static and dynamic loading

Figures 16 to 19 provide detailed visualizations of the maximum tensile and compressive stresses under static and dynamic loading for the raft, arch, pier, and abutments, respectively. Table 1 summarizes the tension and compression stresses in various components before any strengthening measures were taken.

In the raft (Figure 16), tensile stresses reached 2.85 kg/cm², while compressive stresses remained at 0.50 kg/cm², both within acceptable limits. However, in the arches (Figure 17), tensile stresses at the bottom near the arch crown peaked at 4.54 kg/cm², accompanied by compressive stresses of 2.60 kg/cm², which aligns with observed cracking and mortar deterioration in this region. The piers (Figure 18) exhibited maximum compressive stresses of 5.14 kg/cm², with no tensile stresses recorded. Finally, in the abutments (Figure 19), tensile stresses reached 5.80 kg/cm², while compressive stresses were 2.60 kg/cm², reinforcing the conclusion that tensile stresses in these regions exceed allowable limits and require reinforcement.

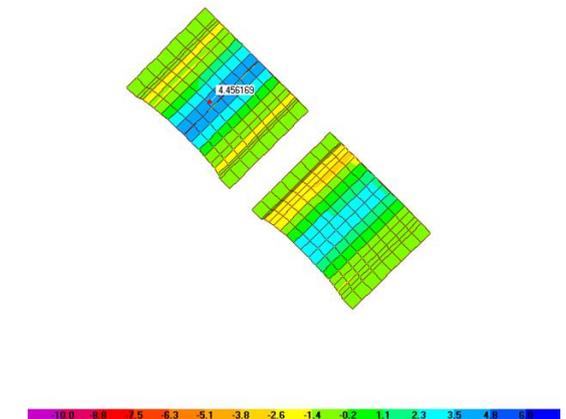
Figure 17. Maximum stresses (kg/cm²) in the original bottom of the arch due to static and dynamic loading in the original state (kg/cm²)

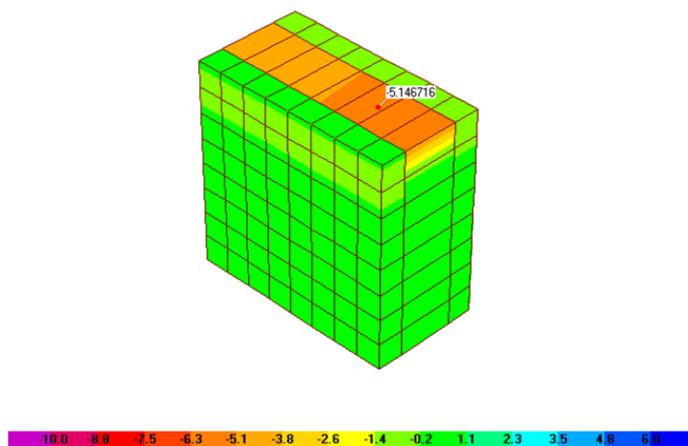
Figure 18. Maximum stresses (kg/cm²) in the original pier due to static and dynamic loading in the original state

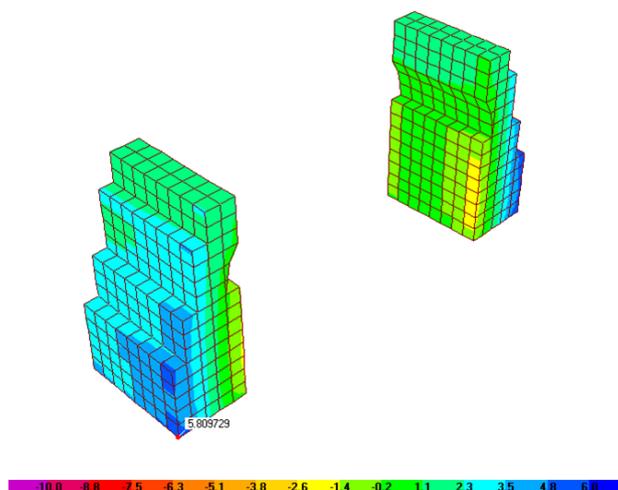
Figure 19. Maximum stresses (kg/cm²) in the original abutment due to static and dynamic loading in the original state

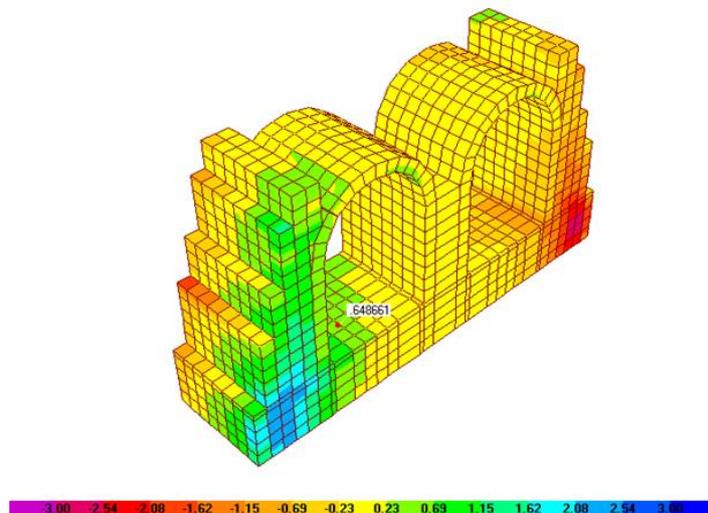
Figure 20. Maximum shear stresses (S1-2) in the original bricks Regulator due to static and dynamic loading in the original state (Kg/cm²)

Figures 20 and 21 show shear stress distribution among a critical cross-section of the Regulator under normal operating conditions – S1-2 and S1-3 directions, respectively. High shear stress was recorded in the arch (2.99 kg/cm²),

while other components like the abutment and pier have lower shear stress levels (0.35 kg/cm² and 0.46 kg/cm², respectively). The data in Table 2 provide a concise view of maximum shear stress values across the regulator's elements before any reinforcement measures. These values highlight the need to prioritize the arch for strengthening due to its elevated shear and tensile stresses.

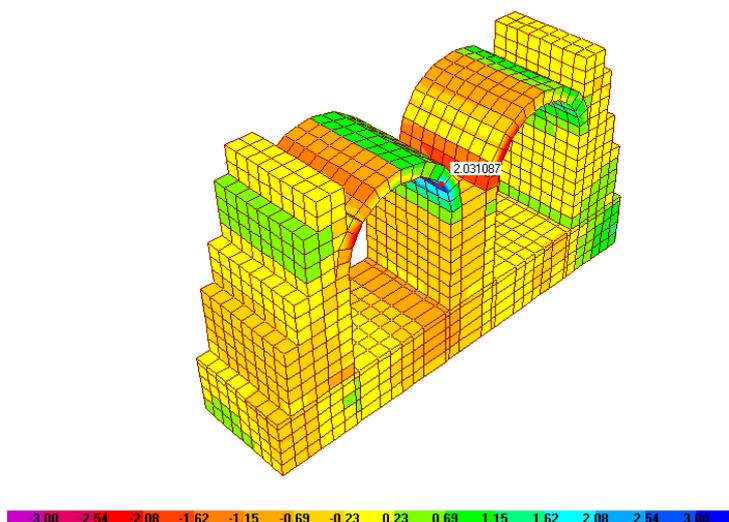
Figure 21. Maximum shear stresses (S1-3) in the original bricks Regulator due to static and dynamic loading in the original state (kg/cm²)

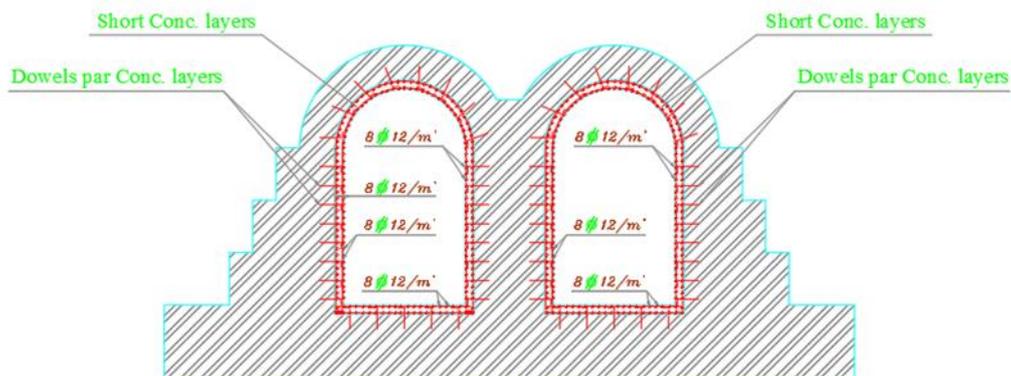
(a) RC jacket details

In this study, the rehabilitation program included constructing an internal RC jacket for the raft, abutment walls, piers, and arches. Before concrete placement, all surfaces were thoroughly cleaned to remove oil, standing water, mud, loose rock, and debris. Cracks were cleaned, moistened, and injected with high-adhesion mortar. Grooves, 200 mm deep and spaced 500 mm apart in both directions, were drilled into the raft, walls, and arches. Steel bars with a diameter of 16 mm ($\text{\O}16$) were chemically anchored into these grooves using a non-shrink cement-based adhesive. Subsequently, a 200 mm thick RC jacket was installed, reinforced with upper and lower layers of steel mesh ($8 \text{ \O}12/\text{m}^2$), as depicted in Figure 22.

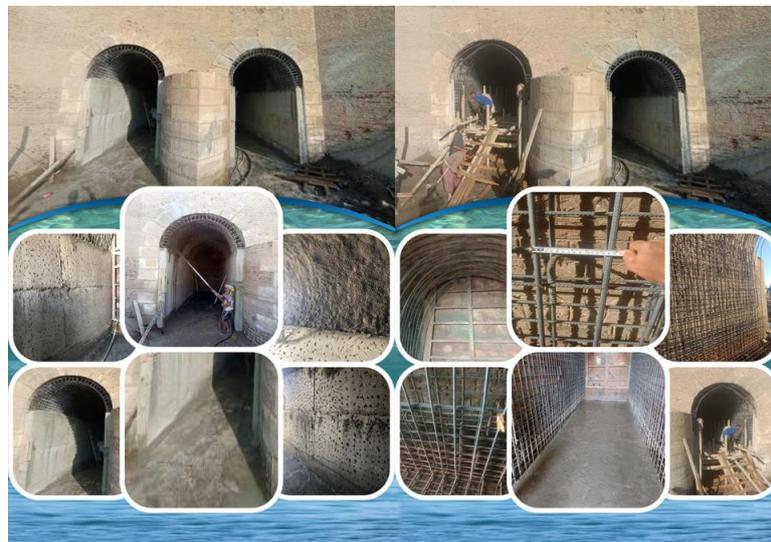
Figure 23. Structural rehabilitation

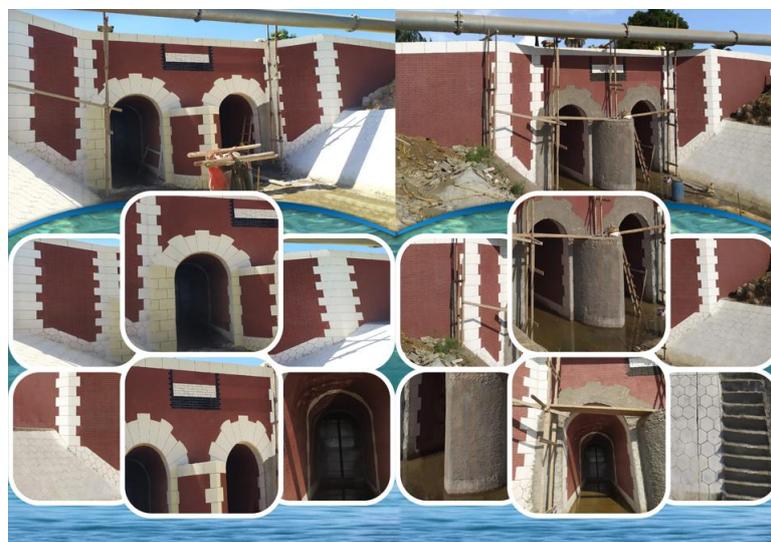
Figure 24. Structural after rehabilitation

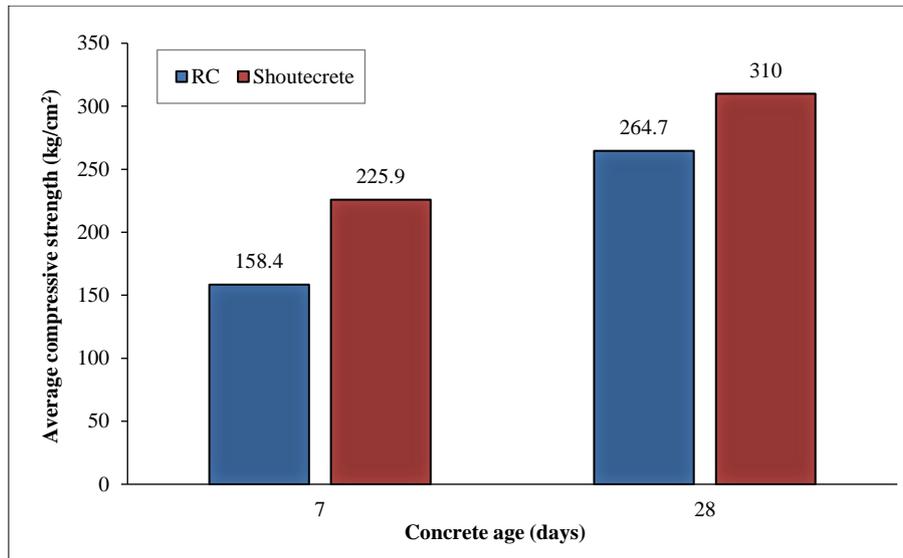
Figure 25. Average compressive strength of reinforced concrete and shotcrete jacket

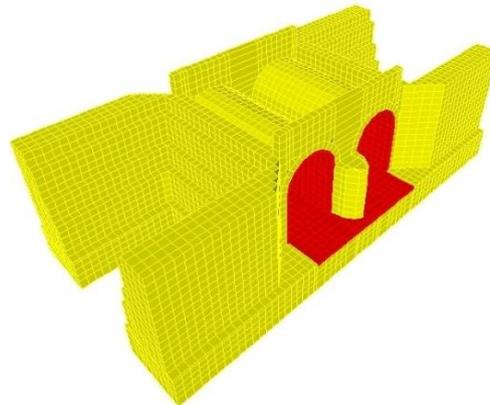
Figure 26. Finite Element Model (FEM) of the entire Regulator shape after strengthening in the downstream direction

The second model simulated the Regulator after the implementation of rehabilitation structural modifications designed to enhance its performance under new loading conditions. The reinforced concrete (RC) jacket was modeled as a 0.50 m × 0.50 m × 0.20 m solid element mesh, with material properties assigned based on the rehabilitation program design. These properties included Young's modulus = 22,000 MPa, Poisson's ratio = 0.20, density = 24 kN/m³, and concrete compressive strength = 260 kg/cm². Figures 26 and 27 illustrate the final stage of the Regulator's modeling after the rehabilitation modifications.

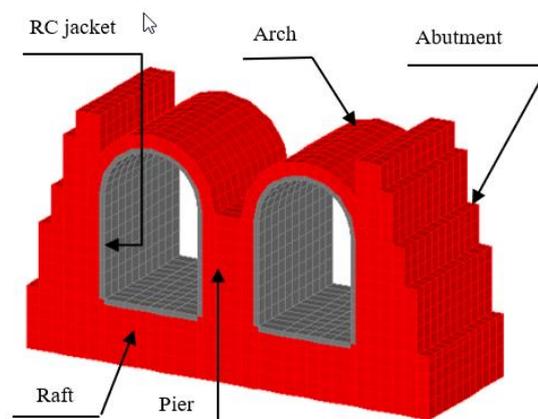
Figure 27. Finite Element Model (FEM) for the Cross-section strip of the Regulator after strengthening

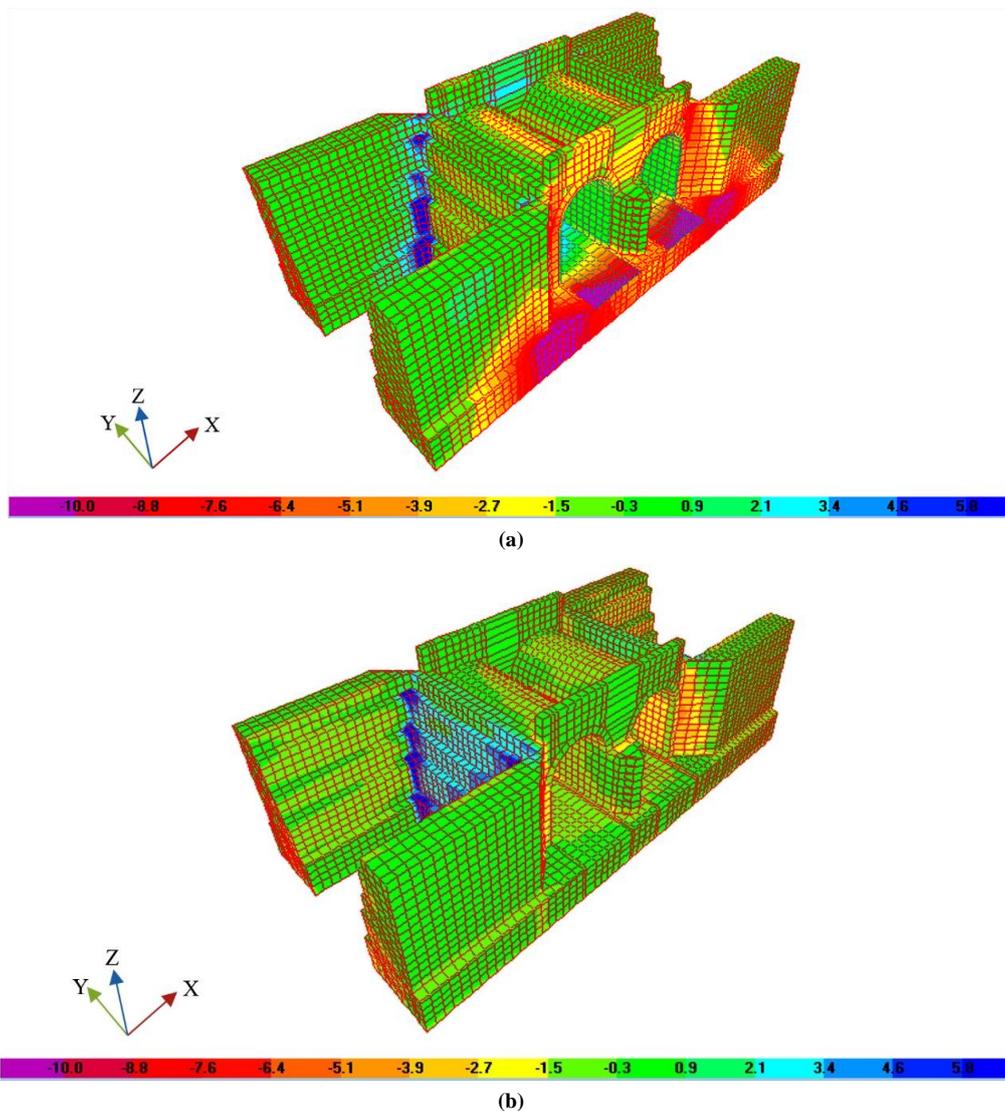
Figure 28. a) Maximum stresses (kg/cm²) in strengthened arch, wall, pier and raft due to static and dynamic loading after strengthening along the x-direction, b) Maximum stresses (kg/cm²) in strengthened arch, wall, pier and raft due to static and dynamic loading after strengthening along the y-direction.

Post-strengthening analysis revealed a significant reduction in critical stress levels across key structural elements. Figure 28-a shows the normal stress distribution in the x-direction, where the wing wall and raft remained in compression, with compressive stresses of approximately 1.4 kg/cm^2 in the wing wall and 10 kg/cm^2 in the raft. In the y-direction (Figure 28-b), no tensile stresses were observed, with maximum compressive stresses recorded at 6.7 kg/cm^2 in the wing wall and 12 kg/cm^2 in the raft, both within acceptable limits relative to the allowable masonry compressive strength.

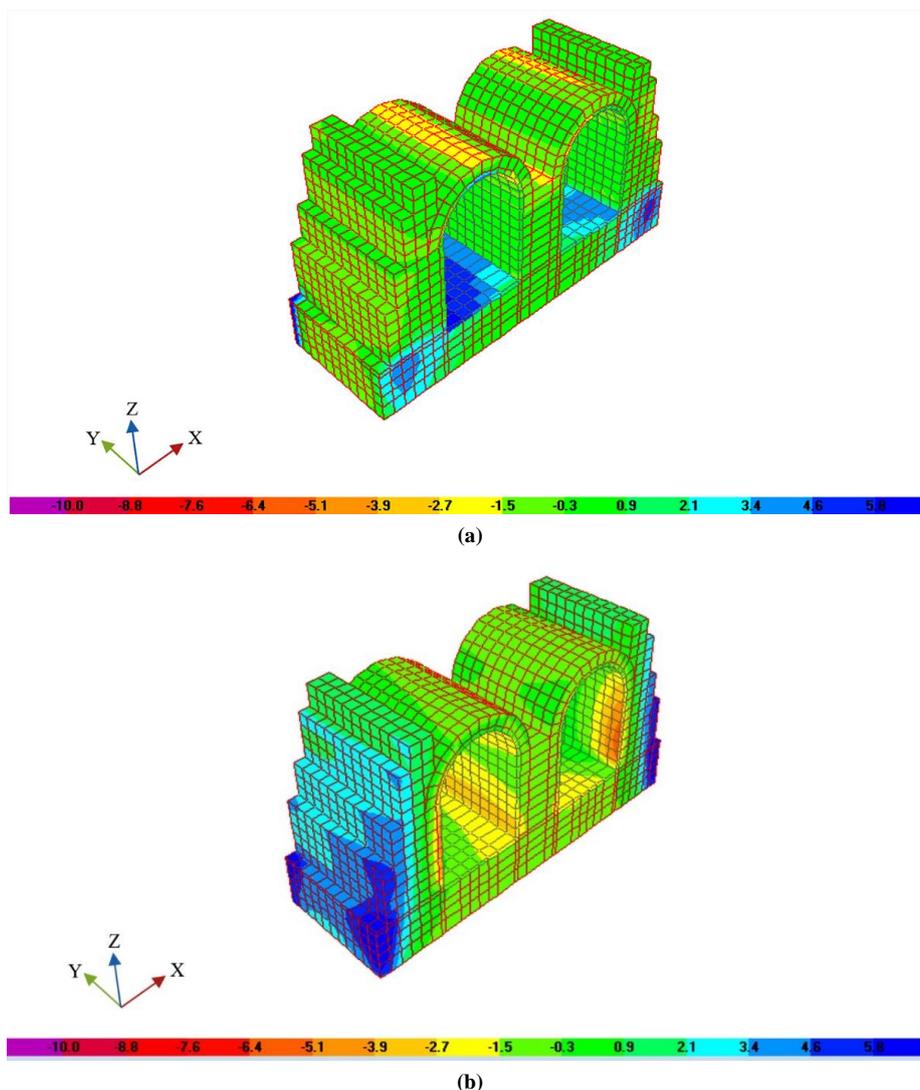
Figure 29. a) Maximum stresses (kg/cm^2) in RC and bricks strip due to static and dynamic loading after strengthening along the x-direction, b) Maximum stresses (kg/cm^2) in RC and bricks strip due to static and dynamic loading after strengthening along the y-direction.

Figure 29-a presents the normal stress distribution in the x-direction for the abutment, raft, pier, and arches. The abutment and pier were entirely in compression, with compressive stresses of around 1.5 kg/cm^2 . However, the arches exhibited maximum compressive stresses of 2.7 kg/cm^2 at the top and tensile stresses of 3.4 kg/cm^2 at the bottom. Local tensile stresses of 4.4 kg/cm^2 were also noted under the abutment in the raft, while the remainder of the raft remained primarily in compression. In the y-direction (Figure 29-b), compressive stresses reached 5.1 kg/cm^2 in the abutment and pier and 1.5 kg/cm^2 in the raft and arches.

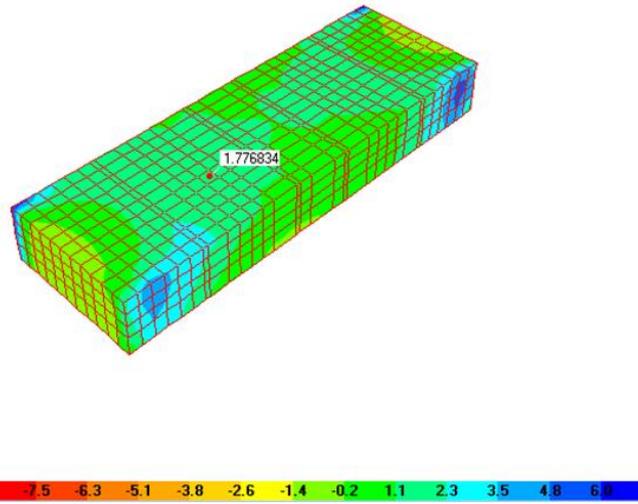
Figure 30. Maximum stresses (kg/cm²) in bricks strip due to static and dynamic loading after strengthening

Following strengthening, the maximum tensile stress in the raft bricks was reduced to 1.78 kg/cm^2 (Figure 30), while the bottom of the arches recorded a maximum tensile stress of 0.63 kg/cm^2 (Figure 31). The compressive stresses in the pier remained below the allowable masonry compressive strength (Figure 32). In the abutment, the maximum tensile stress reached 4.54 kg/cm^2 (Figure 33). Table 4 confirms that the reinforced components achieved improved load distribution, reducing tensile stresses in critical areas to 0.63 kg/cm^2 in the arch bricks, 1.77 kg/cm^2 in the raft, and 4.54 kg/cm^2 in the abutment. These results are consistent with the findings of Bancardino et al. [7], who evaluated the seismic vulnerability of a masonry arch bridge on the San Nicola–Avignano Lucania line using nonlinear static pushover analysis. Their study demonstrated that traditional rehabilitation techniques, such as jacketing and linings, effectively enhanced seismic performance, ensuring compliance with modern code requirements.

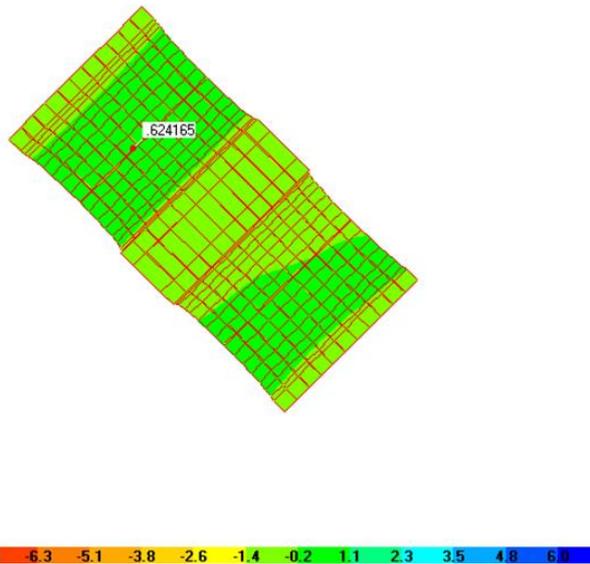
Figure 31. Maximum stresses (kg/cm²) in the strengthened bottom of the brick arch due to static and dynamic loading after strengthening

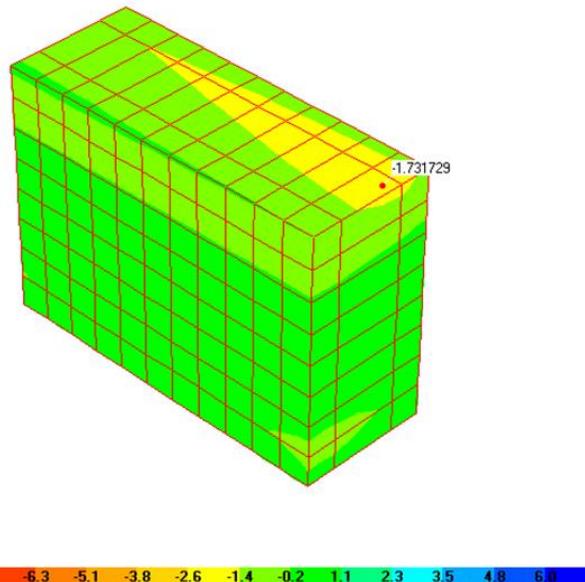
Figure 32. Maximum stresses (kg/cm²) in the strengthened brick pier due to static and dynamic loading after strengthening

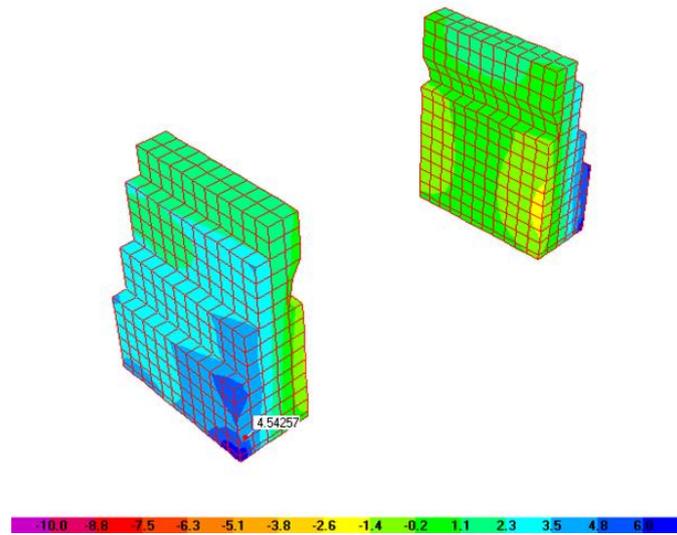
Figure 33. Maximum stresses (kg/cm^2) in the strengthened brick abutment to static and dynamic loading after strengthening

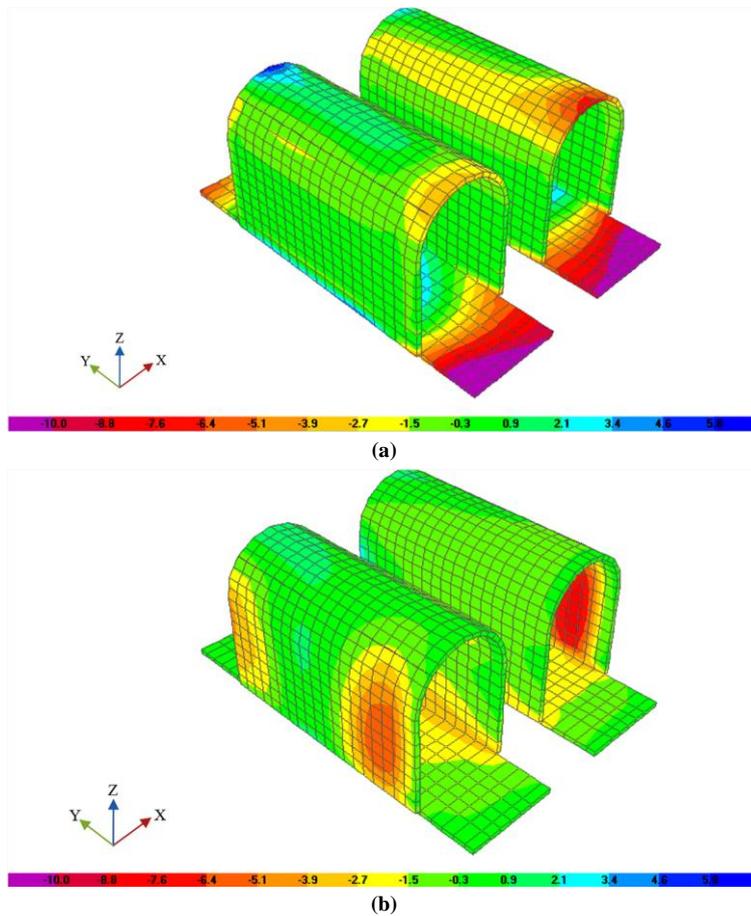
Figure 34. a) Maximum stresses (kg/cm^2) in RC jacket due to static and dynamic loading after strengthening along the x-direction, b) Maximum stresses (kg/cm^2) in RC jacket due to static and dynamic loading after strengthening along y-direction (kg/cm^2).

The implemented strengthening measures in this study significantly improved the Regulator’s resilience. By redistributing stresses and reducing peak concentrations in vulnerable areas, the structure is now better equipped to withstand both static and dynamic forces without sustaining damage. The application of the RC jacket and increased thicknesses in key structural components mitigated potential degradation, extended the operational life of the Regulator, and reduced long-term maintenance requirements. Figures 34-a and 34-b illustrates the stress distribution in the RC jacket post-strengthening, highlighting the effectiveness of the intervention.

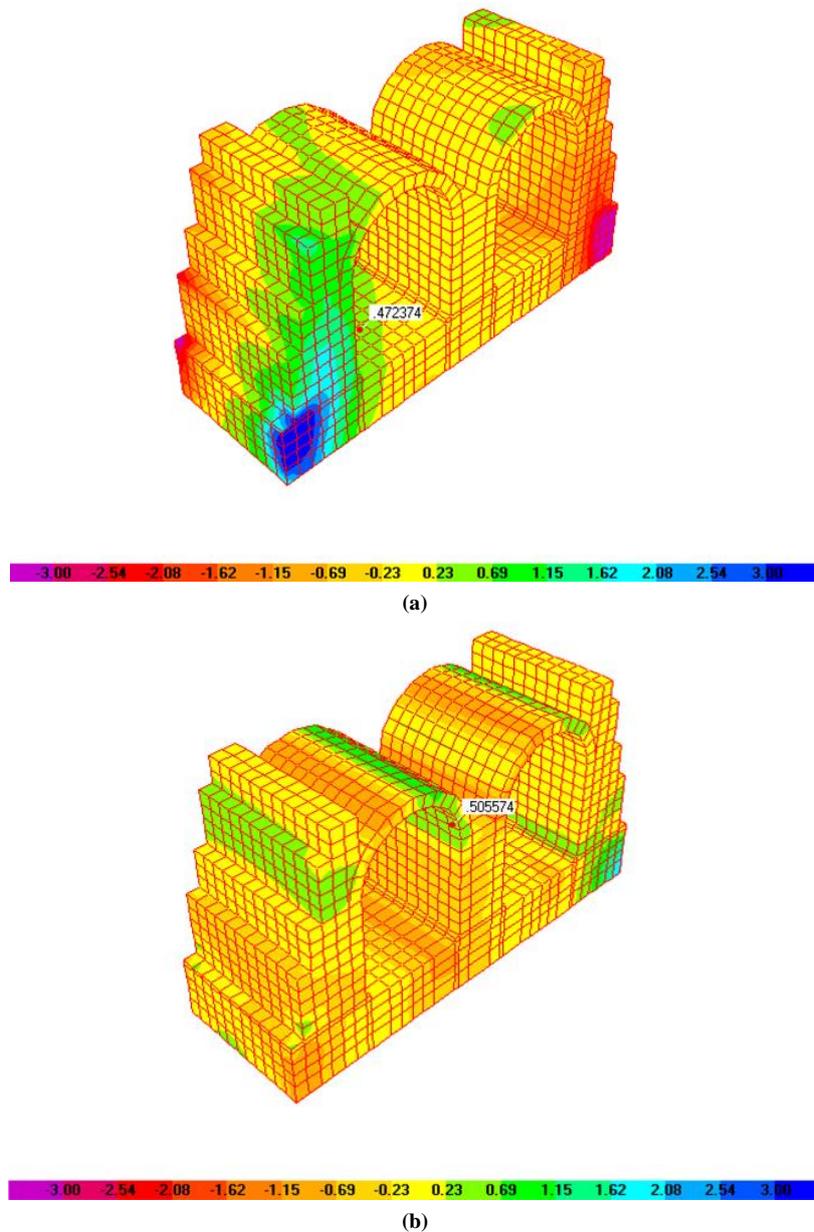
Figure 35. a) Maximum shear stresses (S1-2) in the strengthened bricks Regulator (kg/cm²) due to static and dynamic loading, b) b. Maximum shear stresses (S1-3) in strengthened bricks Regulator (kg/cm²) due to static and dynamic loading

Table 5 and Figure 35 illustrate the maximum shear stresses (S1-2 and S1-3) in the strengthened brick mortar under static and dynamic loading conditions. The raft exhibits the highest shear stress level at 0.70 kg/cm², primarily due to its foundational role in bearing and distributing loads from the entire structure. Despite this, the stress level remains well-managed, indicating that the reinforced structure effectively handles foundational stresses. The arch displays a shear stress of 0.40 kg/cm², which represents a notable reduction compared to its original state. This reduction suggests that the reinforced concrete (RC) jacket successfully redistributes loads, minimizing stress concentrations within the arch.

The abutment maintains a shear stress of 0.35 kg/cm², significantly lower than its pre-strengthened levels. This improvement highlights the effectiveness of the reinforcement in enhancing the abutment's capacity to manage operational loads. Similarly, the pier exhibits a shear stress of 0.46 kg/cm², which remains within safe limits. This result

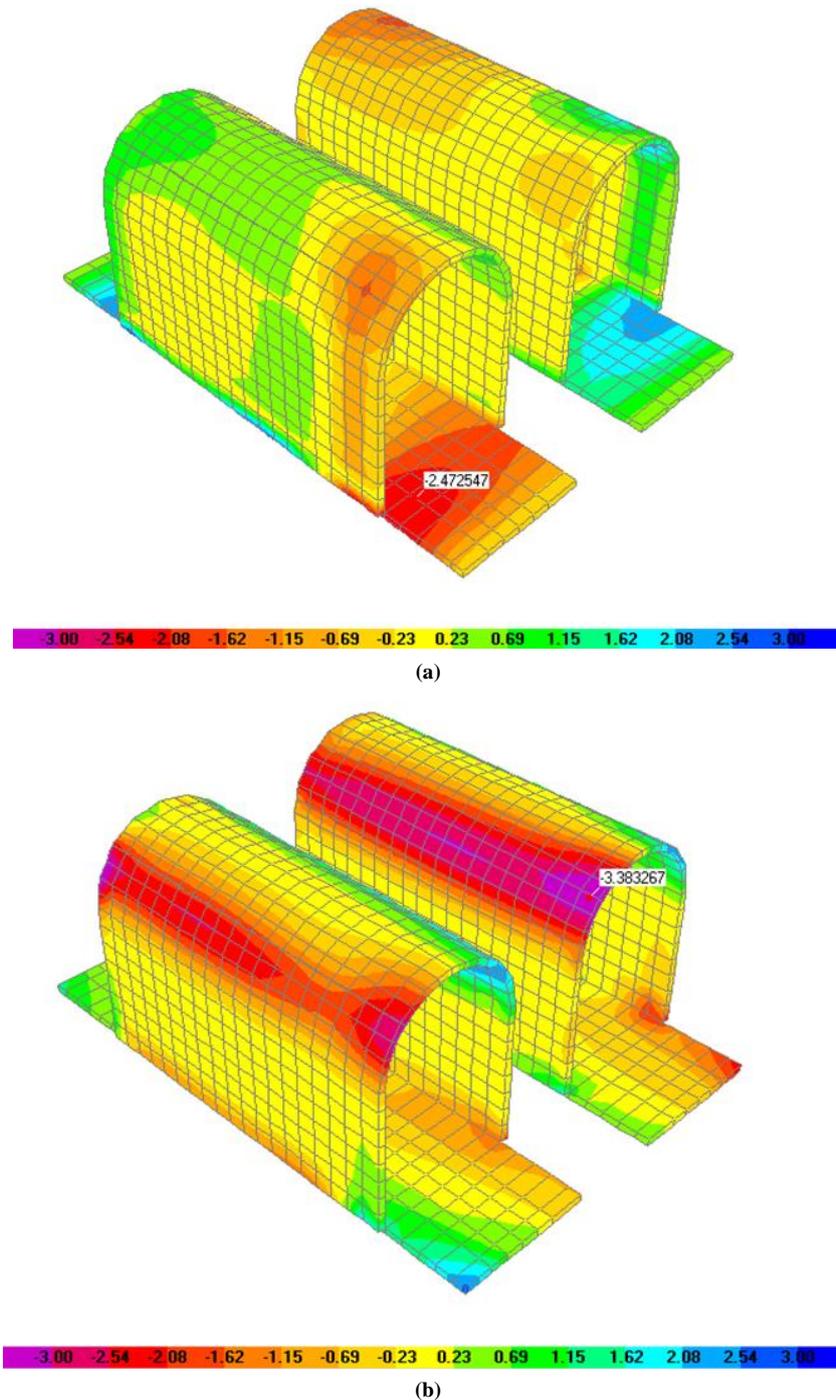
Figure 36. a) Maximum shear stresses(S1-2) in RC jacket (kg/cm²) due to static and dynamic loading after strengthening, b) Maximum shear stresses (S1-3) in RC jacket (kg/cm²) due to static and dynamic loading after strengthening

Figure 36-a illustrates the maximum shear stress (S1-2) within the reinforced concrete (RC) jacket, measured in kg/cm², under both static and dynamic loading conditions after structural strengthening. Similarly, Figure 36-b displays the maximum shear stress (S1-3) under the same load types. These visuals provide insight into the distribution and magnitude of shear stresses post-strengthening, highlighting the RC jacket's enhanced resilience against varied loads. This improvement is crucial for maintaining stability and ensuring stresses remain within the permissible limits defined by the Egyptian Code of Practice [31], setting the context for evaluating concrete cracking stress and allowable thresholds as specified in ECP 203 standards [31].

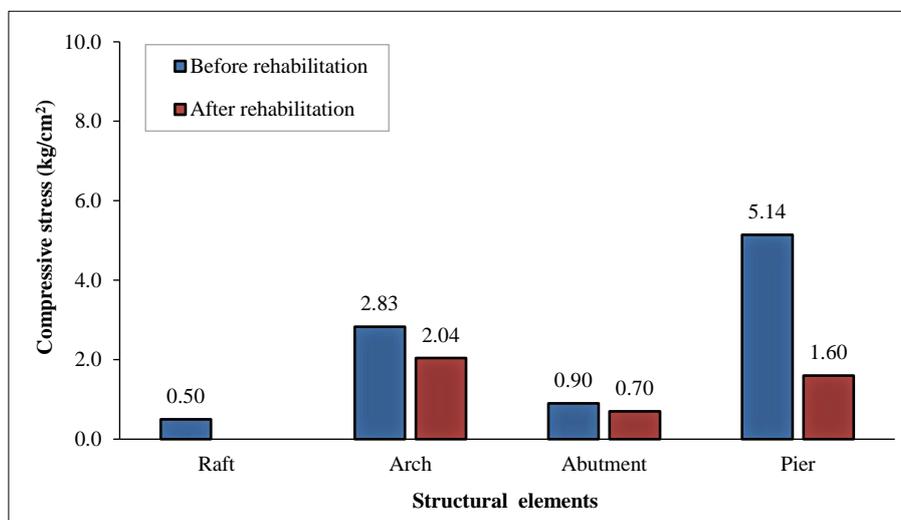
Figure 37. Maximum compressive stresses in bricks before and after rehabilitation

Figures 37 and 38 illustrate the maximum compressive and tensile stresses in the brick elements before and after rehabilitation. These results were obtained from numerical models (SAP2000), where the maximum compression or tension stress at specific points in the brick elements prior to rehabilitation was compared to the corresponding stresses at the same points after rehabilitation. Figure 39 presents the maximum shear stresses in the brick mortar before and after rehabilitation. Similar to the previous results, these shear stress values were extracted from the numerical models at specific points and compared to evaluate the reduction in shear stress post-rehabilitation.

After rehabilitation, the brick's tensile stress decreased by 36%, 84%, and 21% for the raft, arch, and abutment, respectively. Similarly, the brick's compressive stress was reduced by 100%, 28%, 22%, and 69% for the raft, arch, abutment, and pier, respectively. The mortar's shear stress also showed significant reductions of 23% and 86% for the raft and arch, respectively. The RC jacket effectively reduced both the brick's compressive and tensile stresses across structural elements, including the arch, abutment, pier, and raft. Additionally, the RC jacket contributed to a substantial reduction in the brick mortar's shear stresses in the arch and raft, further enhancing the structural performance.

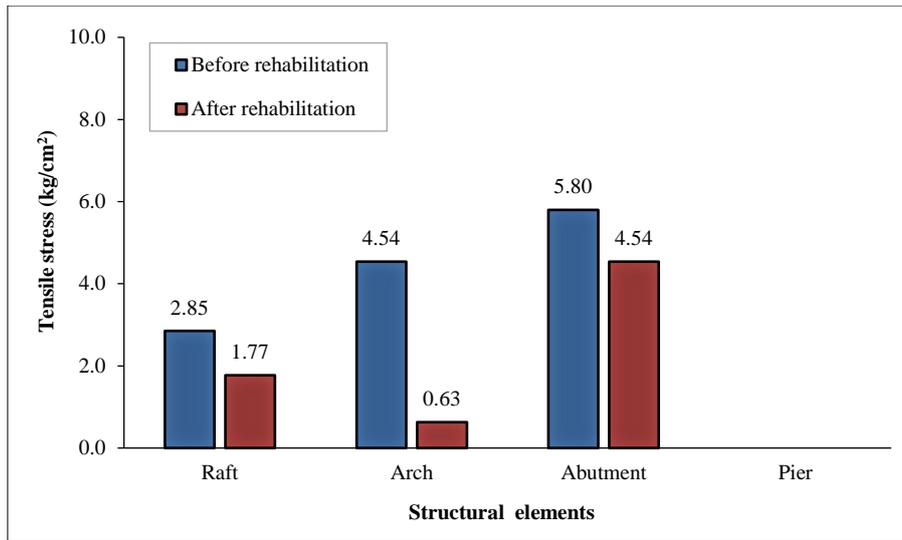
Figure 38. Maximum tensile stresses in bricks before and after rehabilitation
