Structural Assessment and Rehabilitation of an Existing Hydraulic Masonry Structure Supporting Railway

Aly A. Makhlof¹

¹ Construction Research Institute (CRI), National Water Research Center (NWRC), Delta-Barrage, 13621, Egypt.

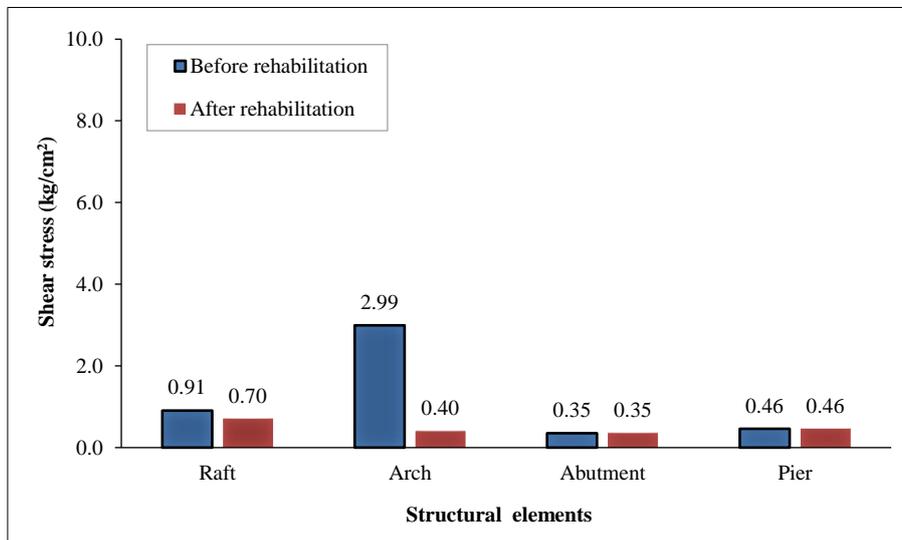
Figure 39. Maximum shear stresses in brick mortar before and after rehabilitation

Figures 37 and 38 illustrate the maximum compressive and tensile stresses in the brick elements before and after rehabilitation. These results were obtained from numerical models (SAP2000), where the maximum compression or tension stress at specific points in the brick elements prior to rehabilitation was compared to the corresponding stresses at the same points after rehabilitation. Figure 39 presents the maximum shear stresses in the brick mortar before and after rehabilitation. Similar to the previous results, these shear stress values were extracted from the numerical models at specific points and compared to evaluate the reduction in shear stress post-rehabilitation.

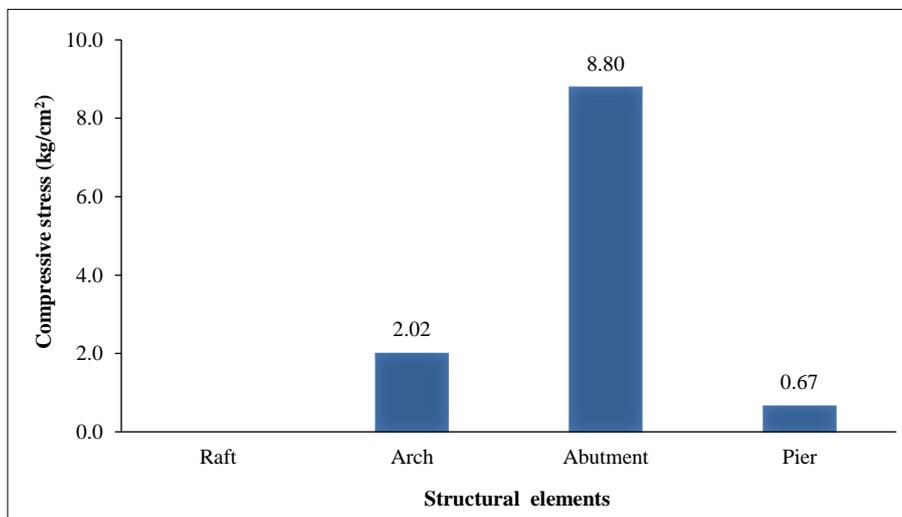
Figure 40. Maximum compressive stresses in RC jacket after rehabilitation

Additionally, Figures 40 and 41 depict the maximum compressive and tensile stresses in the reinforced concrete (RC) jacket after rehabilitation. These stresses were obtained from the numerical models (SAP2000) at the critical points where maximum compression and tension stresses occurred.

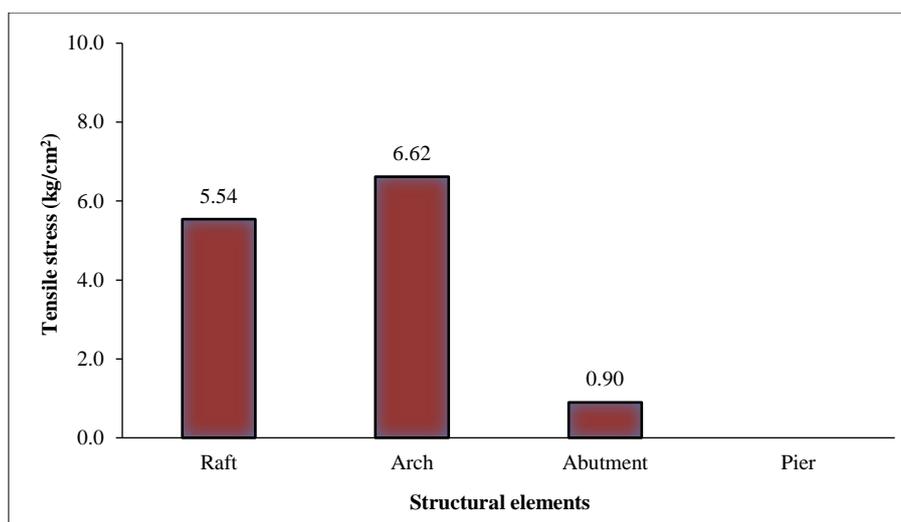
Figure 41. Maximum tensile stresses in RC jacket after rehabilitation
