Experimental Study of Behaviour of Reactive Powder Concrete Strengthening by NSM-CFRP Corbels

Abdul Kareem Qasim Mohammad ^{a*}, Mushriq Fuad Kadhim Al-Shamaa ^a

^a Civil Engineering Department, University of Baghdad, Baghdad, Iraq.

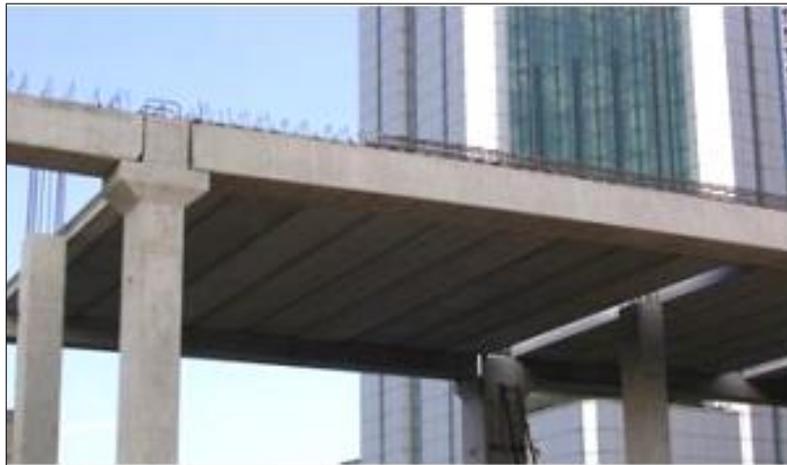
Figure 1. Precast concrete column corbels [2]

It was found from the last earthquake in the world that most collapse of precast buildings was caused by failure of connections. Therefore, an extensive researches should be carried out to improve precast concrete connections. A common simple precast concrete connection is corbel. Reinforced concrete corbels are structural elements widely used in practice. These corbels, by asset of their locations, are possessed as small as possible and are heavily and seriously loaded. Very often their dimensions are imposed by architectural requirements rather than by considerations of engineering facilities. However, when high strength concrete is engaged with these corbels the tendency is to decrease the dimensions the section gets smaller even though the design engineer still has to comply with the design requirements such as concrete cover, bar spacing and the amount of flexural and stirrup reinforcement. Corbels mainly used to carry beams and girders, and to transfer loads to the other structures in bridges and precast concrete constructions, as show in Figure 1.

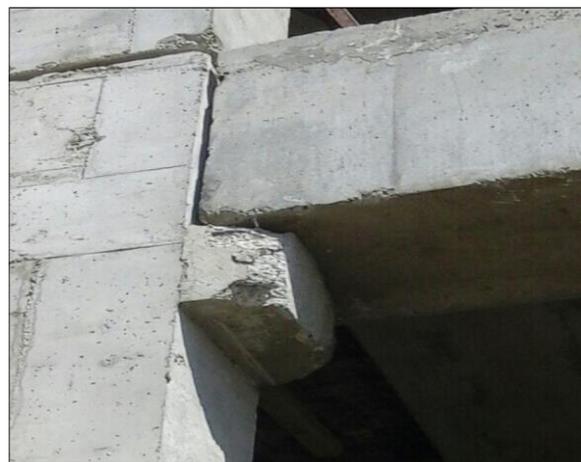
Figure 2. Destroyed corbel in local building under construction

DeLorenzis and Nanni, 2002 If the existing steel reinforcement is reduced in capacity due to: corrosion or increase in traffic loads (e.g. permissible axle weights), as shown in Figure 2, then we should improve the structural design or seismic resistance. In addition to that, attempts needs to be made to use other forms of FRP strengthening in practice researches. Near surface mounted stripes or bars is a promising technique for improvement shear and flexure strength of reinforced concrete members [5].

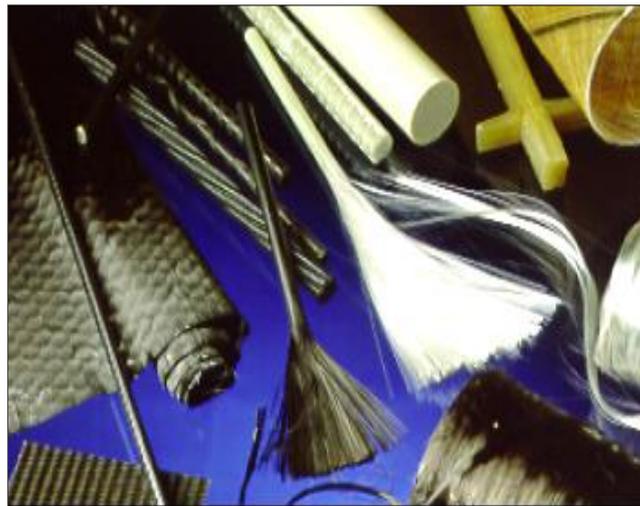
Figure 3. Available materials of FRP products [7]

aramid fibers (AFRP) and carbon fibers (CFRP), and takes several forms, for example, fabric, plates, bars, 2D grid and 3D grid as shown in Figure 3 [6].

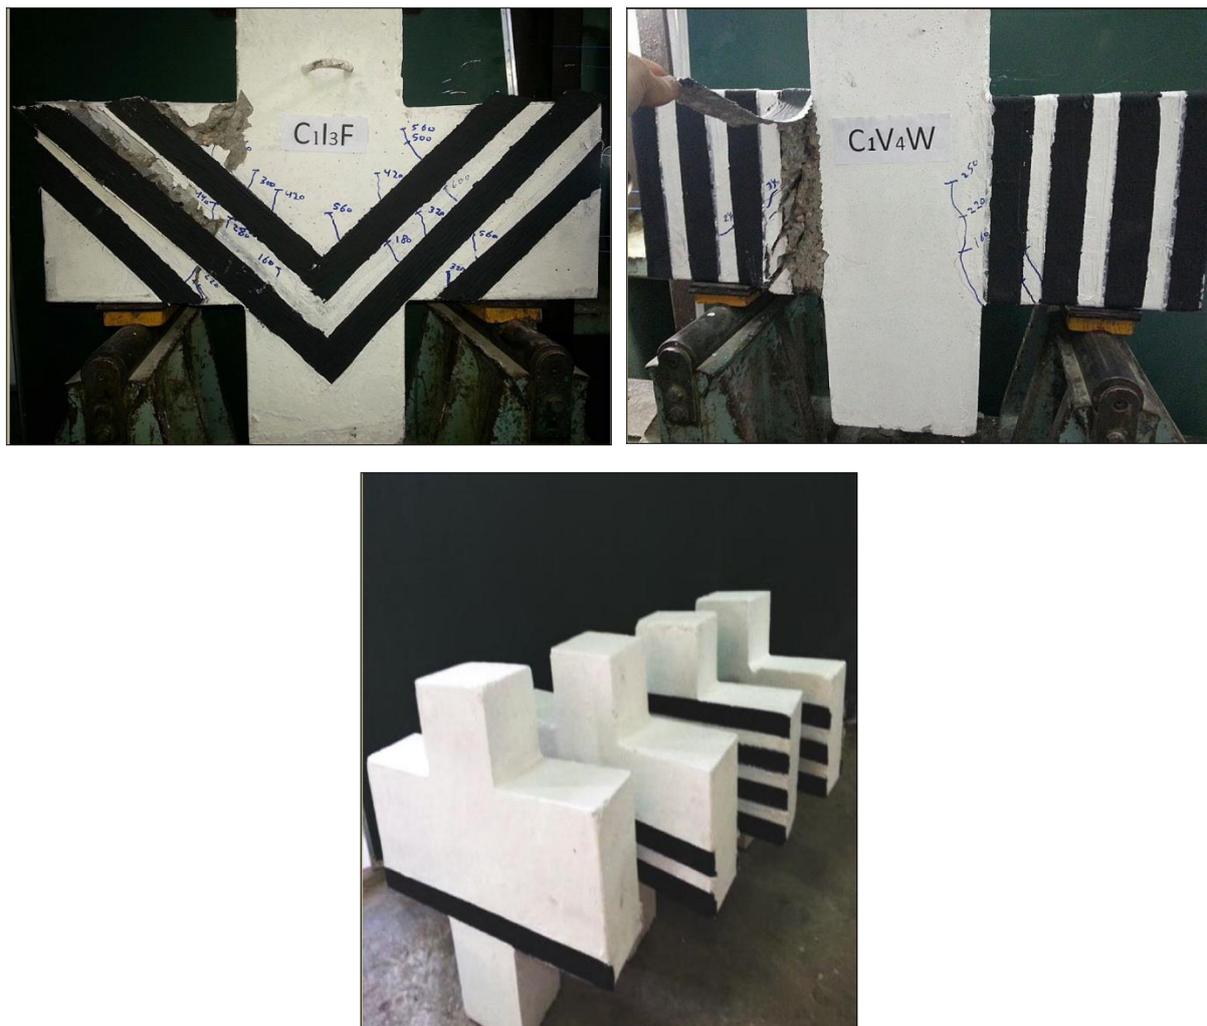
Figure 4. Detail and Geometry of Strengthened Specimens [8]

Abed Attiya (2012) [8] examined the influence of CFRP stripes on the ultimate load capacity of repaired and strengthened concrete corbels. The strengthened corbels with external bonded of CFRP, as shown in Figure 4 had variables for investigation comprised number of CFRP strips, angle of inclination, bonding type of stripes and ratio of shear span s to effective depth (a/d).

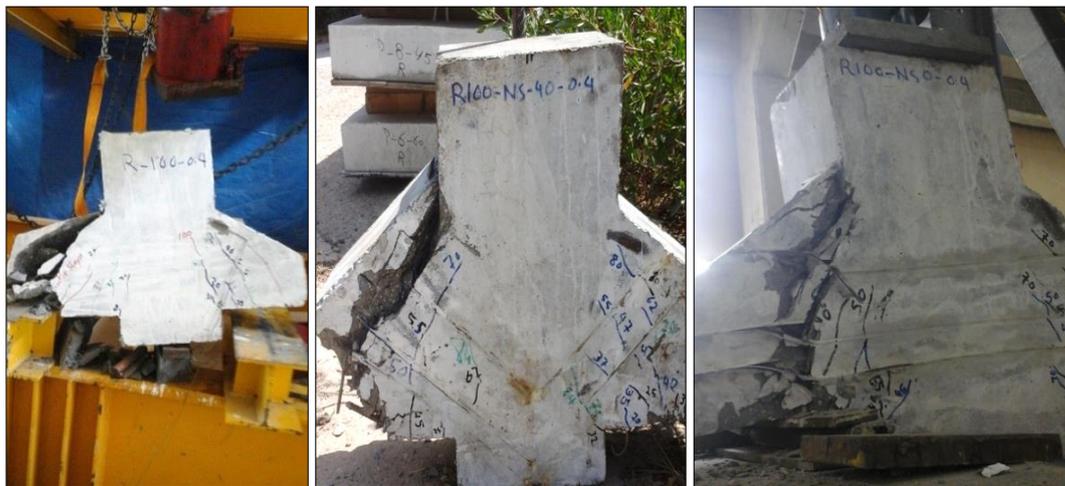
Figure 16. Crack Pattern and failure for strengthening corbels of group B

Corbels of this group were failed in a combination of shear and concrete crushing under compression. During loading these corbels the vertical direct shear crack which appeared at horizontal face as evident in Figure 16, and diagonal cracks formed in each case at the inner edge of the bearing plate towards the loading plate and widened with increasing load, ultimately leading to failure with simultaneous shear and crushing of concrete in the compression zone. The crack continued to widen and propagate until it caused failure, at failure, final destruction occurred by crushing of the concrete in compression at the junction of the column and the inclined face of the corbel as shown clearly in Figure 16. It can be noticed that the shear crack remained fine, failure of all specimens occurred only after a primary diagonal crack parallel to the strut developed between the supports and the intersection of the sloping face of the corbel and the column face.
