Rehabilitation of the Roof Timber Trusses of a Multiuse Pavilion

Abstract

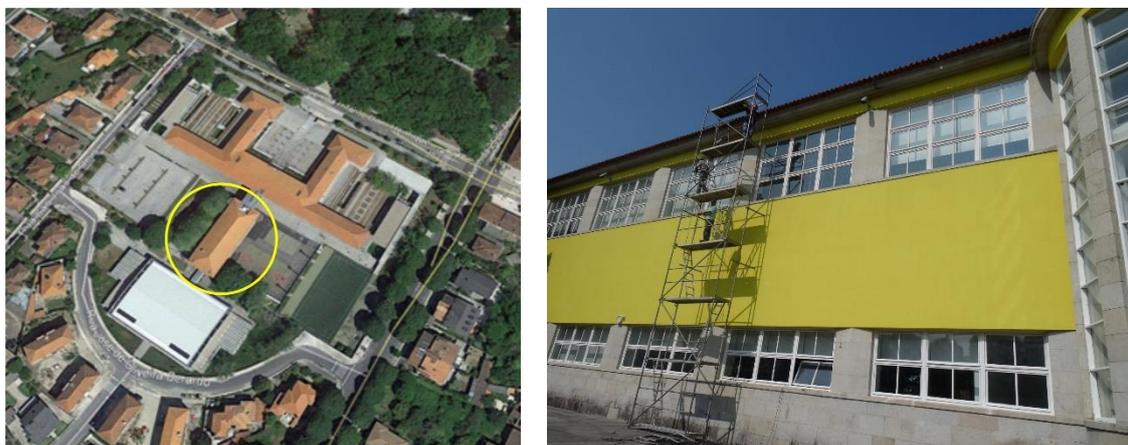
The Central Viseu Lyceum was established in 1849, its name having been changed to “Alves Martins” in 1911, little after the Republic proclamation. The actual facilities were built in 1948, within the frame of an extensive governmental scholar constructions program. Figure 1-left shows an overview of the scholar complex, the yellow circle highlighting the pavilion, whose upper floor is taken by the Multiuse Room, shown in Figure 1-right from the outside. The pavilion is a 2-florey building. The ground floor hosts the school lunchroom. The upper floor was formerly used as the school gymnasium, but the recent construction of a larger and modern one allowed this space to be disaffected from that original use and being reassigned as a multiuse space. It is rectangular in shape, with inner dimensions of 14×20 m. The main entrance is located in the North side, a small stage existing in the opposite side. The roof is of 4-sided hip type, with slopes of 25°.

Figure 1. School overview (left); Multiuse Pavilion (right)

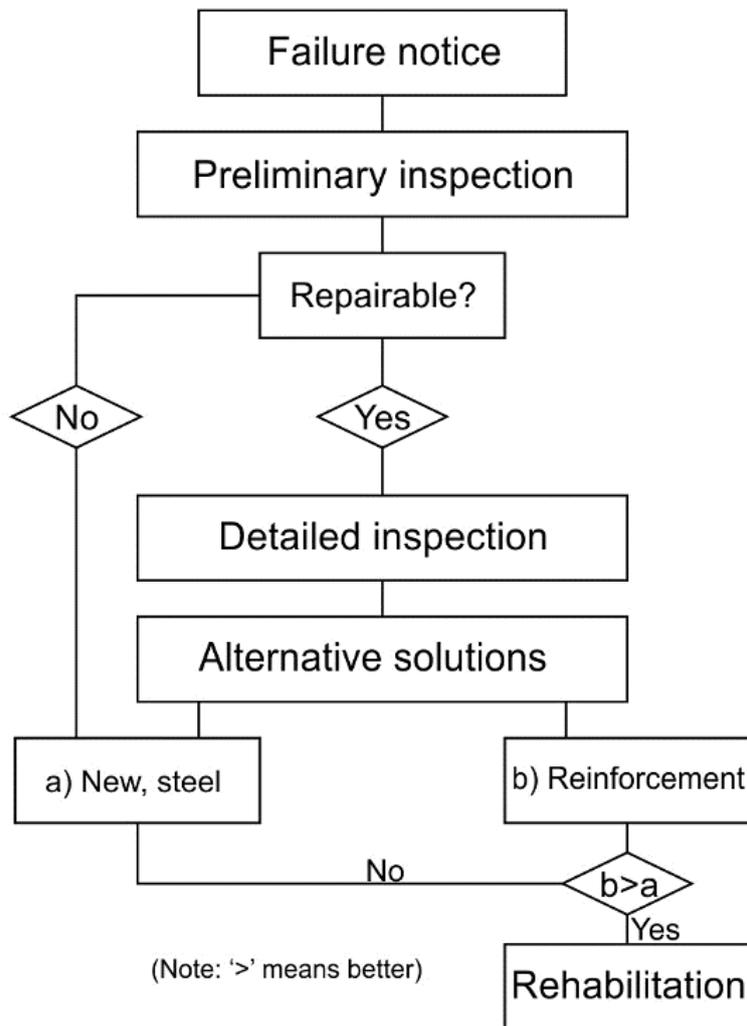
In the following sections, the methodology used to assess the present condition and the proposed intervention procedures are described. Section 2 details the inspection and diagnosis of the timber roof, where the causes and nature of the observed failures was identified and the general intervention needs were identified. Some discussion and detailing on the rehabilitation solution is provided in Section 3, while Section 4 describes the programmed execution procedures as well as the additional inspection work whose need became evident during the execution. The text is closed with the most relevant conclusions drawn from the work. The flowchart in Figure 3 illustrates the whole decision process.

Figure 3. Flowchart of the decision process

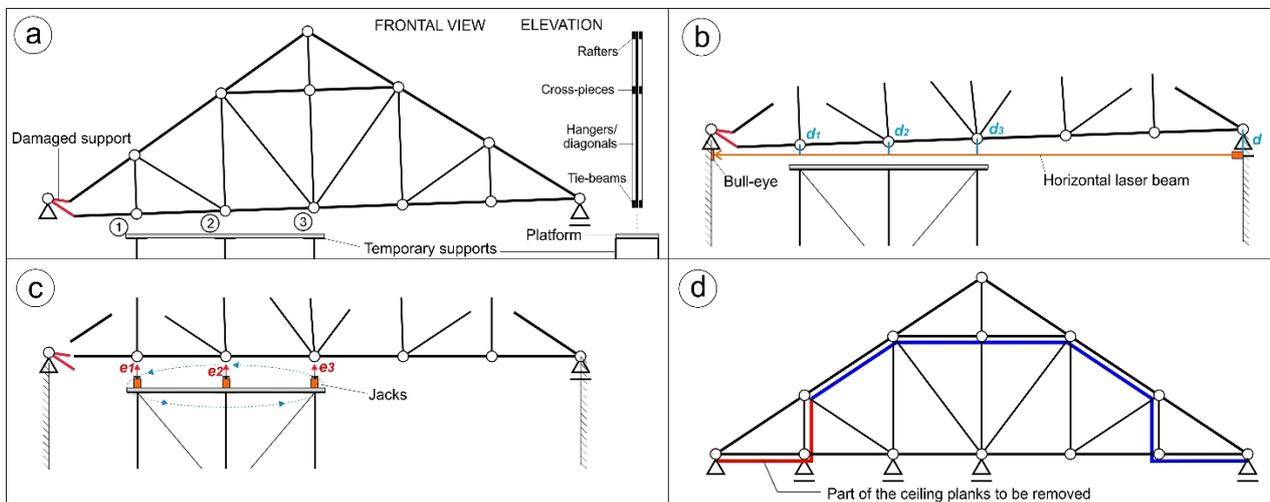
Figure 13. Execution process of the truss propping

- Placement of propping supports under the nodes 1, 2 and 3 (Figure 13-a) and in the middle plan of the truss, with a free gap of 0,30m between the top of the props and the bottom of the nodes;

- Bracing of the props in both the truss in-plane and out-of-plane directions;
- Levelling of a laser beam and bull-eyes on the opposite supporting walls (Figure 13-b). With a ruler or a movable bull-eye, measure the distances d_1 , d_2 and d_3 and, from these, the deflections ($e_i=d-d_i$) of nodes 1, 2 and 3;

- Removal of the ceiling planks between the broken support and the adjacent tie-beam node (Figure 13-d), in order to allow full access to the damaged elements;

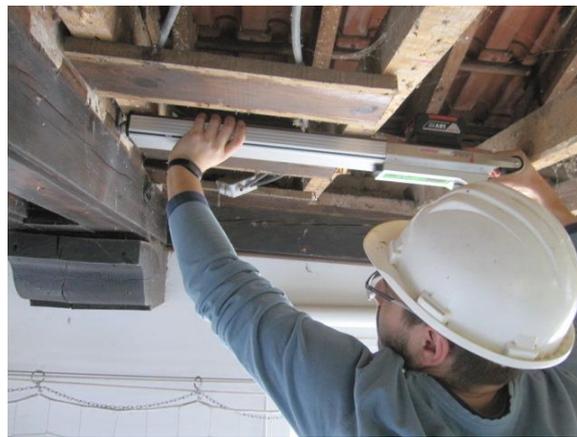
When the ceiling planks were removed and visual contact was established with the structural truss elements, the contractor expressed some doubts regarding the extent of biologic attack of some structural elements. To address this, a late visual inspection and a Resistograph (driller) campaign (Figure 14) were carried out, which confirmed the general good conservation condition of all the elements and, consequently, the execution could proceed as initially planned. The inspection program was as shown in Figure 15.

Figure 14. Assessment drillings

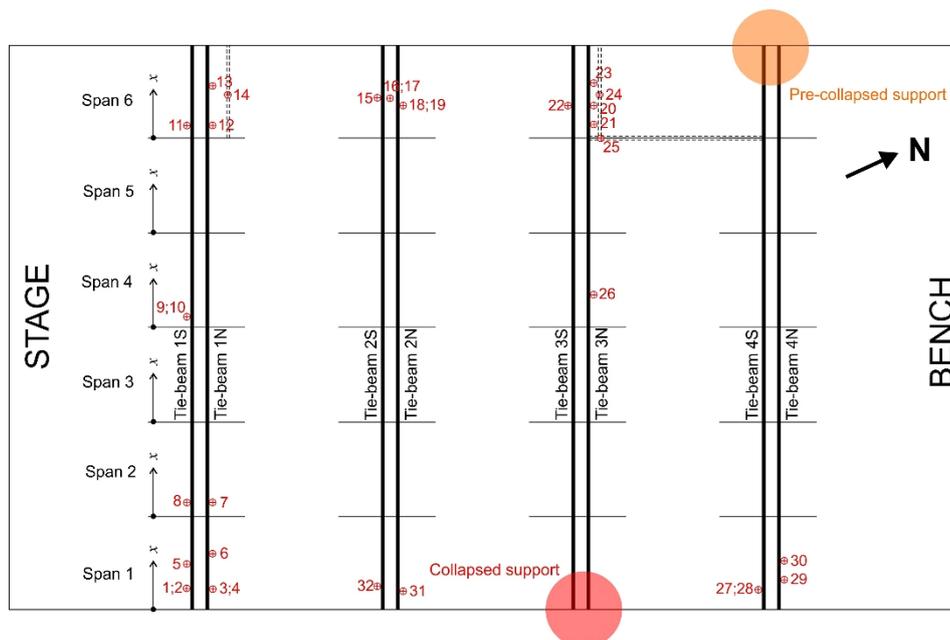
Figure 15. Resistograph drilling program
