Study of Post-Spalling Reinforced Concrete Beam Repair Using Grouting and GFRP Reinforcement

Keywords: Reinforced Concrete; Spalling; Grouting; GFRP.

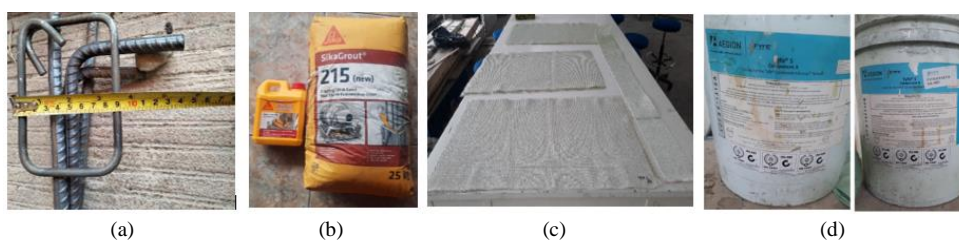
Figure 4. (a) D 13 iron reinforcement and ϕ 8 (b) SikagROUT-215 mortar and Sika bonding adhesive (c) GFRP Woven sheet (d) epoxy resin FRP components A and B

The last procedure for making test objects is reinforcing RC beams using GFRP composites. a) leveling the surface of the beam to be reinforced with GFRP and U-wrap layers and cleaning it from any dirt that might reduce concrete adhesion; b) preparing a mixture of epoxy resin adhesive components A and component B with a weight ratio of 2:1. The stirring process should not be excessive to produce foam and bubbles that can be trapped as air voids in the adhesive; c) Attach the reinforcement material that has been cut and treated with adhesive in the longitudinal direction of the beam and gently press against the adhesive that is still wet. Air voids trapped between the reinforcement layer and the concrete surface will be released by roller pressure in the direction of the reinforcement fibers so that the adhesive blends with the fibers and the concrete surface. Roller pressure perpendicular to the fiber direction is not allowed, as it may change the fiber direction or damage the fiber. Apply the second-stage adhesive over the fully adhered Tyfo SEH-51 GFRP surface to ensure fiber adhesion to the concrete surface. There are two variations of GFRP composite sheet installation on RC beams: reinforcement at the bottom position of RC beams that have been patched (BGRS) and installation of GFRP U-Wrap on both support areas of RC beams (BGRST). The main materials used in this research are shown in Figure 4, and some photos of the procedure for making RC beam specimens are shown in Figure 5.
