Analysis of the Challenges and Technical Solutions for Revitalization of Traditional Buildings in Hot and Humid Climate (Case Study: Anthropology Museum of Local Residents in Kish Island)

7. Introducing the Case Study: Anthropology Museum of Local Residents in Kish Island

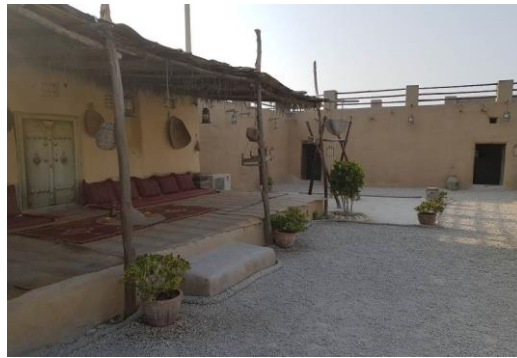
Figure 4. Using local materials to make shading space at the courtyard

Topic	Solutions in Kish Case Study	
Architecture	Courtyard in building	Preservation of central courtyard in old form and increasing semi-open spaces (figure 2) Maximum use of central courtyard for sitting spaces due to new public function of building (figure 3)
	Shading on open spaces and terrace	Using canopy in different parts of courtyard (figure 4)
	Building height	No change in 4-meter height of building
	Building façade	Preserving physical form of building in old form and 1-storey form and using same spaces in the flat floor Using local materials and furniture like mat and thick rope to form courtyard and sitting spaces (figure 5)
Structure	Earthquake	Using brace for courtyard walls and outdoor walls for more resistance (figure 6)
	Skeleton and materials	Using wood and local and natural materials for shading ceilings Using thick walls as insulator (figure 4 and 8)
	Building subsidence	Protecting wooden frames of doors for resistance of openings (figure 7)

Achieving favourable interior temperature	Using split to make inside spaces cool (figure 8) Placement of condensers in less-observable corners of courtyard and under the shade of walls (figure 4)
Infrastructure	Insulation	Protecting old materials like Sarouj (mortar) for inside and outside façade of building causing resistance and relative insulation Protecting thick walls of building causing reduced thermal wastage
	Reduced air humidity	Using platforms for rest spaces at the courtyard to reduce air humidity (figure 9)

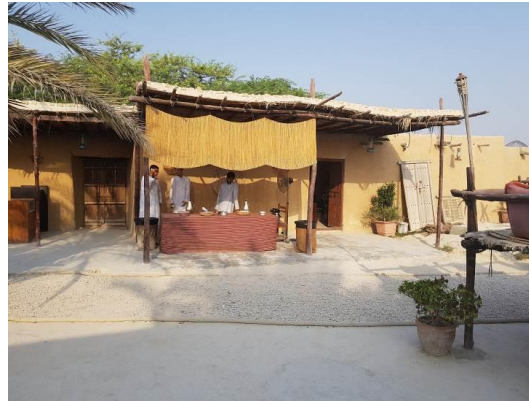
Figure 5. Using local and simple materials like wood mat and rope to form courtyard and create furniture

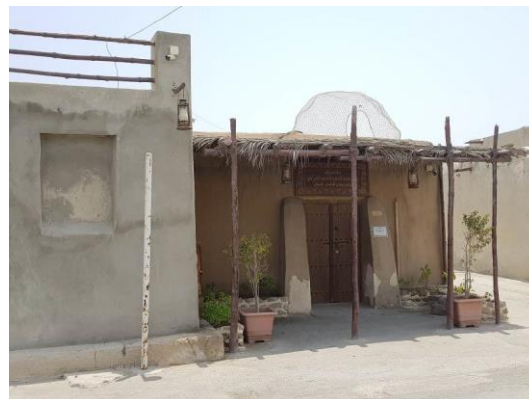
Figure 6. Using bracing in walls and wood in skeleton of canopies for relative resistance against earthquake
